**NYC Department of Education
Building Condition Assessment Survey 2023 - 2024**

Architectural Inspection

K778

Asset: EL PUENTE HS - BROOKLYN, 250 HOOPER STREET, New York, 11211

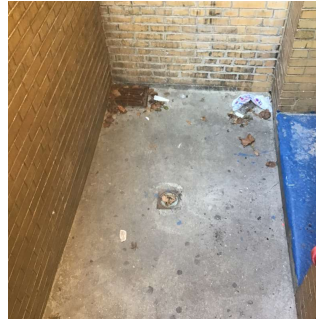
AW3
 No violations recorded.

Question	Response
Architectural	
EXTERIOR	Inspected
AREAWAY	Inspected
Instance on AW1 - AW3	Inspected
Instance Condition	4 - Between Fair and Poor
Instance Quantity	3
Instance Quantity Uom	EACH
Deficiency	AREAWAY DRAINS: DETERIORATED

1
 EACH
 REPLACE
 PRIORITY 4
 LEVEL 2

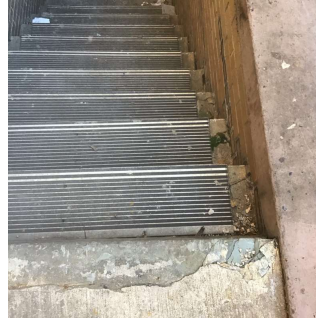
AW2

AREAWAY STAIRS: DETERIORATED
 TREADS/RISERS/NOSINGS

20
 S.F.
 REPLACE
 PRIORITY 4
 LEVEL 2

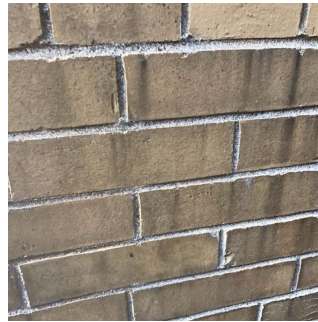
AW1
No violations recorded.

AREAWAY WALLS: DETERIORATED JOINTS

20
S.F.
REPAIR
PRIORITY 3
LEVEL 2

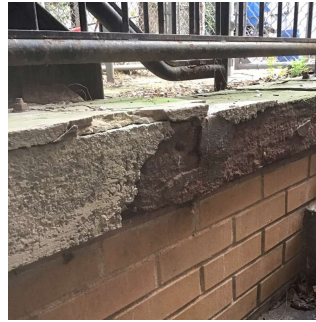
AW1
No violations recorded.

AREAWAY WALLS: DETERIORATED COPING STONE

20
S.F.
REPLACE
PRIORITY 4
LEVEL 2

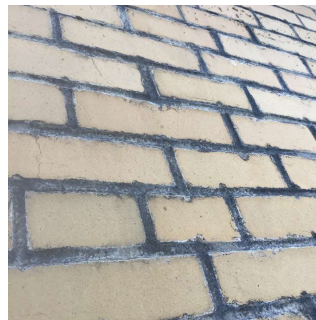
CH
No violations recorded.

BRICK: DETERIORATED JOINTS

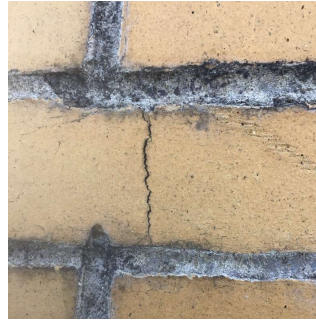
BRICK: MINOR CRACKS AND SPALLING

K778
 30
 S.F.
 RESTITCH
 PRIORITY 3
 LEVEL 2

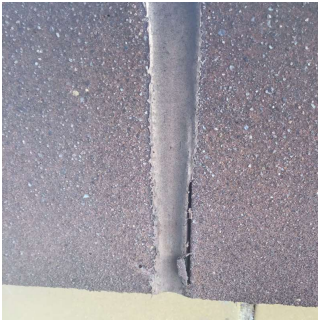
Violations	CH No violations recorded.
COPING	
Condition	Inspected 2 - Between Good and Fair
Deficiency	CAST STONE: DETERIORATED TRANSVERSE JOINTS
Roof Plan reference	K778

Hooper Street
Deficiency Quantity	10
Quantity Uom	L.F.
Potential Action	MAINTENANCE
Urgency of Action	PRIORITY 3
Purpose of Action	LEVEL 2
Deficiency Photo1

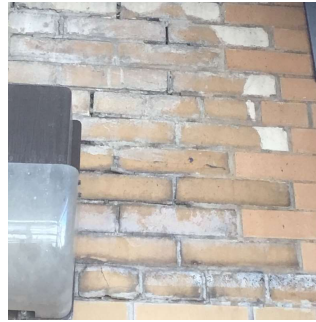
Facade B

BRICK: DETERIORATED JOINTS

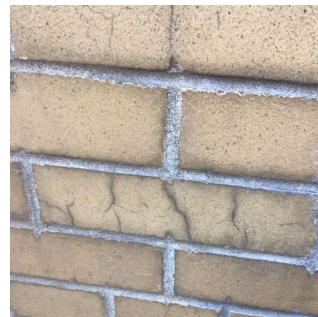
Facade C

BRICK: MINOR CRACKS AND SPALLING

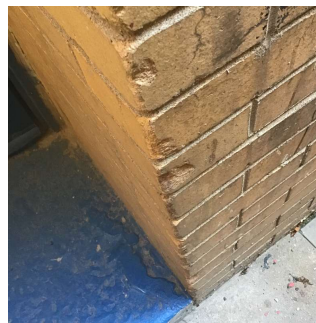
Facade D

BRICK: CRACKS/DISPLACED/SPALLED BRICK AT BUILDING CORNERS

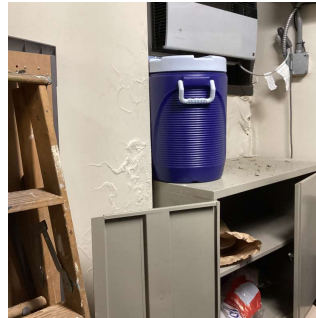
BRICK: WATER INFILTRATION IN INSTRUCTIONAL SPACE

Facade B - Room 105 (shown), Multipurpose Room, Stair B/3
No violations recorded.

REPAIR

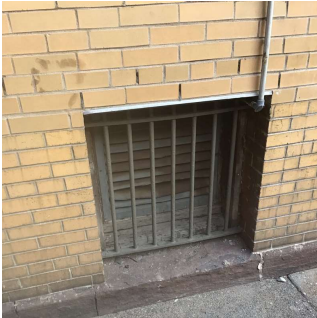
BROKEN/ DENTED BLADES

30
S.F.
REPLACE
PRIORITY 4
LEVEL 2

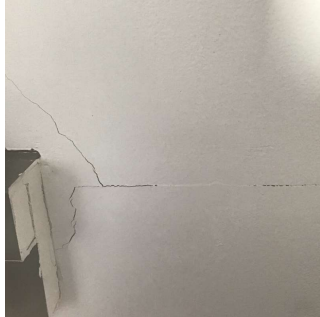
Roof 1
Instance Quantity	6,000
Instance Quantity Uom	S.F.
Does the roof have major mechanical equipment sitting on Dunnage Steel less than 18" above the Roofing?	No
Does this roof instance have a Sustainable Roof System?	Yes
Sustainable Roof Type	White Roof
Sustainable Roof Location (Roof Number)	Roof 1
Do solar panels exist on these roofs?	No
Is/Are the roof(s) suitable for Solar Panel installation?	No
Installation Year	2019
Source of Installation	Custodial Staff
Deficiency	No deficiencies recorded
ROOFING DRAINS	Inspected
Condition	2 - Between Good and Fair
Deficiency	No deficiencies recorded
Specialties	Inspected
BULKHEAD/PENTHOUSE	Inspected
Condition	3 - Fair
Deficiency	BULKHEAD/PENTHOUSE WALLS/INTERIOR: PLASTER CRACKS/SPALLING
Roof Plan reference	K778

Deficiency Quantity	20
Quantity Uom	S.F.
Potential Action	REPLACE
Urgency of Action	PRIORITY 4
Purpose of Action	LEVEL 2

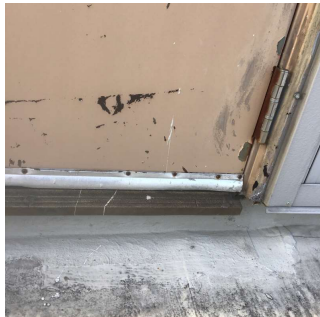
Violations	BH1 No violations recorded.
Deficiency	BULKHEAD/PENTHOUSE DOORS: DETERIORATED DOOR AND FRAME
Roof Plan reference	K778

Deficiency Quantity	1
Quantity Uom	EACH
Potential Action	REPLACE DOOR AND FRAME
Urgency of Action	PRIORITY 4
Purpose of Action	LEVEL 2
Deficiency Photo1

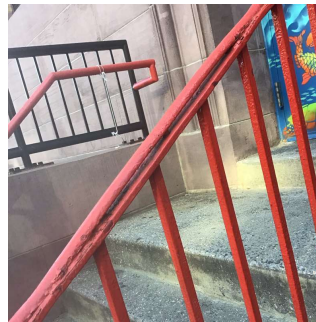
Facade A

RUST - MAJOR

REPLACE

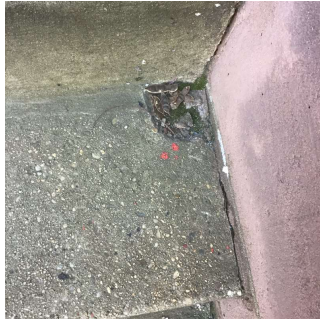
Violations	AW3 No violations recorded.
STAIRS/RAMPS	
Condition	Inspected 2 - Between Good and Fair
Deficiency	CONCRETE: CRACKS/SPALLING - MINOR
Roof Plan reference	K778

Deficiency Quantity	10
Quantity Uom	S.F.
Potential Action	REPAIR
Urgency of Action	PRIORITY 3
Purpose of Action	LEVEL 2
Deficiency Photo1

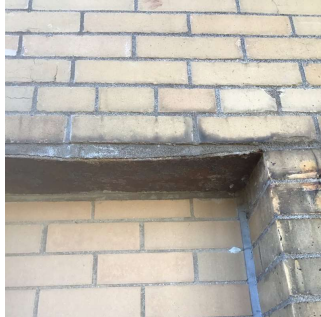
Facade B

Deficiency	STEEL: MAJOR RUSTING
------------	----------------------

Potential Action	REPLACE
------------------	---------

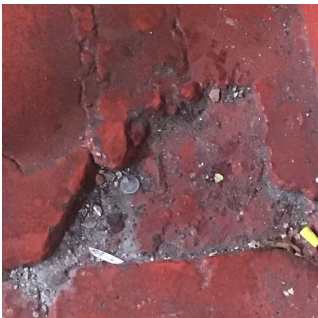
Violations	Basement - Boiler Room No violations recorded.
Deficiency	CONCRETE SLAB ON GRADE: THRU CRACKS
Deficiency Location/Instance	Basement - Boiler Room
Deficiency Quantity	30
Quantity Uom	S.F.
Potential Action	REPLACE
Urgency of Action	PRIORITY 4
Purpose of Action	LEVEL 5
Deficiency Photo1

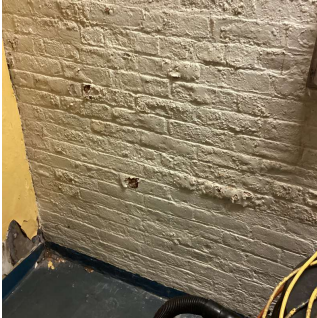
Violations	Basement - Boiler Room No violations recorded.
FOUNDATION WALLS	Inspected
Material Type(s)	Concrete, Masonry
Condition	4 - Between Fair and Poor
Deficiency	BRICK: WATER INFILTRATION IN INSTRUCTIONAL SPACE

Deficiency Location/Instance	Basement - Cafeteria, Cafeteria Exit Vestibule
Deficiency Quantity	200

Question	Response
INTERIOR	
STRUCTURAL	
FOUNDATION WALLS	
Quantity Uom	S.F.
Potential Action	INSTALL WATERPROOFING
Urgency of Action	PRIORITY 5
Purpose of Action	LEVEL 5
Deficiency Photo1

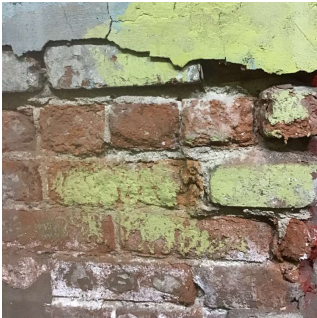
Violations	Cafeteria Exit Vestibule No violations recorded.
Deficiency	BRICK: CRACKED/SPALLED
Deficiency Location/Instance	Basement - Boiler Room, Meter Room
Deficiency Quantity	70
Quantity Uom	S.F.
Potential Action	RESTITCH
Urgency of Action	PRIORITY 4
Purpose of Action	LEVEL 5
Deficiency Photo1

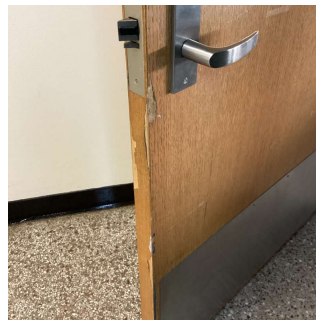
Room 401
No violations recorded.

WOOD: DETERIORATED DOOR
Rooms 206, 401, 403, 405
4
EACH
MAINTENANCE
PRIORITY 3
LEVEL 2

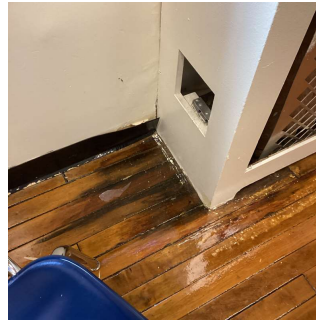
Room 403

WOOD: DAMAGED/DETERIORATED
Rooms 403, 302
30
S.F.
REPLACE
PRIORITY 3
LEVEL 2

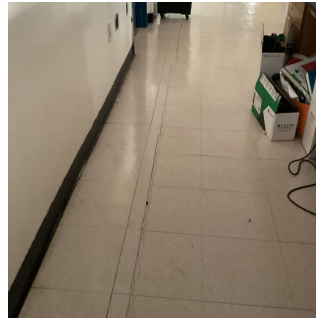
Room 401

VINYL TILES: DETERIORATED SUBSTRATE

REPLACE

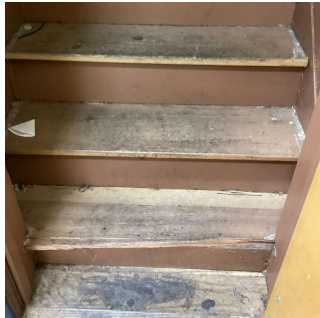
Yes	Tripping Hazard	Severely broken tread edge is a potential safety hazard.	INTERIOR STAIRS/RAMP S: INTERIOR Stairs and Landings	Room 102	Ralthie Llorens	Custodian

Violations	Stair B/1 No violations recorded.
Stairs and Landings	
Condition	Inspected 3 - Fair
Deficiency	WOOD: BROKEN/DETERIORATED
Deficiency Location/Instance	Room 102
Deficiency Quantity	10
Quantity Uom	S.F.
Potential Action	REPLACE
Urgency of Action	PRIORITY 5
Purpose of Action	LEVEL 6
Deficiency Photo1
