**NYC Department of Education**  
**Building Condition Assessment Survey 2023 - 2024**

Architectural Inspection

K780

**Asset:**       **PRE-K CENTER @ 7401 FORT HAMILTON PARKWAY - BROOKLYN, 7401 FORT HAMILTON PARKWAY, New York, 11228**

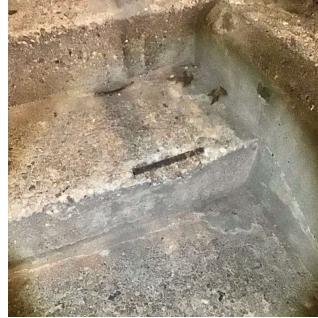
AW1

AREAWAY WALLS: CRACKS AND SPALLING

REPLACE  
 PRIORITY 4  
 LEVEL 2

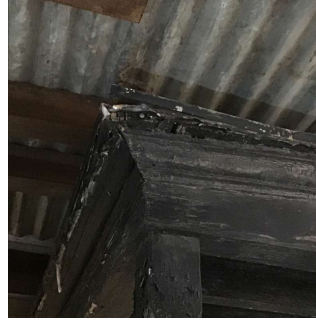
Facade A - Exit 5

BRICK: DETERIORATED CAP

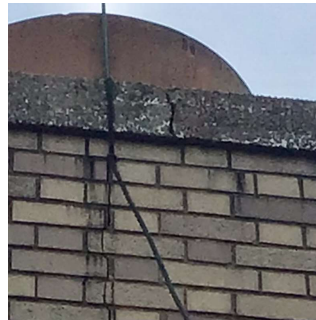
Roof 2 - CH

BRICK: DETERIORATED JOINTS

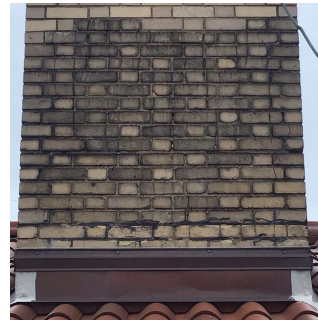
Roof 2 - CH

**BRICK: MAJOR / THRU CRACKS**

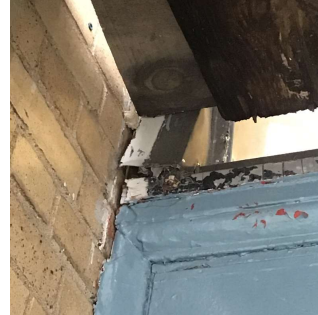
Facade C - Exit 2

METAL: DENTED, MAJOR RUSTING

20  
 S.F.  
 REPLACE

PRIORITY 4  
LEVEL 2

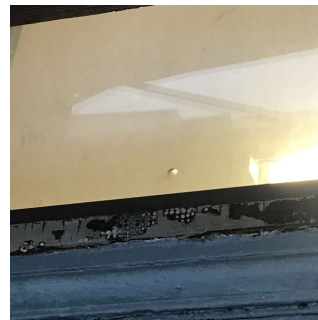
Facade C - Exit 3

METAL: BROKEN GLASS

10  
S.F.  
MAINTENANCE  
PRIORITY 3  
LEVEL 2

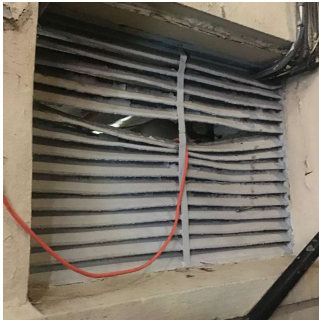
Question	Response
<b>EXTERIOR</b>	
<b>EXTERIOR SOFFITS</b>	Inspected
Condition	2 - Between Good and Fair
Deficiency	No deficiencies recorded
<b>LOADING DOCK</b>	Does not Exist
<b>LOUVER</b>	Inspected
Condition	3 - Fair
Deficiency	<b>BROKEN/ DENTED BLADES</b>
Roof Plan reference

Deficiency Quantity	10
Quantity Uom	S.F.
Potential Action	REPLACE
Urgency of Action	PRIORITY 4
Purpose of Action	LEVEL 2
Deficiency Photo1

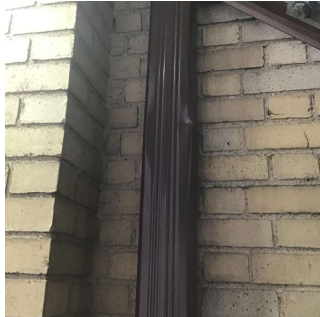
Question	Response
<b>EXTERIOR</b>	
<b>ROOF</b>	
<b>Roofing</b>	
<b>ROOF HATCH/SMOKE HATCH</b>	Does not Exist
<b>LEADERS, GUTTERS, DOWNSPOUTS, SCUPPERS</b>	Inspected
Condition	3 - Fair
Deficiency	DAMAGED/MISSING
Roof Plan reference	<p>K780</p>

Deficiency Quantity	50
Quantity Uom	L.F.
Potential Action	REPLACE
Urgency of Action	PRIORITY 4
Purpose of Action	LEVEL 2
Deficiency Photo1

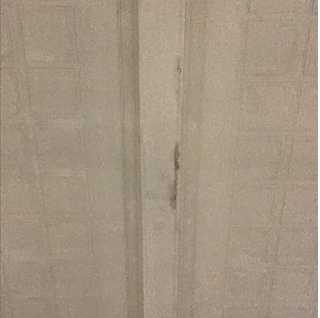
Question	Response
<b>EXTERIOR</b>	
<b>ROOF</b>	
<b>Roofing</b>	
<b>ROOFING</b>	
Does the roof have major mechanical equipment sitting on Dunnage Steel less than 18" above the Roofing?	No
Does this roof instance have a Sustainable Roof System?	Yes
Sustainable Roof Type	White Roof
Sustainable Roof Location (Roof Number)	Roof 1
Do solar panels exist on these roofs?	No
Is/Are the roof(s) suitable for Solar Panel installation?	No
Installation Year	2015
Source of Installation	Custodial Staff
Deficiency	MODIFIED BITUMEN: ROOFING: MAJOR ACTIVE ROOF LEAKS IN NON-INSTRUCTIONAL SPACE
Roof Plan reference	<p>K780</p>

Deficiency Quantity	300
Quantity Uom	S.F.
Potential Action	REPLACE ROOFING WITHOUT MAJOR EQUIPMENT REMOVAL
Urgency of Action	PRIORITY 5
Purpose of Action	LEVEL 2
Deficiency Photo1

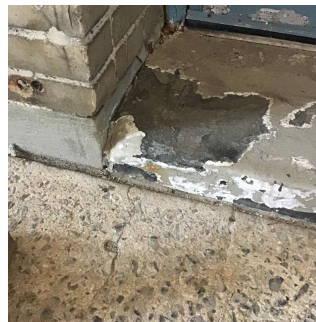
Facade A - Main Entrance

Deficiency	STONE: CRACKS/SPALLING - MINOR
------------	--------------------------------

REPAIR

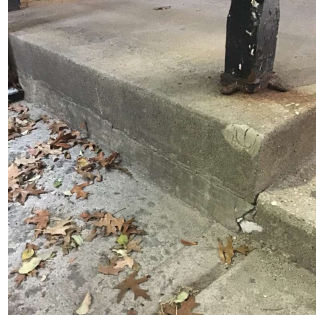
Facade A - Exit 5

Deficiency	CONCRETE: CRACKS/SPALLING - MAJOR
------------	-----------------------------------

REPLACE

PRIORITY 4  
 LEVEL 2

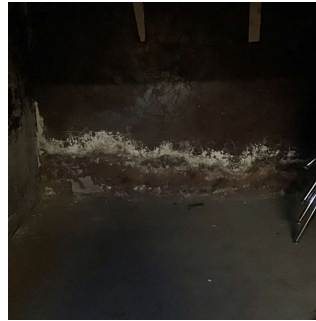
Question	Response
<b>INTERIOR</b>	
<b>STRUCTURAL</b>	
<b>COLUMNS/BEAMS/BEARING WALLS</b>	
Deficiency Photo1	 
Violations	Boiler Room No violations recorded.
<b>FLOOR STRUCTURE</b>	
Condition	Inspected 3 - Fair
Deficiency	CONCRETE: CRACKS/SPALLED/REINFORCEMENT EXPOSED
Deficiency Location/Instance	Basement - Electrical Panel Room, Boiler Room
Deficiency Quantity	30
Quantity Uom	S.F.
Potential Action	REPAIR
Urgency of Action	PRIORITY 3
Purpose of Action	LEVEL 5
Deficiency Photo1	 
Violations	Basement - Electrical Panel Room No violations recorded.
<b>FOUNDATION WALLS</b>	
Material Type(s)	Inspected Concrete, Masonry
Condition	4 - Between Fair and Poor
Deficiency	CONCRETE: WATER INFILTRATION IN NON- INSTRUCTIONAL SPACE
Deficiency Location/Instance	Basement - Exit 3
Deficiency Quantity	100
Quantity Uom	S.F.
Potential Action	INSTALL WATERPROOFING
Urgency of Action	PRIORITY 5
Purpose of Action	LEVEL 5

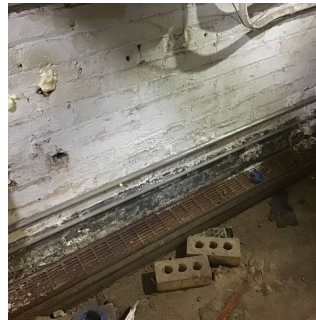
Boiler Room

**BRICK: WATER INFILTRATION IN NON- INSTRUCTIONAL SPACE**

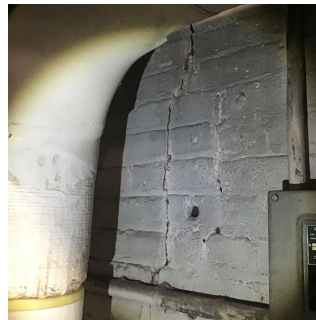
Boiler Room

**BRICK: CRACKED/SPALLED**

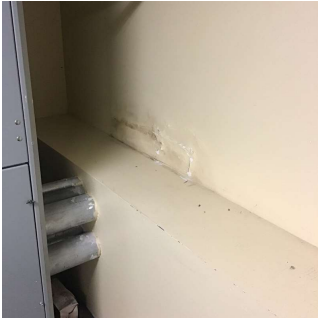
Question	Response
<b>INTERIOR</b>	
<b>STRUCTURAL</b>	
<b>FOUNDATION WALLS</b>	
Violations	No violations recorded.
Deficiency	CONCRETE: WATER INFILTRATION IN ELECTRICAL PANEL ROOM
Deficiency Location/Instance	Basement - Electrical Panel Room
Deficiency Quantity	100
Quantity Uom	S.F.
Potential Action	INSTALL WATERPROOFING
Urgency of Action	PRIORITY 5
Purpose of Action	LEVEL 6
Deficiency Photo1

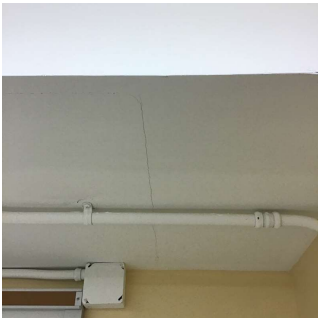
Staff Lounge

Violations	Basement - Electrical Panel Room No violations recorded.
<b>ROOF STRUCTURE</b>	
Condition	Inspected 2 - Between Good and Fair
Deficiency	No deficiencies recorded
<b>VAULTS-BUNKERS</b>	
Does not Exist	
<b>AUDITORIUM</b>	
Does not Exist	
<b>CAFETERIA</b>	
Does not Exist	
<b>CLASSROOMS/CORRIDORS/ADMIN SPACES</b>	
<b>Ceiling</b>	
Condition	Inspected 2 - Between Good and Fair
Deficiency	GYPSUM BOARD: DAMAGED/DETERIORATED
Deficiency Location/Instance	Staff Lounge, Corridor near Staff Lounge, By Men Toilet Room - Basement

Deficiency Quantity	30
Quantity Uom	S.F.
Potential Action	REPLACE
Urgency of Action	PRIORITY 3
Purpose of Action	LEVEL 2
Deficiency Photo1

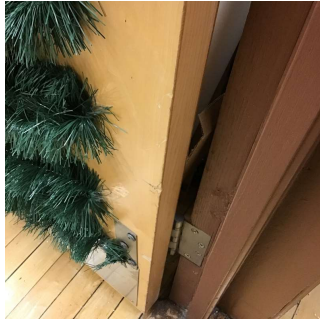
Question	Response
<b>INTERIOR</b>	
<b>CLASSROOMS/CORRIDORS/ADMIN SPACES</b>	
<b>Ceiling</b>	Inspected
Violations	No violations recorded.
<b>Door(s)</b>	Inspected
Condition	5 - Poor
Deficiency	WOOD: DETERIORATED DOOR
Deficiency Location/Instance	Room 201, Corridor near Auditorium
Deficiency Quantity	2
Quantity Uom	EACH
Potential Action	MAINTENANCE
Urgency of Action	PRIORITY 3
Purpose of Action	LEVEL 2
Deficiency Photo1

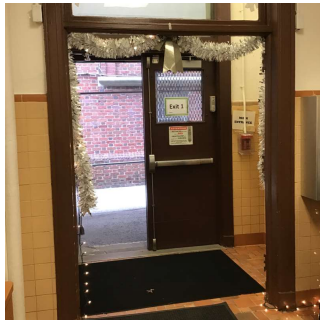
Violations	Room 201 No violations recorded.
Deficiency	WOOD: MISSING DOOR
Deficiency Location/Instance	Main Entrance - Vestibule, Corridor near Stairs A/2,1, B/2
Deficiency Quantity	6
Quantity Uom	EACH
Potential Action	MAINTENANCE
Urgency of Action	PRIORITY 3
Purpose of Action	LEVEL 2
Deficiency Photo1

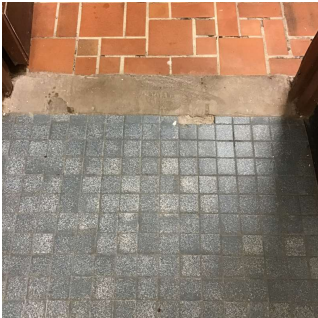
Question	Response
<b>INTERIOR</b>	
<b>CLASSROOMS/CORRIDORS/ADMIN SPACES</b>	
<b>Floor Finish</b>	
Violations	No violations recorded.
Deficiency	CERAMIC TILE: BROKEN/MISSING TILES
Deficiency Location/Instance	Corridor near Stair B/Basement
Deficiency Quantity	10
Quantity Uom	S.F.
Potential Action	REPLACE
Urgency of Action	PRIORITY 3
Purpose of Action	LEVEL 2
Deficiency Photo1

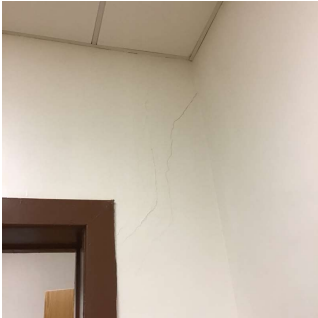
Violations	Corridor near Stair B/Basement No violations recorded.
<b>Walls</b>	Inspected
Condition	2 - Between Good and Fair
Deficiency	PLASTER: CRACKS/SPALLING
Deficiency Location/Instance	Corridor near Rooms 213,211,209,C108, By Stair B/Basement and others
Deficiency Quantity	70
Quantity Uom	S.F.
Potential Action	REPLACE
Urgency of Action	PRIORITY 3
Purpose of Action	LEVEL 2
Deficiency Photo1

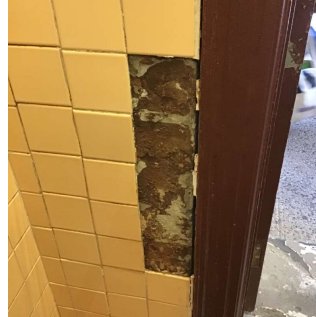
Main Entrance Vestibule

Violations	Corridor near Room 209 No violations recorded.
Deficiency	CERAMIC TILE: BROKEN/ MISSING
Deficiency Location/Instance	Main Entrance Vestibule, Corridor near Stair B/1, By Rooms 205,204,202 and others

Deficiency Quantity	100
Quantity Uom	S.F.
Potential Action	REPLACE
Urgency of Action	PRIORITY 3

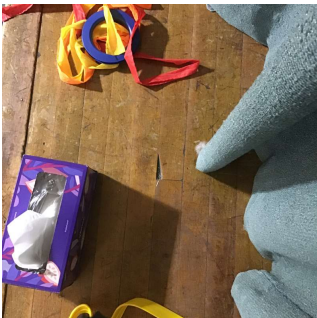
Question	Response
<b>INTERIOR</b>	
<b>MULTI-PURPOSE ROOM</b>	
<b>Stage</b>	
<b>Stage</b>	
Instance on 1st Floor	Inspected
Condition	2 - Between Good and Fair
Deficiency	DAMAGED FLOOR
Deficiency Location/Instance	Right Side
Deficiency Quantity	10
Quantity Uom	S.F.
Potential Action	REPLACE
Urgency of Action	PRIORITY 3
Purpose of Action	LEVEL 2
Deficiency Photo1

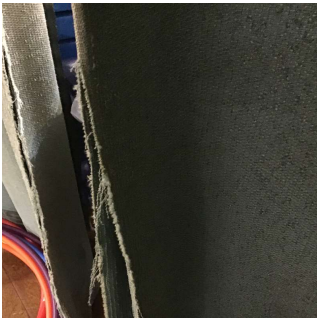
Right Side
Violations	No violations recorded.
<b>Stage Curtain Rigging</b>	
Instance on 1st Floor	Inspected
Condition	2 - Between Good and Fair
Deficiency	No deficiencies recorded
<b>Stage Curtains</b>	
Instance on 1st Floor	Inspected
Condition	3 - Fair
Deficiency	WORN/DETERIORATED
Deficiency Location/Instance	Right & Left Side
Deficiency Quantity	200
Quantity Uom	S.F.
Potential Action	REPLACE
Urgency of Action	PRIORITY 3
Purpose of Action	LEVEL 2
Deficiency Photo1

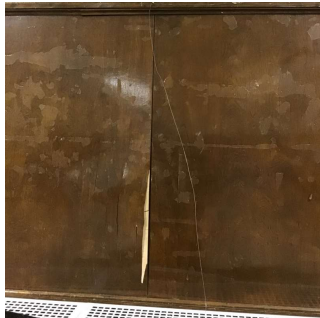
Question	Response
<b>INTERIOR</b>	
<b>MULTI-PURPOSE ROOM</b>	
<b>Walls</b>	
Instance on 1st Floor	Inspected
Condition	5 - Poor
Deficiency	WOOD PANELING: DETERIORATED
Deficiency Location/Instance	Near Main Entrance, Right and Left Side
Deficiency Quantity	200
Quantity Uom	S.F.
Potential Action	REPLACE
Urgency of Action	PRIORITY 3
Purpose of Action	LEVEL 2
Deficiency Photo1

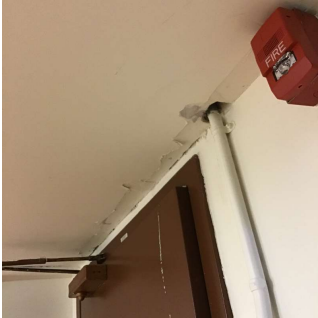
Question	Response
<b>INTERIOR</b>	
<b>STAIRS/RAMPS: INTERIOR</b>	
<b>Ceiling</b>	Inspected
Condition	2 - Between Good and Fair
Deficiency	GYPSUM BOARD: DAMAGED/DETERIORATED
Deficiency Location/Instance	Stair B/Basement
Deficiency Quantity	10
Quantity Uom	S.F.
Potential Action	REPLACE
Urgency of Action	PRIORITY 3
Purpose of Action	LEVEL 2
Deficiency Photo1

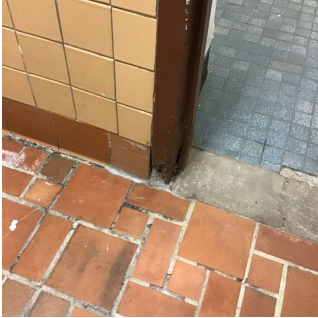
Violations	Stair B/Basement No violations recorded.
<b>Door(s)</b>	Inspected
Condition	5 - Poor
Deficiency	METAL: DETERIORATED DOOR AND FRAME
Deficiency Location/Instance	Stairs A/Basement, B/Basement
Deficiency Quantity	2
Quantity Uom	EACH
Potential Action	MAINTENANCE
Urgency of Action	PRIORITY 3
Purpose of Action	LEVEL 2
Deficiency Photo1

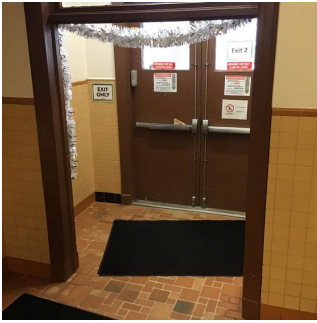
Violations	Stair B/Basement No violations recorded.
Deficiency	METAL: MISSING DOOR
Deficiency Location/Instance	Exit 2,3 - Vestibules
Deficiency Quantity	4
Quantity Uom	EACH
Potential Action	MAINTENANCE
Urgency of Action	PRIORITY 3

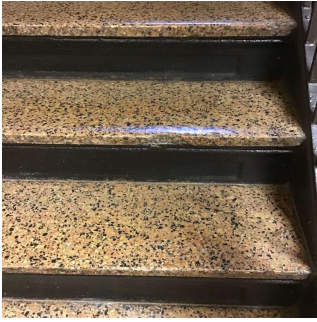
Violations	Exit 2 - Vestibule No violations recorded.
<b>Partition</b>	Does not Exist
<b>Railings</b>	Inspected
Condition	2 - Between Good and Fair
Deficiency	No deficiencies recorded
<b>Stairs and Landings</b>	Inspected
Condition	3 - Fair
Deficiency	TERRAZZO: CRACKS
Deficiency Location/Instance	Stairs A/1,Basement, B/2,1,Basement and others
Deficiency Quantity	80
Quantity Uom	S.F.
Potential Action	REPLACE
Urgency of Action	PRIORITY 3
Purpose of Action	LEVEL 2
Deficiency Photo1

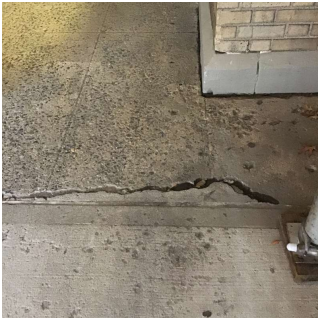
By Playground
Violations	No violations recorded.

<b>Student Non-Use</b>	Does not Exist
<b>Student Use</b>	Does not Exist
<b>Site Sidewalks &amp; Walkways</b>	Inspected
<b>Asphalt</b>	Does not Exist
<b>Concrete</b>	Inspected
Condition	3 - Fair
Deficiency	DAMAGED/DETERIORATED/MISSING SECTIONS
Deficiency Location/Instance	Near Main Entrance, next to Exit 4, By Playground
Deficiency Quantity	150
Quantity Uom	S.F.
Potential Action	REPLACE
Urgency of Action	PRIORITY 3
Purpose of Action	LEVEL 2
Deficiency Photo1

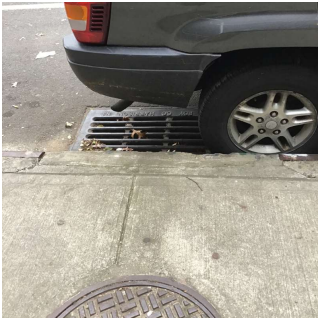
Question	Response
<b>SITE</b>	
<b>PAVING</b>	
<b>Site Sidewalks &amp; Walkways</b>	Inspected
<b>Pavers</b>	Does not Exist
<b>DOT Sidewalk</b>	Inspected
<b>Asphalt</b>	Does not Exist
<b>Concrete</b>	Inspected
Condition	2 - Between Good and Fair
Deficiency	DAMAGED CURBS
Deficiency Location/Instance	74th Street, Ft. Hamilton Parkway
Deficiency Quantity	40
Quantity Uom	L.F.
Potential Action	REPLACE
Urgency of Action	PRIORITY 3
Purpose of Action	LEVEL 2
Deficiency Photo1
