**NYC Department of Education**  
**Building Condition Assessment Survey 2023 - 2024**

Architectural Inspection

**K781**

**Asset:**           **WEST BROOKLYN COMMUNITY HS - K, 1053 41ST STREET, New York, 11219**

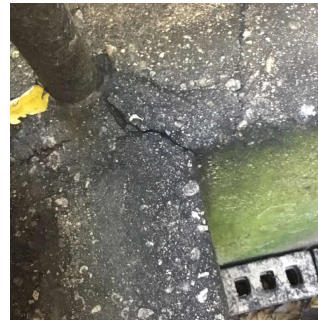
AW2  
No violations recorded.

Question	Response
<b>Architectural</b>	
<b>EXTERIOR</b>	Inspected
<b>AREAWAY</b>	Inspected
Instance on AW1-AW3	Inspected
Instance Condition	3 - Fair
Instance Quantity	3
Instance Quantity Uom	EACH
Deficiency	AREAWAY WALLS: CRACKS AND SPALLING

50  
S.F.  
REPAIR  
PRIORITY 3  
LEVEL 2

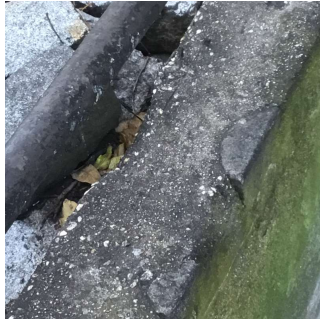
AREAWAY WALLS: CRACKS AND SPALLING

20  
S.F.  
REPLACE  
PRIORITY 4  
LEVEL 2

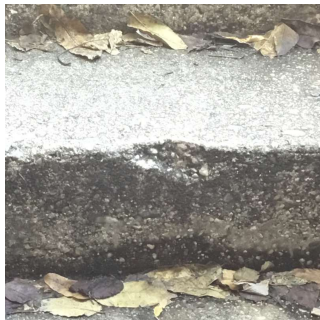
Violations	AW2 No violations recorded.
Deficiency	AREAWAY STAIRS: DETERIORATED TREADS/RISERS/NOSINGS
Roof Plan reference	K781

Deficiency Quantity	10
Quantity Uom	S.F.
Potential Action	REPLACE
Urgency of Action	PRIORITY 4
Purpose of Action	LEVEL 2
Deficiency Photo1

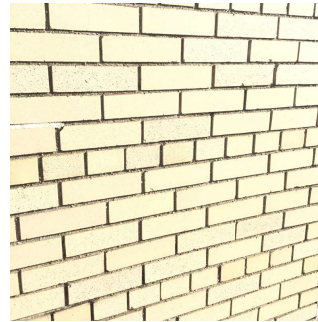
Chimney

Violations	AW3 No violations recorded.
<b>AWNINGS AND CANOPIES</b>	Does not Exist
<b>CHIMNEY</b>	Inspected
Material Type(s)	Masonry
Condition	3 - Fair
Deficiency	BRICK: DETERIORATED JOINTS

80  
S.F.  
REPOINT  
PRIORITY 3  
LEVEL 2

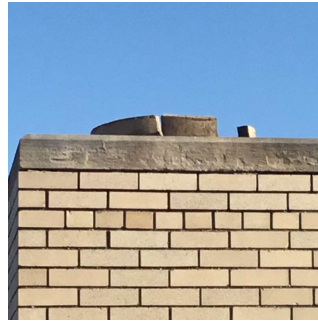
Chimney

BRICK: DETERIORATED CAP

15  
L.F.  
REPLACE  
PRIORITY 3  
LEVEL 2

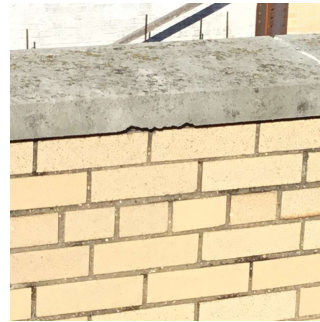
CAST STONE: CRACKED/BROKEN PIECES

20  
L.F.  
REPLACE-IN-KIND  
PRIORITY 4  
LEVEL 2

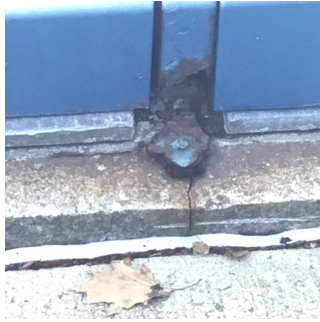
METAL: DETERIORATED DOOR AND FRAME - MAJOR DETERIORATION

<p>41st Street</p> <p>Fort Hamilton Parkway</p>
Deficiency Quantity	3
Quantity Uom	EACH
Potential Action	REPLACE
Urgency of Action	PRIORITY 4
Purpose of Action	LEVEL 2
Deficiency Photo1

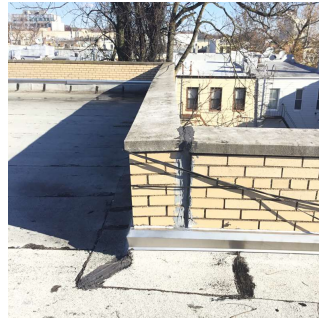
Question	Response
<b>EXTERIOR</b>	
<b>PARAPETS</b>	
Instance Condition	5 - Poor
Instance Quantity	3,500
Instance Quantity Uom	C.F.
Deficiency	BRICK: OUT OF PLUMB
Roof Plan reference	<p>K781</p>

Deficiency Quantity	140
Quantity Uom	C.F.
Potential Action	REMOVE AND REBUILD
Urgency of Action	PRIORITY 4
Purpose of Action	LEVEL 2
Deficiency Photo1

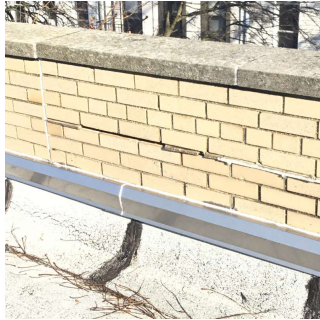
Violations	No violations recorded.
Deficiency	BRICK: DETERIORATED JOINTS
Roof Plan reference	<p>K781</p>

Deficiency Quantity	25
Quantity Uom	S.F.
Potential Action	REPOINT
Urgency of Action	PRIORITY 4
Purpose of Action	LEVEL 2

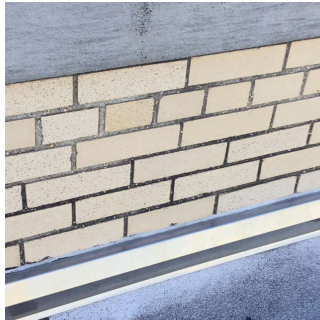
Violations	Roof 1 No violations recorded.
Deficiency	BRICK: DETERIORATED JOINTS
Roof Plan reference	K781

Deficiency Quantity	400
Quantity Uom	S.F.
Potential Action	REPOINT
Urgency of Action	PRIORITY 3
Purpose of Action	LEVEL 2
Deficiency Photo1

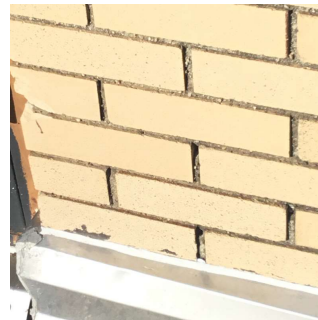
BH1

Question	Response
<b>EXTERIOR</b>	
<b>ROOF</b>	
<b>Roofing</b>	
<b>ROOFING</b>	
Deficiency Photo1	 
	Roof 1 - Room 206
Violations	No violations recorded.
Deficiency	MODIFIED BITUMEN: ROOFING: MAJOR ACTIVE ROOF LEAKS IN INSTRUCTIONAL SPACE
Roof Plan reference	K781  
Deficiency Quantity	500
Quantity Uom	S.F.
Potential Action	REPLACE ROOFING WITHOUT MAJOR EQUIPMENT REMOVAL
Urgency of Action	PRIORITY 5
Purpose of Action	LEVEL 2
Deficiency Photo1	 
	Roof 1 - Room 202 (Roof 1 - Gymnasium similar)
Violations	No violations recorded.
<b>ROOFING DRAINS</b>	Does not Exist
<b>Specialties</b>	Inspected
<b>BULKHEAD/PENTHOUSE</b>	Inspected
Condition	4 - Between Fair and Poor
Deficiency	BULKHEAD/PENTHOUSE WALLS/EXTERIOR: DETERIORATED JOINTS

20  
S.F.  
REPOINT  
PRIORITY 4  
LEVEL 2

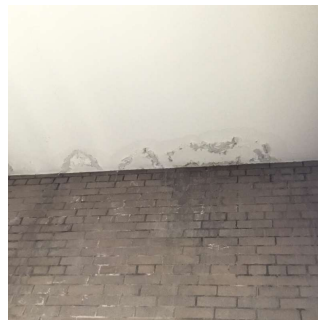
BH2

**BULKHEAD/PENTHOUSE CEILING: PLASTER DAMAGED/DETERIORATED**

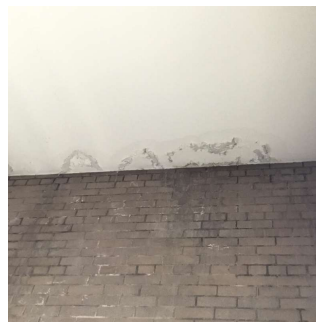
**BULKHEAD/PENTHOUSE ROOF: MAJOR LEAKAGE**

200  
S.F.  
REPLACE  
PRIORITY 5  
LEVEL 2

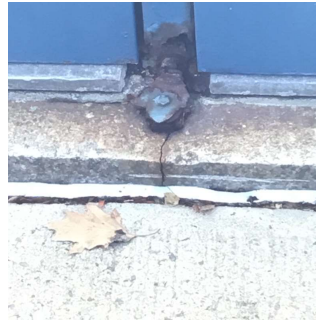
Facade K

STONE: CRACKS/SPALLING - MINOR

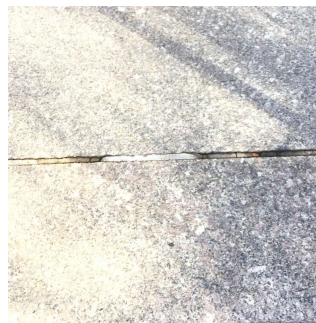
Facade A

STONE: DETERIORATED JOINTS

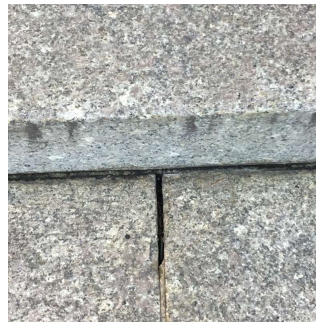
Facade A

STONE: DETERIORATED JOINTS

10  
L.F.  
REPOINT  
PRIORITY 4  
LEVEL 2

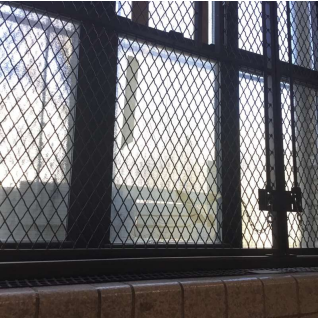
Question	Response
<b>EXTERIOR</b>	
<b>WINDOWS</b>	
<b>WINDOWS</b>	
Urgency of Action	PRIORITY 3
Purpose of Action	LEVEL 2
Deficiency Photo1	No photo recorded
Violations	No violations recorded.
Deficiency	ALUMINUM - DOUBLE HUNG: BROKEN PANE
Roof Plan reference	K781

Deficiency Quantity	90
Quantity Uom	S.F.
Potential Action	MAINTENANCE
Urgency of Action	PRIORITY 3
Purpose of Action	LEVEL 2
Deficiency Photo1

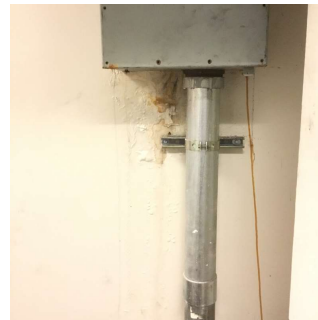
Electrical Panel Room

CONCRETE: WATER INFILTRATION IN ELECTRICAL PANEL ROOM

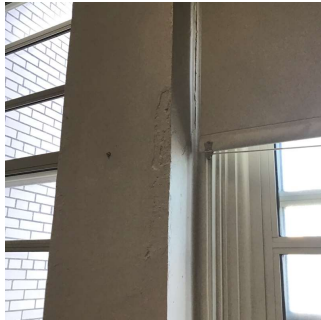
Question	Response
<b>INTERIOR</b>	
<b>CLASSROOMS/CORRIDORS/ADMIN SPACES</b>	
<b>Walls</b>	Inspected
Condition	2 - Between Good and Fair
Deficiency	PLASTER: CRACKS/SPALLING
Deficiency Location/Instance	Rooms 217, 204, Corridor near Room 201,101,019, and others
Deficiency Quantity	70
Quantity Uom	S.F.
Potential Action	REPLACE
Urgency of Action	PRIORITY 3
Purpose of Action	LEVEL 2
Deficiency Photo1

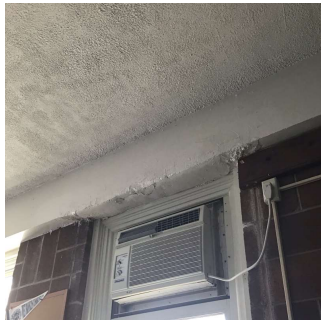
Room 204
Violations	No violations recorded.
Deficiency	PLASTER: CRACKS/SPALLING - ACTIVE LEAK
Deficiency Location/Instance	Room 202
Deficiency Quantity	20
Quantity Uom	S.F.
Potential Action	REPLACE
Urgency of Action	PRIORITY 5
Purpose of Action	LEVEL 2
Deficiency Photo1
