NYC Department of Education
Building Condition Assessment Survey 2023 - 2024

Architectural Inspection

K783

Asset: CHARTER SCHOOL FOR EXCELLENCE -K, 239 PATCHEN AVENUE, New York, 11233

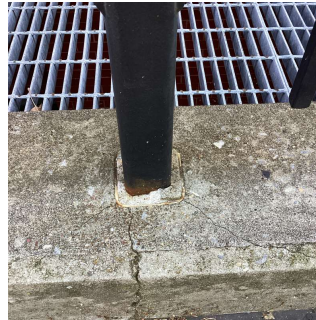
AW5
 No violations recorded.

Question	Response
Architectural	
EXTERIOR	Inspected
AREAWAY	Inspected
Instance on AW1 - AW5	Inspected
Instance Condition	3 - Fair
Instance Quantity	5
Instance Quantity Uom	EACH
Deficiency	AREAWAY WALLS: CRACKS AND SPALLING
Roof Plan reference	K783
Deficiency Quantity	50
Quantity Uom	S.F.
Potential Action	REPAIR
Urgency of Action	PRIORITY 3
Purpose of Action	LEVEL 2

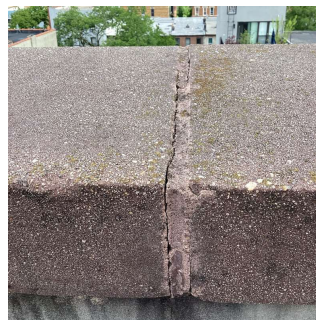
Roof 1
 No violations recorded.

CAST STONE: DETERIORATED TRANSVERSE JOINTS

40
 L.F.
 MAINTENANCE
 PRIORITY 3
 LEVEL 2

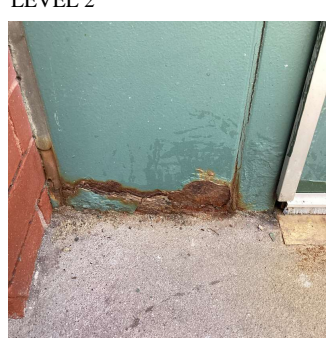
Question	Response
EXTERIOR	
CORNICE	Inspected
Condition	2 - Between Good and Fair
Deficiency	No deficiencies recorded
DOORS	Inspected
DOORS AND FRAMES	Inspected
Condition	2 - Between Good and Fair
Deficiency	No deficiencies recorded
DOOR HARDWARE	Inspected
Condition	3 - Fair
Deficiency	No deficiencies recorded
LINTELS	Inspected
Condition	2 - Between Good and Fair
Deficiency	No deficiencies recorded
TRANSOM/SIDE LIGHT	Inspected
Condition	3 - Fair
Deficiency	METAL: DENTED, MAJOR RUSTING
Roof Plan reference	<p>K783</p>

Deficiency Quantity	10
Quantity Uom	S.F.
Potential Action	REPLACE
Urgency of Action	PRIORITY 4
Purpose of Action	LEVEL 2
Deficiency Photo1

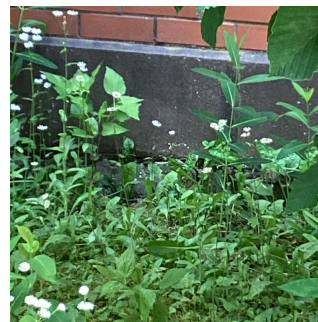
Facade B

STONE: CHIPPED/SPALLED/BROKEN PIECES - MAJOR

REPLACE

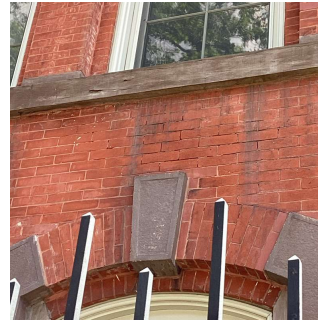
Facade A

BRICK: DETERIORATED JOINTS

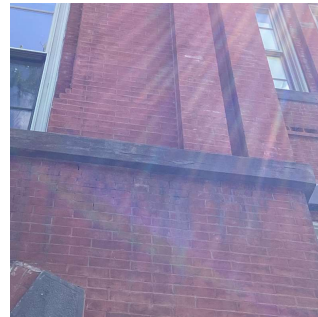
Facade A

STONE: CHIPPED/SPALLED/BROKEN PIECES - MINOR

REPAIR

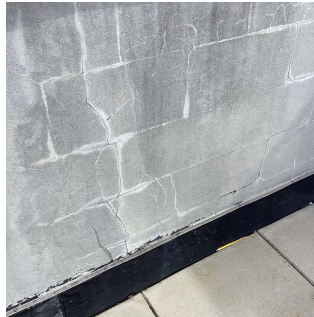
Roof 1

Deficiency	CONCRETE: MINOR CRACKS, SPALLING
------------	----------------------------------

REPAIR

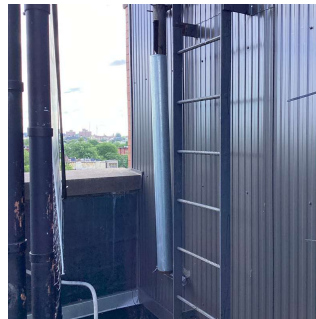
Roof 7
No violations recorded.

Deficiency	DAMAGED/MISSING
------------	-----------------

Deficiency Quantity	10
Quantity Uom	L.F.
Potential Action	REPLACE
Urgency of Action	PRIORITY 4
Purpose of Action	LEVEL 2
Deficiency Photo1

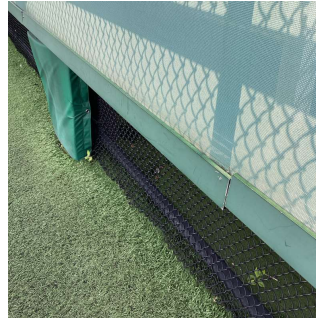
Roof 4
 No violations recorded.

Deficiency	CHAIN LINK: DETERIORATED, MAJOR RUSTING
------------	---

REPLACE
 PRIORITY 4
 LEVEL 2

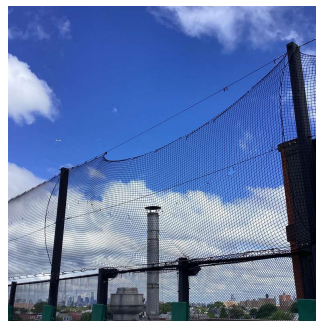
Roof 4
 No violations recorded.

MESH: DETERIORATED

150
 S.F.
 REPLACE
 PRIORITY 4
 LEVEL 2

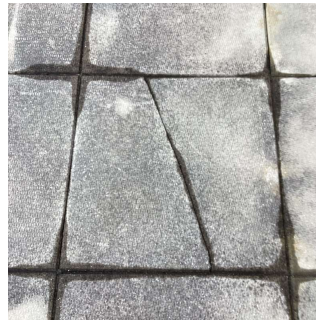
Roof 1
No violations recorded.

Installation Year	2006
Source of Installation	Custodial Staff
Deficiency	IRMA: ROOFING: DETERIORATED PAVERS WITH INTEGRAL INSULATION
Roof Plan reference	<p>K783</p>

S.F.
REPLACE
PRIORITY 4
LEVEL 2

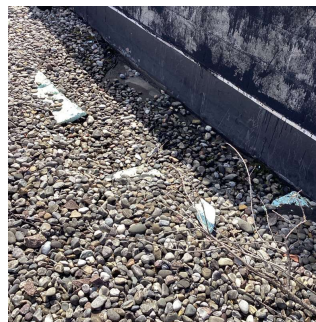
Roof 7
No violations recorded.

IRMA: ROOFING: DAMAGED INSULATION
K783

110
S.F.
REPLACE
PRIORITY 4
LEVEL 2

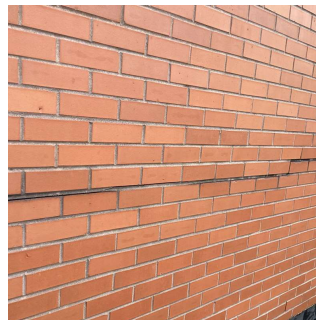
BH2
No violations recorded.

**BULKHEAD/PENTHOUSE WALLS/EXTERIOR:
CRACKS/SPALLING - MAJOR**

25
S.F.
REPLACE
PRIORITY 4
LEVEL 2

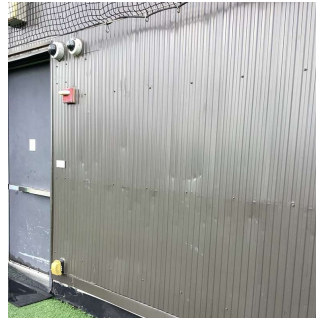
BH2

**BULKHEAD/PENTHOUSE WALLS/EXTERIOR: DAMAGED
METAL SIDING**

60
S.F.
REPLACE
PRIORITY 4
LEVEL 2

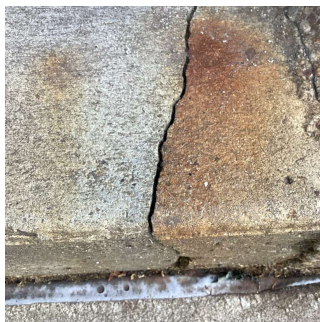
Violations	Facade B No violations recorded.
RAILINGS	Does not Exist
STAIRS/RAMPS	Inspected
Condition	3 - Fair
Deficiency	CONCRETE: CRACKS/SPALLING - MAJOR
Roof Plan reference	K783

Deficiency Quantity	10
Quantity Uom	S.F.
Potential Action	REPLACE
Urgency of Action	PRIORITY 4
Purpose of Action	LEVEL 2
Deficiency Photo1

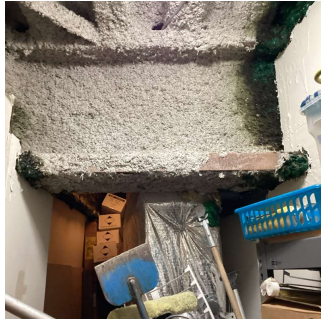
Question	Response
EXTERIOR	
WINDOWS	
LINTELS	Inspected
Condition	2 - Between Good and Fair
Deficiency	No deficiencies recorded
WINDOWS	
Material Type(s)	Aluminum
Instance on Aluminum - Double Hung: All Facades except Facade C	Inspected
Instance Condition	3 - Fair
Instance Quantity	5,700
Instance Quantity Uom	S.F.
Are these windows insulated	Yes
Installation Year	2006
Source of Installation	Custodial Staff
Deficiency	No deficiencies recorded
INTERIOR	
POOLS	Does not Exist
STRUCTURAL	
COLUMNS/BEAMS/BEARING WALLS	Inspected
Condition	4 - Between Fair and Poor
Deficiency	STEEL COLUMNS/BEAMS: DETERIORATED/MISSING SPRAY-ON FIREPROOFING
Deficiency Location/Instance	Basement - Room 005, Room 018B, Room 003A, Electrical Room
Deficiency Quantity	40
Quantity Uom	S.F.
Potential Action	REPLACE
Urgency of Action	PRIORITY 4
Purpose of Action	LEVEL 5
Deficiency Photo1

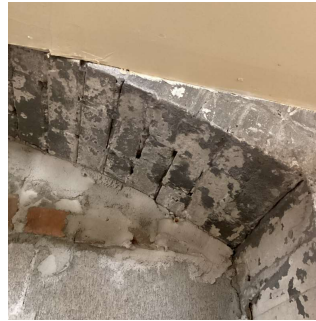
Basement - Sprinkler Room

Violations	Basement - Room 005 No violations recorded.
Deficiency	MASONRY BEARING WALL: DETERIORATED JOINTS

Deficiency Location/Instance	Basement - Sprinkler Room, Storage, Electrical Room, Boiler Room
Deficiency Quantity	40
Quantity Uom	S.F.
Potential Action	REPOINT
Urgency of Action	PRIORITY 4
Purpose of Action	LEVEL 5

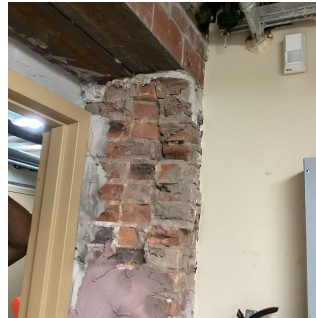
Basement - Electrical Room

MASONRY BEARING WALL: CRACKED/SPALLED

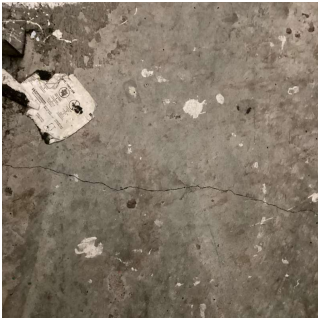
Question	Response
INTERIOR	
STRUCTURAL	
FLOOR STRUCTURE	
Violations	Basement - Room 010B No violations recorded.
Deficiency	CONCRETE: CRACKS/SPALLED/REINFORCEMENT EXPOSED
Deficiency Location/Instance	Room 404
Deficiency Quantity	10
Quantity Uom	S.F.
Potential Action	REPAIR
Urgency of Action	PRIORITY 3
Purpose of Action	LEVEL 5
Deficiency Photo1

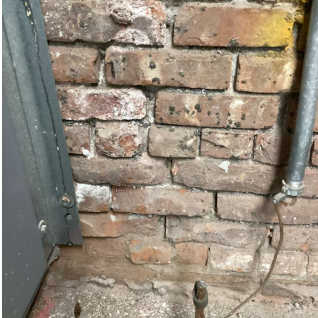
Violations	Room 404 No violations recorded.
FOUNDATION WALLS	
Material Type(s)	Inspected Concrete, Masonry
Condition	4 - Between Fair and Poor
Deficiency	BRICK: DETERIORATED JOINTS
Deficiency Location/Instance	Basement - Boiler Room, Electrical Room, Fire Pump Room, Sprinkler Room
Deficiency Quantity	180
Quantity Uom	S.F.
Potential Action	REPOINT
Urgency of Action	PRIORITY 4
Purpose of Action	LEVEL 5
Deficiency Photo1

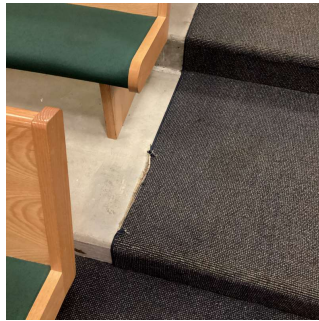
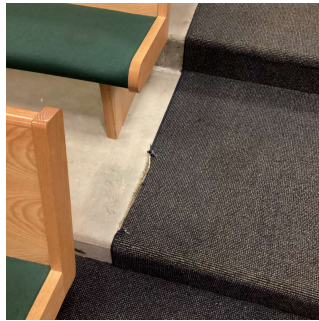
Right Side Aisle

Instance on Basement (500 Seats)	Inspected
Condition	2 - Between Good and Fair
Deficiency	CARPET: WORN/DETERIORATED
Deficiency Location/Instance	Right and Left Side Aisle, Near Entrance
Deficiency Quantity	40
Quantity Uom	S.F.
Potential Action	REPLACE
Urgency of Action	PRIORITY 3
Purpose of Action	LEVEL 2
Deficiency Photo1

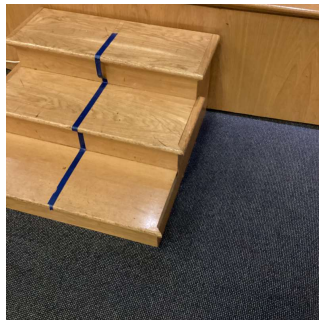
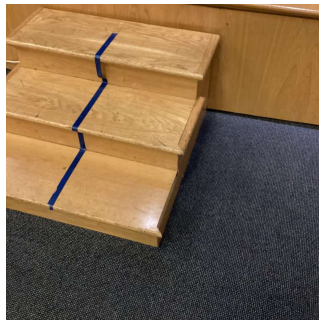
Instance on Basement (500 Seats)	Inspected
Stage	Inspected
Instance on Basement (500 Seats)	Inspected
Condition	2 - Between Good and Fair
Deficiency	DAMAGED STEPS
Deficiency Location/Instance	Left Side
Deficiency Quantity	10
Quantity Uom	S.F.
Potential Action	REPLACE
Urgency of Action	PRIORITY 3
Purpose of Action	LEVEL 2
Deficiency Photo1

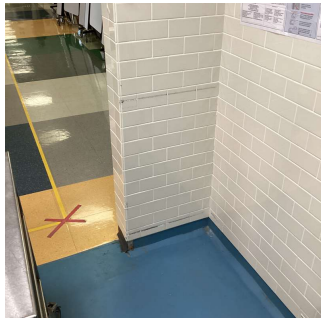
Violations	Near Entrance No violations recorded.
Deficiency	CERAMIC TILE: BROKEN/ MISSING
Deficiency Location/Instance	Near Serving Area
Deficiency Quantity	10
Quantity Uom	S.F.
Potential Action	REPLACE
Urgency of Action	PRIORITY 3
Purpose of Action	LEVEL 2
Deficiency Photo1

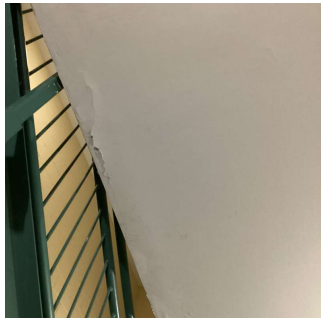
Deficiency	GYPSUM BOARD: DAMAGED/DETERIORATED
Deficiency Location/Instance	Stairs A/3, B/4
Deficiency Quantity	20
Quantity Uom	S.F.
Potential Action	REPLACE
Urgency of Action	PRIORITY 3
Purpose of Action	LEVEL 2
Deficiency Photo1

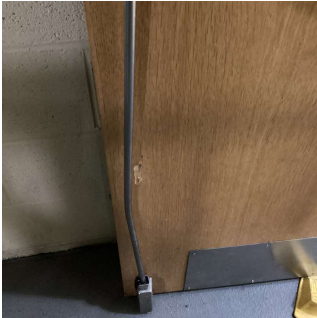
Question	Response
INTERIOR	
STAIRS/RAMPS: INTERIOR	
Ceiling	Inspected
	Stair B/4
Violations	No violations recorded.
Door(s)	Inspected
Condition	5 - Poor
Deficiency	WOOD: DETERIORATED DOOR
Deficiency Location/Instance	Stair C/2
Deficiency Quantity	1
Quantity Uom	EACH
Potential Action	MAINTENANCE
Urgency of Action	PRIORITY 4
Purpose of Action	LEVEL 4
Deficiency Photo1

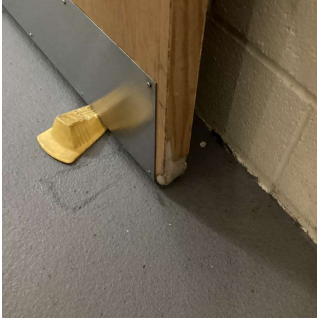
Violations	Stair C/2 35671633P
Deficiency	WOOD: DETERIORATED DOOR
Deficiency Location/Instance	Stairs B/4, C/1
Deficiency Quantity	3
Quantity Uom	EACH
Potential Action	MAINTENANCE
Urgency of Action	PRIORITY 3
Purpose of Action	LEVEL 2
Deficiency Photo1
