NYC Department of Education
Building Condition Assessment Survey 2023 - 2024

Architectural Inspection

K784

Asset: **ACHIEVEMENT FIRST ENDEAVOR CHARTER SCHOOL- BROOKLYN, 510
WAVERLY AVENUE, New York, 11238**

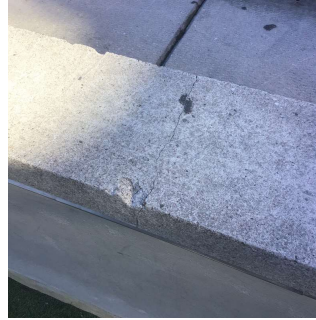
Roof 10 - South

Question	Response
Architectural	
EXTERIOR	Inspected
AREAWAY	Does not Exist
AWNINGS AND CANOPIES	Inspected
Condition	2 - Between Good and Fair
Deficiency	No deficiencies recorded
CHIMNEY	Inspected
Material Type(s)	Metal
Condition	2 - Between Good and Fair
Deficiency	No deficiencies recorded
COPING	Inspected
Condition	3 - Fair
Deficiency	CAST STONE: CRACKED/BROKEN PIECES
Roof Plan reference	K784

Deficiency Quantity	10
Quantity Uom	L.F.
Potential Action	REPLACE-IN-KIND
Urgency of Action	PRIORITY 4
Purpose of Action	LEVEL 2

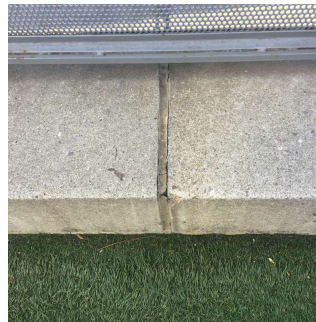
Roof 9 - Facade A

CAST STONE: DETERIORATED TRANSVERSE JOINTS

MAINTENANCE

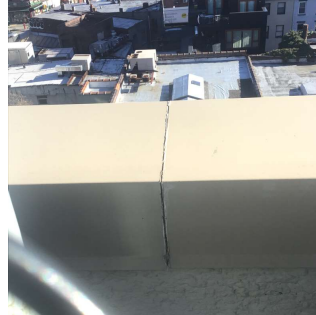
Roof 10 - Facade A

METAL: DETERIORATED JOINTS

REPAIR
 PRIORITY 3
 LEVEL 2

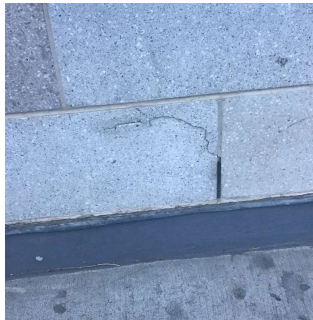
Facade A

CONCRETE MASONRY UNIT: DETERIORATED MASONRY SILLS - MINOR

REPAIR

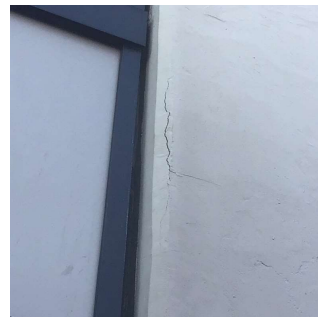
Facade A

CAST IN PLACE / PRE-CAST CONCRETE: MINOR CRACKS/SPALLING

REPAIR

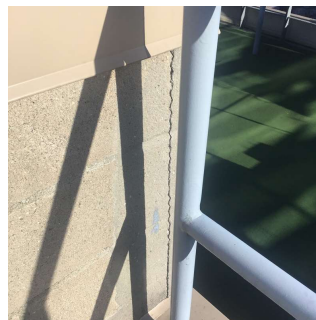
Roof 3

Deficiency	CONCRETE MASONRY UNITS: MAJOR DETERIORATION/CRACKS
------------	--

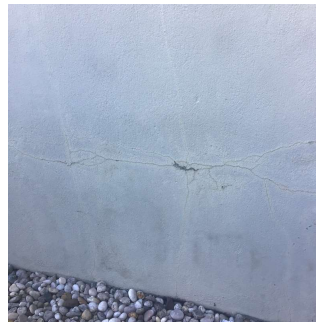
BH1
No violations recorded.

Deficiency Quantity	10
Quantity Uom	S.F.
Potential Action	REPLACE
Urgency of Action	PRIORITY 3
Purpose of Action	LEVEL 2
Deficiency Photo1	 
	PH
Violations	No violations recorded.
Deficiency	BULKHEAD/PENTHOUSE WALLS/EXTERIOR: CRACKS/SPALLING - MINOR

50
S.F.
REPAIR
PRIORITY 3
LEVEL 2

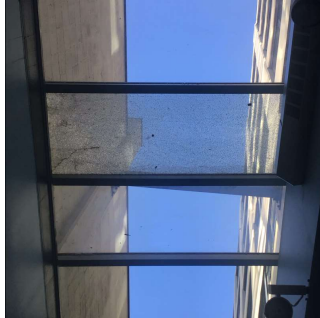
BROKEN GLASS

30
S.F.
MAINTENANCE
PRIORITY 3

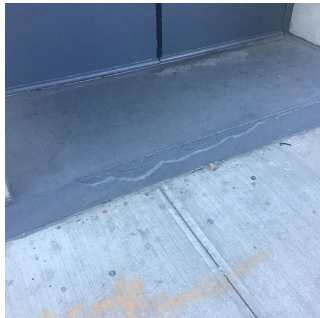
Violations	Facade A - South End No violations recorded.

Violations	SK No violations recorded.
ROOF/GRAVITY TANK	Inspected
Condition	2 - Between Good and Fair
Deficiency	No deficiencies recorded
STAIRS/RAMPS: EXTERIOR	Inspected
BUILDING CHEEK/FLANK WALLS	Does not Exist
RAILINGS	Does not Exist
STAIRS/RAMPS	Inspected
Condition	3 - Fair
Deficiency	CONCRETE: CRACKS/SPALLING - MAJOR
Roof Plan reference	K784

Deficiency Quantity	10
Quantity Uom	S.F.
Potential Action	REPLACE
Urgency of Action	PRIORITY 4
Purpose of Action	LEVEL 2
Deficiency Photo1

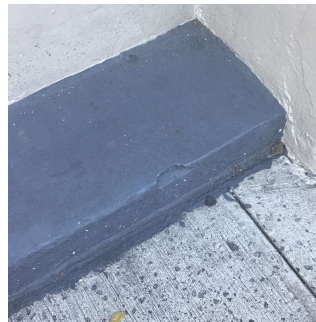
Facade A - North End
No violations recorded.

CONCRETE: CRACKS/SPALLING - MINOR

10
S.F.
REPAIR
PRIORITY 3
LEVEL 2

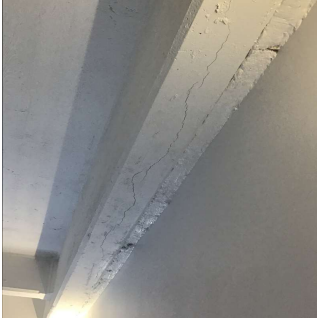
Question	Response
INTERIOR	
STRUCTURAL	
COLUMNS/BEAMS/BEARING WALLS	
Condition	3 - Fair
Deficiency	STEEL COLUMNS/BEAMS: DETERIORATED CONCRETE FIREPROOFING
Deficiency Location/Instance	Basement - Room 015, 2nd Floor - Stair A/2
Deficiency Quantity	30
Quantity Uom	S.F.
Potential Action	REPLACE
Urgency of Action	PRIORITY 3
Purpose of Action	LEVEL 5
Deficiency Photo1

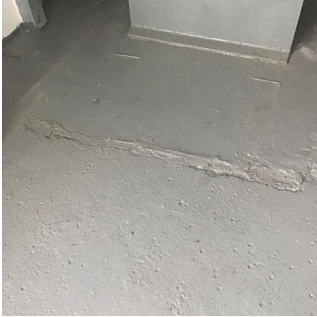
Violations	Stair A/2 No violations recorded.
FLOOR STRUCTURE	
Condition	Inspected 3 - Fair
Deficiency	CONCRETE: CRACKS/SPALLED/REINFORCEMENT EXPOSED
Deficiency Location/Instance	PH - Elevator Machine Room, 6th Floor - Stair A/6
Deficiency Quantity	30
Quantity Uom	S.F.
Potential Action	REPAIR
Urgency of Action	PRIORITY 3
Purpose of Action	LEVEL 5
Deficiency Photo1

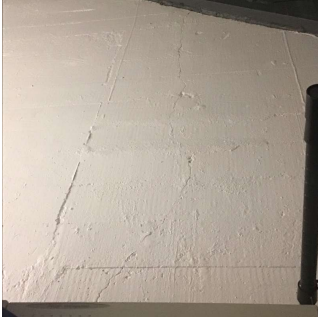
Violations	Elevator Machine Room No violations recorded.
FOUNDATION WALLS	
Material Type(s)	Inspected Concrete
Condition	2 - Between Good and Fair
Deficiency	CONCRETE: CRACKED/SPALLED/REINFORCEMENT EXPOSED

Deficiency Location/Instance	Basement - Room 013
Deficiency Quantity	20
Quantity Uom	S.F.

Question	Response
INTERIOR	
STRUCTURAL	
FOUNDATION WALLS	
Potential Action	REPAIR
Urgency of Action	PRIORITY 3
Purpose of Action	LEVEL 5
Deficiency Photo1

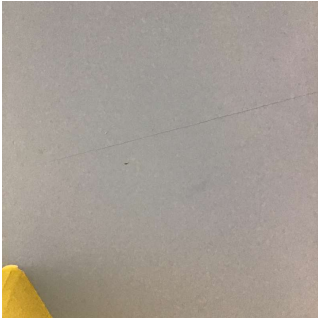
Room 013
Violations	No violations recorded.
ROOF STRUCTURE	
Condition	Inspected
Deficiency	2 - Between Good and Fair
	No deficiencies recorded
VAULTS-BUNKERS	
	Does not Exist
AUDITORIUM	
	Does not Exist
CAFETERIA	
Instance on Basement	Inspected
	Inspected
Ceiling	
Instance on Basement	Inspected
Condition	2 - Between Good and Fair
Deficiency	GYPNUM BOARD: DAMAGED/DETERIORATED
Deficiency Location/Instance	Near center
Deficiency Quantity	20
Quantity Uom	S.F.
Potential Action	REPLACE
Urgency of Action	PRIORITY 3
Purpose of Action	LEVEL 2
Deficiency Photo1

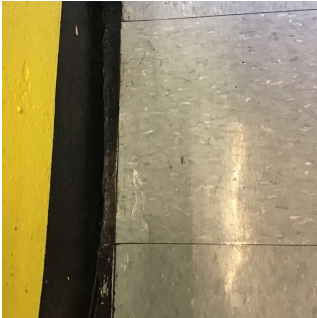
Question	Response
INTERIOR	
CAFETERIA	
Fixed Equipment	
Instance on Basement	Does not Exist
Floor Finish	
Instance on Basement	Inspected
Condition	2 - Between Good and Fair
Deficiency	VINYL TILES: BROKEN/DETERIORATED/MISSING TILES
Deficiency Location/Instance	Near Servery
Deficiency Quantity	10
Quantity Uom	S.F.
Potential Action	REPLACE
Urgency of Action	PRIORITY 3
Purpose of Action	LEVEL 2
Deficiency Photo1

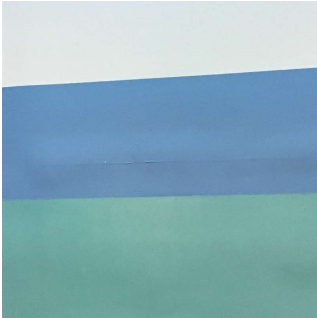
Violations	Near servery No violations recorded.
Sliding-folding Partition	
Instance on Basement	Does not Exist
Stage	
Instance on Basement	Does not Exist
Walls	
Instance on Basement	Inspected
Condition	2 - Between Good and Fair
Deficiency	GYPSUM BOARD: DETERIORATED
Deficiency Location/Instance	Near skylights, Basement - Girls, center, Entrance
Deficiency Quantity	40
Quantity Uom	S.F.
Potential Action	REPLACE
Urgency of Action	PRIORITY 3
Purpose of Action	LEVEL 2
Deficiency Photo1

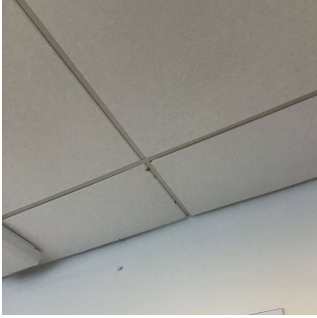
Question	Response
INTERIOR	
CAFETERIA	Inspected
Window Curtains/Shades/Blinds	
Instance on Basement	Does not Exist
CLASSROOMS/CORRIDORS/ADMIN SPACES	Inspected
Ceiling	Inspected
Condition	2 - Between Good and Fair
Deficiency	ACOUSTIC TILES: DAMAGED/MISSING
Deficiency Location/Instance	Room 503
Deficiency Quantity	10
Quantity Uom	S.F.
Potential Action	REPLACE
Urgency of Action	PRIORITY 3
Purpose of Action	LEVEL 2
Deficiency Photo1

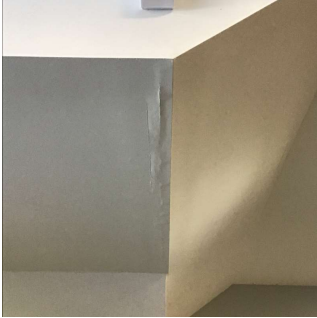
Main Entrance Lobby
Violations	No violations recorded.
Door(s)	Inspected
Condition	2 - Between Good and Fair
Deficiency	No deficiencies recorded
Floor Finish	Inspected
Condition	2 - Between Good and Fair

Room 503
Violations	No violations recorded.
Deficiency	GYPSUM BOARD: DAMAGED/DETERIORATED
Deficiency Location/Instance	Room 217, Main Entrance Lobby
Deficiency Quantity	20
Quantity Uom	S.F.
Potential Action	REPLACE
Urgency of Action	PRIORITY 3
Purpose of Action	LEVEL 2
Deficiency Photo1

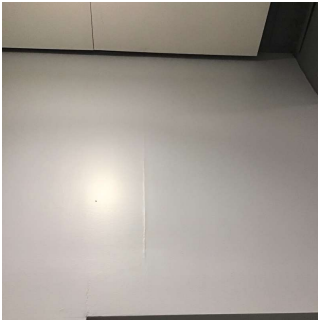
Question	Response
INTERIOR	
CLASSROOMS/CORRIDORS/ADMIN SPACES	
Walls	
Deficiency Photo1

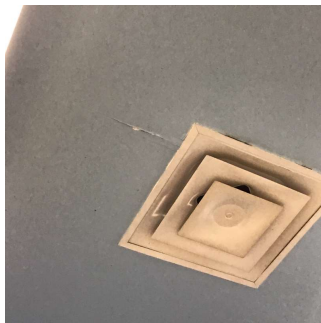
Question	Response
INTERIOR	
KITCHEN	
Ceiling	
Deficiency Photo1

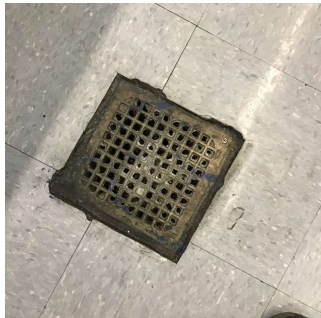
Violations	<p>Servery No violations recorded.</p>
Door(s)	
Instance on Basement	Inspected
Condition	2 - Between Good and Fair
Deficiency	No deficiencies recorded
Floor Finish	
Instance on Basement	Inspected
Condition	2 - Between Good and Fair
Deficiency	VINYL TILES: BROKEN/DETERIORATED/MISSING TILES
Deficiency Location/Instance	Servery
Deficiency Quantity	10
Quantity Uom	S.F.
Potential Action	REPLACE
Urgency of Action	PRIORITY 3
Purpose of Action	LEVEL 2
Deficiency Photo1

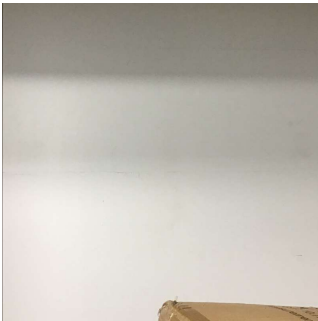
Violations	<p>Servery No violations recorded.</p>
Walls	
Instance on Basement	Inspected
Condition	2 - Between Good and Fair
Deficiency	GYPSON BOARD: DETERIORATED
Deficiency Location/Instance	Kitchen staff locker
Deficiency Quantity	10
Quantity Uom	S.F.
Potential Action	REPLACE
Urgency of Action	PRIORITY 3
Purpose of Action	LEVEL 2

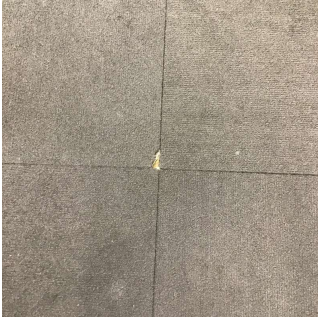
Violations	Kitchen staff locker No violations recorded.
LIBRARY	
Instance on Room 410	Inspected
Built-in Furnishing	Inspected
Instance on Room 410	Does not Exist
Ceiling	
Instance on Room 410	Inspected
Condition	2 - Between Good and Fair
Deficiency	No deficiencies recorded
Door(s)	
Instance on Room 410	Inspected
Condition	2 - Between Good and Fair
Deficiency	No deficiencies recorded
Floor Finish	
Instance on Room 410	Inspected
Condition	2 - Between Good and Fair
Deficiency	CARPET: WORN/DETERIORATED
Deficiency Location/Instance	Near Entrance, center
Deficiency Quantity	20
Quantity Uom	S.F.
Potential Action	REPLACE
Urgency of Action	PRIORITY 3
Purpose of Action	LEVEL 2
Deficiency Photo1

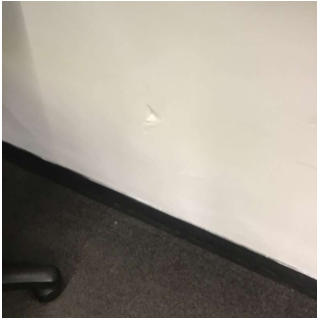
Question	Response
INTERIOR	
LIBRARY	
Walls	
Deficiency	GYPNUM BOARD: DETERIORATED
Deficiency Location/Instance	Near Windows
Deficiency Quantity	10
Quantity Uom	S.F.
Potential Action	REPLACE
Urgency of Action	PRIORITY 3
Purpose of Action	LEVEL 2
Deficiency Photo1

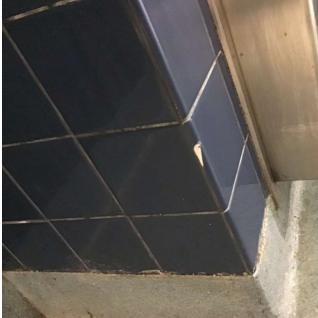
Question	Response
INTERIOR	
TOILET ROOMS - STAFF	
Floor Finish	Inspected
	6th Floor - Staff Toilet
Violations	No violations recorded.
Stalls	Does not Exist
Walls	Inspected
Condition	2 - Between Good and Fair
Deficiency	CERAMIC TILE: BROKEN/ MISSING
Deficiency Location/Instance	5th Floor - Staff Toilet
Deficiency Quantity	10
Quantity Uom	S.F.
Potential Action	REPLACE
Urgency of Action	PRIORITY 3
Purpose of Action	LEVEL 2
Deficiency Photo1

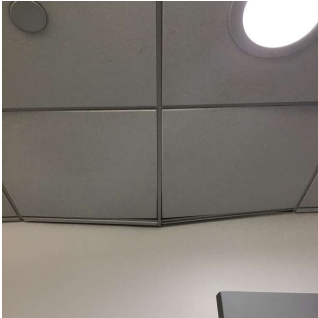
Violations	5th Floor - Staff Toilet No violations recorded.
TOILET ROOMS - STUDENTS	
	Inspected
Ceiling	Inspected
Condition	2 - Between Good and Fair
Deficiency	ACOUSTIC TILES: DAMAGED/MISSING
Deficiency Location/Instance	6th/5th/4th/1st Floor - Boys and Girls, and others
Deficiency Quantity	100
Quantity Uom	S.F.
Potential Action	REPLACE
Urgency of Action	PRIORITY 3
Purpose of Action	LEVEL 2
Deficiency Photo1

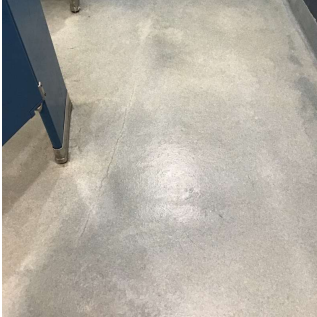
Question	Response
INTERIOR	
TOILET ROOMS - STUDENTS	
Door(s)	Inspected
Deficiency	No deficiencies recorded
Floor Finish	Inspected
Condition	2 - Between Good and Fair
Deficiency	EPOXY FLOORING: CRACKS/SPALLING
Deficiency Location/Instance	Basement - Girls, Boys, 1st Floor - Boys, Gymnasium - Boys, penthouse- Gender Neutral
Deficiency Quantity	100
Quantity Uom	S.F.
Potential Action	REPLACE
Urgency of Action	PRIORITY 3
Purpose of Action	LEVEL 2
Deficiency Photo1

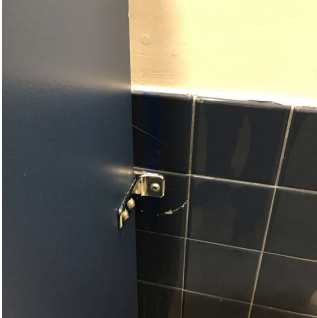
Violations	Basement - Girls No violations recorded.
Stalls	Inspected
Condition	2 - Between Good and Fair
Deficiency	No deficiencies recorded
Walls	Inspected
Condition	2 - Between Good and Fair
Deficiency	CERAMIC TILE: BROKEN/ MISSING
Deficiency Location/Instance	5th Floor - Boys, 4th Floor - Girls, 3rd Floor - Boys, Girls, Gymnasium - Girls, and others
Deficiency Quantity	50
Quantity Uom	S.F.
Potential Action	REPLACE
Urgency of Action	PRIORITY 3
Purpose of Action	LEVEL 2

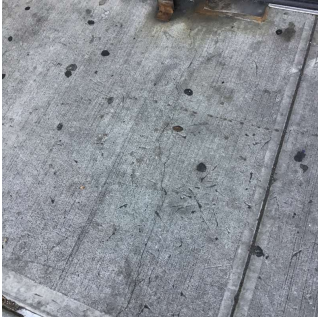
Question	Response
SITE	
PAVING	
Site Sidewalks & Walkways	
Concrete	
Deficiency Photo1

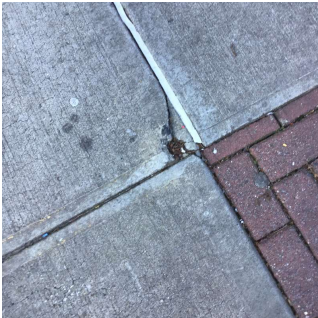
Violations	Along Waverly Avenue No violations recorded.
Pavers	Does not Exist
DOT Sidewalk	Inspected
Asphalt	Does not Exist
Concrete	Inspected
Condition	4 - Between Fair and Poor
Deficiency	DAMAGED/DETERIORATED/MISSING SECTIONS
Deficiency Location/Instance	Along Waverly Avenue
Deficiency Quantity	475
Quantity Uom	S.F.
Potential Action	REPLACE
Urgency of Action	PRIORITY 3
Purpose of Action	LEVEL 2
Deficiency Photo1

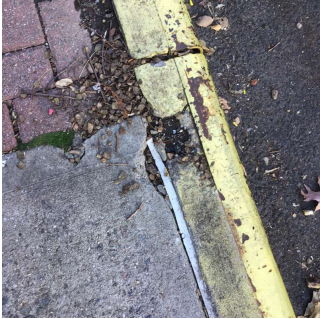
Violations	Along Waverly Avenue No violations recorded.
Deficiency	DAMAGED CURBS
Deficiency Location/Instance	Along Waverly Avenue
Deficiency Quantity	40
Quantity Uom	L.F.
Potential Action	REPLACE
Urgency of Action	PRIORITY 3
Purpose of Action	LEVEL 2
