NYC Department of Education
Building Condition Assessment Survey 2023 - 2024

Architectural Inspection

K787

Asset: **PRE-K CENTER @ 1215 AVENUE X-BROOKLYN, 1215 AVENUE X, New York, 11235**

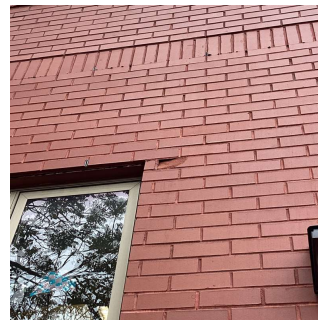
Question	Response
EXTERIOR	
DOORS	
DOORS AND FRAMES	
Roof Plan reference	
Deficiency Quantity	10
Quantity Uom	L.F.
Potential Action	MAINTENANCE
Urgency of Action	PRIORITY 3
Purpose of Action	LEVEL 2
Deficiency Photo1	
Violations	Facade A - Main Entrance No violations recorded.
DOOR HARDWARE	Inspected
Condition	2 - Between Good and Fair
Deficiency	No deficiencies recorded
LINTELS	Inspected
Condition	2 - Between Good and Fair
Deficiency	No deficiencies recorded
TRANSOM/SIDE LIGHT	Inspected
Condition	2 - Between Good and Fair
Deficiency	No deficiencies recorded
EXTERIOR WALLS	Inspected
Material Type(s)	Masonry, Steel
Replacement Quantity	12,000
Replacement Uom	S.F.
Instance on All Facades	Inspected
Instance Condition	2 - Between Good and Fair
Instance Quantity	12,000
Instance Quantity Uom	S.F.
Deficiency	BRICK: MINOR CRACKS AND SPALLING

RESTITCH

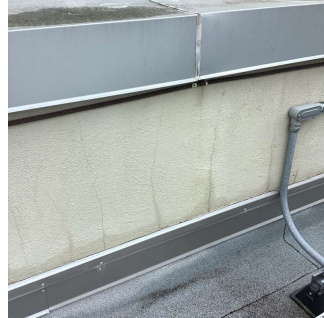
Question	Response
EXTERIOR	
PARAPETS	
Instance Quantity	300
Instance Quantity Uom	C.F.
Deficiency	CONCRETE: MINOR CRACKS, SPALLING
Roof Plan reference

Violations	Roof 1 - Facade C No violations recorded.
PLAZA DECK	Does not Exist
ROOF	Inspected
Roofing	Inspected
Replacement Quantity	3,500
Replacement Uom	S.F.
ROOF HATCH/SMOKE HATCH	Does not Exist
LEADERS, GUTTERS, DOWNSPOUTS, SCUPPERS	Inspected
Condition	2 - Between Good and Fair
Deficiency	No deficiencies recorded
ROOF BARRIER/FENCE	Inspected
Condition	2 - Between Good and Fair
Deficiency	No deficiencies recorded
ROOF CAGE	Does not Exist
ROOFING	Inspected
Instance on Modified Bitumen: Roofs 1 - 2	Inspected
Instance Condition	4 - Between Fair and Poor

Deficiency Quantity	80
Quantity Uom	S.F.
Potential Action	REPAIR
Urgency of Action	PRIORITY 3
Purpose of Action	LEVEL 2
Deficiency Photo1

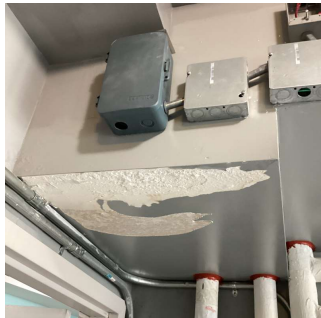
Roof 1 - Boiler Room (Room 307)
Violations	No violations recorded.
Instance on Metal: Roof 3	Inspected

Question	Response
EXTERIOR	
ROOF	
Roofing	
ROOFING	
Instance Photo	 
	Roof 1
Instance Quantity	3,000
Instance Quantity Uom	S.F.
Does the roof have major mechanical equipment sitting on Dunnage Steel less than 18" above the Roofing?	No
Does this roof instance have a Sustainable Roof System?	Yes
Sustainable Roof Type	White Roof
Sustainable Roof Location (Roof Number)	Roofs 1, 2
Do solar panels exist on these roofs?	No
Is/Are the roof(s) suitable for Solar Panel installation?	No
Installation Year	2015
Source of Installation	Custodial Staff
Deficiency	MODIFIED BITUMEN: ROOFING: MAJOR ACTIVE ROOF LEAKS IN NON-INSTRUCTIONAL SPACE
Roof Plan reference	 
Deficiency Quantity	100
Quantity Uom	S.F.
Potential Action	REPLACE ROOFING WITHOUT MAJOR EQUIPMENT REMOVAL
Urgency of Action	PRIORITY 5
Purpose of Action	LEVEL 2
Deficiency Photo1

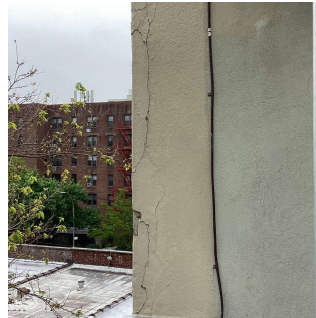
BH1

Roof 3
Instance Quantity	500
Instance Quantity Uom	S.F.
Does the roof have major mechanical equipment sitting on Dunnage Steel less than 18" above the Roofing?	No
Does this roof instance have a Sustainable Roof System?	No
Do solar panels exist on these roofs?	No
Is/Are the roof(s) suitable for Solar Panel installation?	No
Installation Year	2015
Source of Installation	Custodial Staff
Deficiency	No deficiencies recorded
ROOFING DRAINS	Inspected
Condition	2 - Between Good and Fair
Deficiency	No deficiencies recorded
Specialties	Inspected
BULKHEAD/PENTHOUSE	Inspected
Condition	3 - Fair
Deficiency	BULKHEAD/PENTHOUSE WALLS/EXTERIOR: CRACKS/SPALLING - MAJOR
Roof Plan reference

Deficiency Quantity	20
Quantity Uom	S.F.
Potential Action	REPLACE
Urgency of Action	PRIORITY 4
Purpose of Action	LEVEL 2

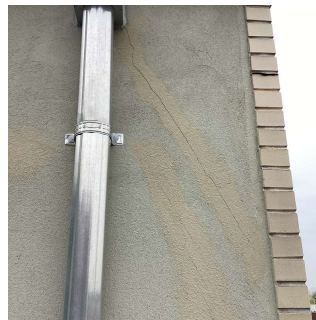
BH2

**BULKHEAD/PENTHOUSE WALLS/EXTERIOR:
CRACKS/SPALLING - MINOR**

REPAIR

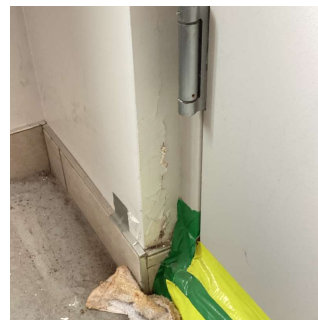
BH2
No violations recorded.

**BULKHEAD/PENTHOUSE WALLS/INTERIOR: GYPSUM
BOARD DAMAGED/DETERIORATED**

10
S.F.
REPLACE
PRIORITY 3
LEVEL 2

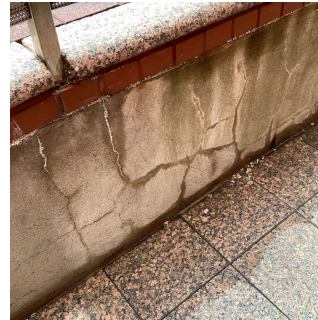
Facade A - HC Ramp

Deficiency	STUCCO CEMENT SURFACE: CRACKS/SPALLING - MINOR
------------	--

REPAIR

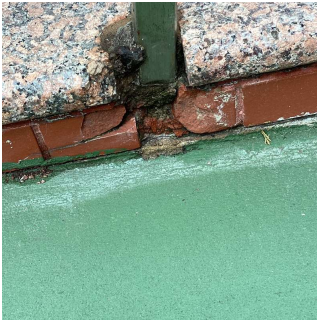
Deficiency	BRICK: CRACKS/SPALLING - MINOR
------------	--------------------------------

Violations	Facade A - HC Ramp No violations recorded.
Deficiency	BRICK: DETERIORATED COPING STONE
Roof Plan reference

REPAIR

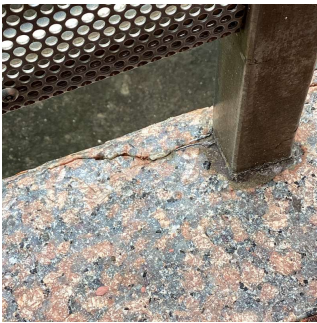
Violations	Facade A - HC Ramp No violations recorded.
RAILINGS	Inspected
Condition	2 - Between Good and Fair
Deficiency	No deficiencies recorded
STAIRS/RAMPS	Inspected
Condition	3 - Fair
Deficiency	STONE: CRACKS/SPALLING - MAJOR

Deficiency Quantity	15
Quantity Uom	S.F.
Potential Action	REPLACE
Urgency of Action	PRIORITY 4
Purpose of Action	LEVEL 2
Deficiency Photo1

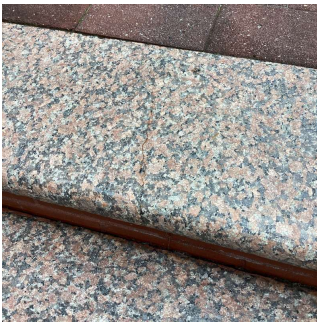
STONE: CRACKS/SPALLING - MINOR

Violations	Facade A No violations recorded.
WINDOWS	Inspected
Replacement Quantity	1,500
Replacement Uom	S.F.
EXTERIOR GUARDS	Does not Exist
LINTELS	Inspected
Condition	2 - Between Good and Fair
Deficiency	No deficiencies recorded
WINDOWS	Inspected
Material Type(s)	Aluminum
Instance on Aluminum - Other: All Facades	Inspected
Instance Condition	2 - Between Good and Fair
Instance Quantity	1,500
Instance Quantity Uom	S.F.
Are these windows insulated	Yes
Installation Year	2015
Source of Installation	Custodial Staff
Deficiency	No deficiencies recorded
INTERIOR	Inspected
POOLS	Does not Exist
STRUCTURAL	Inspected
COLUMNS/BEAMS/BEARING WALLS	Inspected
Condition	2 - Between Good and Fair
Deficiency	No deficiencies recorded
FLOOR STRUCTURE	Inspected
Condition	2 - Between Good and Fair
Deficiency	CONCRETE SLAB ON GRADE: THRU CRACKS
Deficiency Location/Instance	Electrical Room inside Room C02

10
S.F.
REPAIR
PRIORITY 3
LEVEL 2

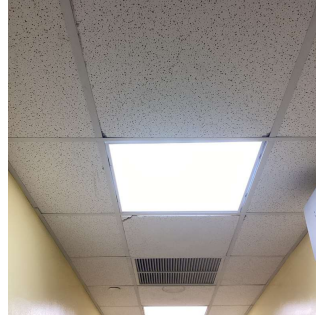
Question	Response
INTERIOR	
STRUCTURAL	
FLOOR STRUCTURE	
Deficiency Photo1	 
Violations	Electrical Room inside Room C02 No violations recorded.
FOUNDATION WALLS	
Material Type(s)	Inspected Concrete
Condition	2 - Between Good and Fair
Deficiency	No deficiencies recorded
ROOF STRUCTURE	
Condition	Inspected 2 - Between Good and Fair
Deficiency	No deficiencies recorded
VAULTS-BUNKERS	
Does not Exist	
AUDITORIUM	
Does not Exist	
CAFETERIA	
Does not Exist	
CLASSROOMS/CORRIDORS/ADMIN SPACES	
Inspected	
Ceiling	
Condition	Inspected 2 - Between Good and Fair
Deficiency	GYPSUM BOARD: DAMAGED/DETERIORATED
Deficiency Location/Instance	Room 301, Main Entrance, Corridor near Rooms 304, 306
Deficiency Quantity	60
Quantity Uom	S.F.
Potential Action	REPLACE
Urgency of Action	PRIORITY 3
Purpose of Action	LEVEL 2
Deficiency Photo1	 
Violations	Main Entrance No violations recorded.
Deficiency	ACOUSTIC TILES: DAMAGED/MISSING
Deficiency Location/Instance	Corridor near Room C04

Deficiency Quantity	30
Quantity Uom	S.F.
Potential Action	REPLACE

Urgency of Action	PRIORITY 3
Purpose of Action	LEVEL 2
Deficiency Photo1

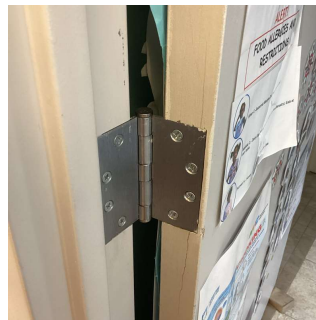
Condition	5 - Poor
Deficiency	WOOD: DETERIORATED DOOR
Deficiency Location/Instance	Room 301
Deficiency Quantity	1
Quantity Uom	EACH
Potential Action	MAINTENANCE
Urgency of Action	PRIORITY 3
Purpose of Action	LEVEL 2
Deficiency Photo1

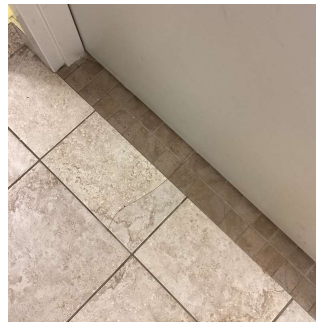
Condition	2 - Between Good and Fair
Deficiency	CERAMIC TILE: BROKEN/MISSING TILES
Deficiency Location/Instance	Corridor near Room C04
Deficiency Quantity	10
Quantity Uom	S.F.
Potential Action	REPLACE
Urgency of Action	PRIORITY 3
Purpose of Action	LEVEL 2

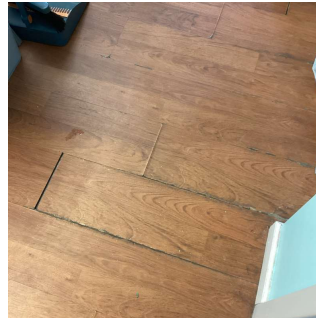
Room 301

WOOD: DAMAGED/DETERIORATED

Rooms 101, 106, 208, 301, 308 and others

REPLACE

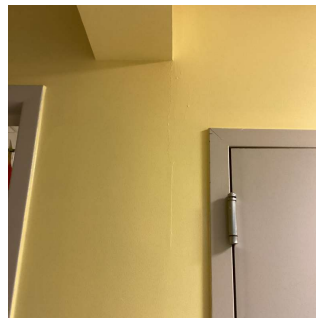
GYPSON BOARD: DETERIORATED

Corridor near Rooms 307, C05

REPLACE

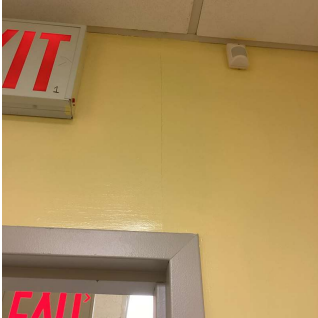
Instance on Basement (600 SF)	Inspected
Condition	2 - Between Good and Fair
Deficiency	No deficiencies recorded
Walls	
Instance on Basement (600 SF)	Inspected
Condition	2 - Between Good and Fair
Deficiency	GYPSUM BOARD: DETERIORATED
Deficiency Location/Instance	Near Main Entrance
Deficiency Quantity	10

Violations	Near Main Entrance No violations recorded.
LIBRARY	Does not Exist
LOCKER ROOM	Does not Exist
MULTI-PURPOSE ROOM	Inspected
Instance on Basement (1,200 SF)	Inspected
Ceiling	
Instance on Basement (1,200 SF)	Inspected
Condition	2 - Between Good and Fair
Deficiency	No deficiencies recorded
Door(s)	
Instance on Basement (1,200 SF)	Inspected
Condition	2 - Between Good and Fair
Deficiency	No deficiencies recorded
Fixed Equipment	
Instance on Basement (1,200 SF)	Does not Exist
Floor Finish	
Instance on Basement (1,200 SF)	Inspected
Condition	2 - Between Good and Fair
Deficiency	No deficiencies recorded
Sliding-folding Partition	
Instance on Basement (1,200 SF)	Does not Exist
Stage	
Instance on Basement (1,200 SF)	Does not Exist
Walls	
Instance on Basement (1,200 SF)	Inspected

Question	Response
INTERIOR	
KITCHEN	
Walls	
Quantity Uom	S.F.
Potential Action	REPLACE
Urgency of Action	PRIORITY 3
Purpose of Action	LEVEL 2
Deficiency Photo1

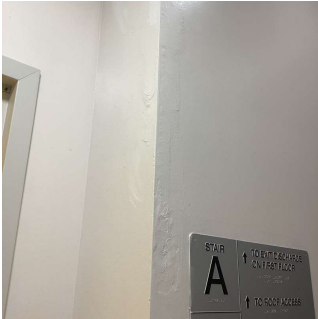
Question	Response
INTERIOR	
STAIRS/RAMPS: INTERIOR	
Stairs and Landings	Inspected
Violations	No violations recorded.
Walls	Inspected
Condition	2 - Between Good and Fair
Deficiency	GYPSUM BOARD: DETERIORATED
Deficiency Location/Instance	Stairs A/Basement, 3
Deficiency Quantity	30
Quantity Uom	S.F.
Potential Action	REPLACE
Urgency of Action	PRIORITY 3
Purpose of Action	LEVEL 2
Deficiency Photo1

Violations	Stair A/Basement No violations recorded.
TOILET ROOMS - STAFF	Inspected
Ceiling	Inspected
Condition	2 - Between Good and Fair
Deficiency	No deficiencies recorded
Door(s)	Inspected
Condition	2 - Between Good and Fair
Deficiency	No deficiencies recorded
Floor Finish	Inspected
Condition	2 - Between Good and Fair
Deficiency	No deficiencies recorded
Stalls	Does not Exist
Walls	Inspected
Condition	2 - Between Good and Fair
Deficiency	No deficiencies recorded
TOILET ROOMS - STUDENTS	Inspected
Ceiling	Inspected
Condition	2 - Between Good and Fair

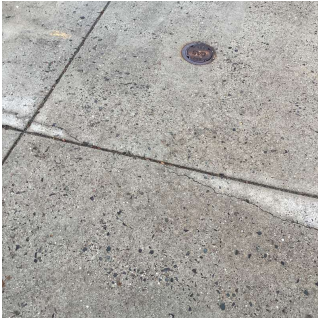
Question	Response
SITE	
PAVING	
Site Sidewalks & Walkways	Inspected
Concrete	Inspected
Deficiency	No deficiencies recorded
Pavers	Inspected
Condition	2 - Between Good and Fair
Deficiency	No deficiencies recorded
DOT Sidewalk	Inspected
Asphalt	Does not Exist
Concrete	Inspected
Condition	3 - Fair
Deficiency	DAMAGED/DETERIORATED/MISSING SECTIONS
Deficiency Location/Instance	Avenue X
Deficiency Quantity	100
Quantity Uom	S.F.
Potential Action	REPLACE
Urgency of Action	PRIORITY 3
Purpose of Action	LEVEL 2
Deficiency Photo1

Violations	Avenue X No violations recorded.
Pavers	Does not Exist
PLAYGROUNDS	Inspected
Instance on Rear of Building	Inspected
Benches	
Instance on Rear of Building	Inspected
Condition	2 - Between Good and Fair
Deficiency	No deficiencies recorded
Fence	
Instance on Rear of Building	Inspected
Condition	2 - Between Good and Fair
Deficiency	No deficiencies recorded
Pavement	
Instance on Rear of Building	Does not Exist
