NYC Department of Education
Building Condition Assessment Survey 2023 - 2024

Architectural Inspection

K798

Asset: CESIAH TORO MULLANE SCHOOL - K, 696 JAMAICA AVENUE, New York, 11208

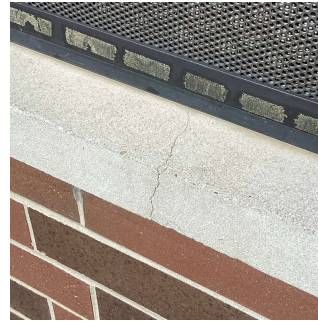
Facade D

BRICK: DETERIORATED MASONRY SILLS - MINOR

REPAIR

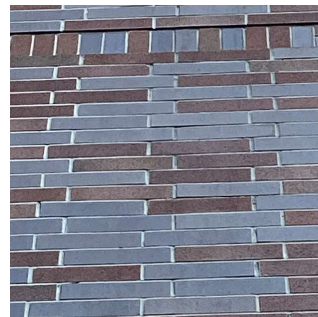
Facade C

BRICK: DETERIORATED JOINTS

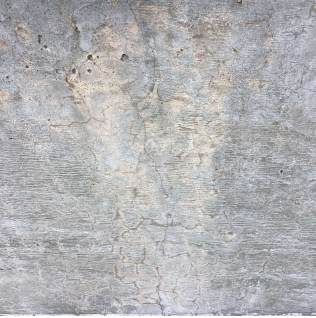
Question	Response
EXTERIOR	
EXTERIOR SOFFITS	Inspected
Condition	2 - Between Good and Fair
Deficiency	No deficiencies recorded
LOADING DOCK	Does not Exist
LOUVER	Inspected
Condition	2 - Between Good and Fair
Deficiency	No deficiencies recorded
PARAPETS	Inspected
Material Type(s)	Concrete
Replacement Quantity	4,500
Replacement Uom	C.F.
Instance on All Roofs	Inspected
Instance Condition	3 - Fair
Instance Quantity	4,500
Instance Quantity Uom	C.F.
Deficiency	CONCRETE: MINOR CRACKS, SPALLING
Roof Plan reference

Deficiency Quantity	80
Quantity Uom	S.F.
Potential Action	REPAIR
Urgency of Action	PRIORITY 3
Purpose of Action	LEVEL 2
Deficiency Photo1

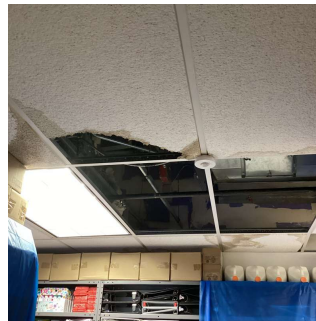
Roof 1 - Room 514

Deficiency	IRMA: ROOFING: MAJOR ACTIVE ROOF LEAKS IN NON-INSTRUCTIONAL SPACE

100
S.F.
REPLACE ROOFING WITHOUT MAJOR EQUIPMENT REMOVAL
PRIORITY 5
LEVEL 2

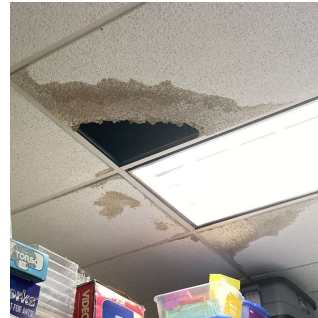
IRMA: ROOFING: MAJOR ACTIVE ROOF LEAKS IN INSTRUCTIONAL SPACE

Roof 1 - Room 505 (Roof 1 - Room 519, Corridor near Room 516, Corridor near Room 515, Corridor near Room 520 similar)

600
S.F.
REPLACE ROOFING WITHOUT MAJOR EQUIPMENT REMOVAL
PRIORITY 5
LEVEL 2

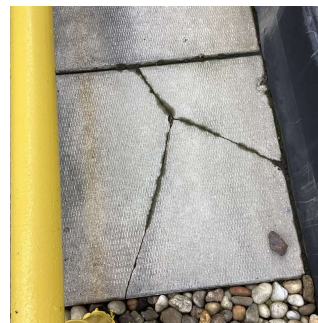
Roof 1

IRMA: ROOFING: DETERIORATED PAVERS WITH INTEGRAL INSULATION

REPLACE

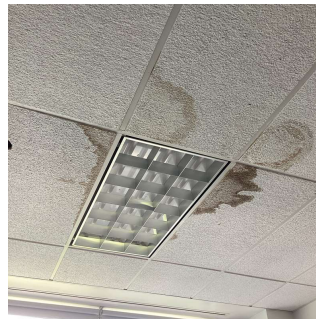
IRMA: ROOFING: MAJOR ACTIVE ROOF LEAKS IN INSTRUCTIONAL SPACE

Roof 1 - Rooms 515 (shown) 516, Roof 2 - Library (similar)
 35663297P

300
 S.F.
 REPLACE ROOFING WITHOUT MAJOR EQUIPMENT
 REMOVAL
 PRIORITY 5
 LEVEL 4

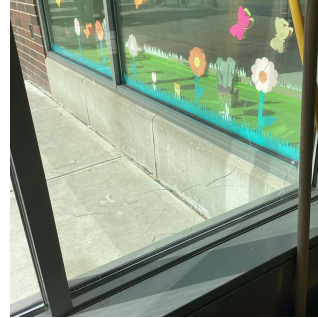
Facade D

Question	Response
EXTERIOR	
ROOF	
Specialties	
DORMER	Does not Exist
DUNNAGE STEEL	Does not Exist
SKYLIGHT/ROOF VENT	Does not Exist
ROOF/GRAVITY TANK	Does not Exist
STAIRS/RAMPS: EXTERIOR	Does not Exist
WINDOWS	Inspected
Replacement Quantity	9,500
Replacement Uom	S.F.
EXTERIOR GUARDS	Inspected
Condition	2 - Between Good and Fair
Deficiency	No deficiencies recorded
LINTELS	Inspected
Condition	2 - Between Good and Fair
Deficiency	No deficiencies recorded
WINDOWS	Inspected
Material Type(s)	Aluminum
Instance on Aluminum - Other: All Facades	Inspected
Instance Condition	3 - Fair
Instance Quantity	9,500
Instance Quantity Uom	S.F.
Are these windows insulated	Yes
Installation Year	2009
Source of Installation	Custodial Staff
Deficiency	ALUMINUM - OTHER: BROKEN PANE
Roof Plan reference	<p>K798</p>
Elevation	
Deficiency Quantity	100
Quantity Uom	S.F.
Potential Action	MAINTENANCE

PRIORITY 3
LEVEL 4

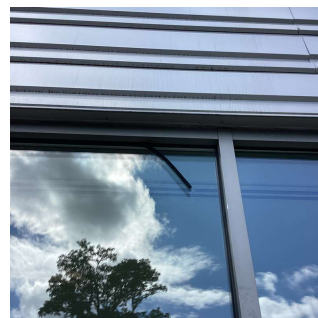
ALUMINUM - OTHER: AIR/WATER INFILTRATION, DETERIORATED JOINTS WITH DAMAGED CAULKING

Question	Response
EXTERIOR	
WINDOWS	
WINDOWS	
Violations	Facade D - 1st Floor (Facade C - Room 422A similar throughout) No violations recorded.
Deficiency	ALUMINUM - OTHER: AIR/WATER INFILTRATION
Roof Plan reference	<p>K798</p>  
Elevation	 
Deficiency Quantity	30
Quantity Uom	L.F.
Potential Action	REPLACE TRIM, SILLS OR WEATHERSTRIPPING
Urgency of Action	PRIORITY 5
Purpose of Action	LEVEL 2
Deficiency Photo1	 
Violations	Facade C - Room 522 No violations recorded.
INTERIOR	
Inspected	
POOLS	
Does not Exist	
STRUCTURAL	
Inspected	
COLUMNS/BEAMS/BEARING WALLS	
Inspected	
Condition	2 - Between Good and Fair
Deficiency	STEEL COLUMNS/BEAMS: DETERIORATED/MISSING SPRAY-ON FIREPROOFING
Deficiency Location/Instance	Basement - Room B11
Deficiency Quantity	20

100
L.F.
MAINTENANCE
PRIORITY 3
LEVEL 2

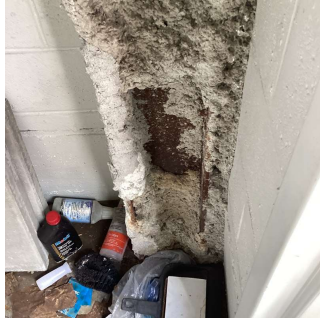
Question	Response
INTERIOR	
STRUCTURAL	
COLUMNS/BEAMS/BEARING WALLS	
Quantity Uom	S.F.
Potential Action	REPLACE
Urgency of Action	PRIORITY 3
Purpose of Action	LEVEL 5
Deficiency Photo1	 
Violations	Basement - Room B11 No violations recorded.
FLOOR STRUCTURE	Inspected
Condition	3 - Fair
Deficiency	CONCRETE SLAB ON GRADE: THRU CRACKS
Deficiency Location/Instance	Basement - Rooms B09, B11
Deficiency Quantity	80
Quantity Uom	S.F.
Potential Action	REPAIR
Urgency of Action	PRIORITY 3
Purpose of Action	LEVEL 5
Deficiency Photo1	 
Violations	Basement - Room B09 No violations recorded.
FOUNDATION WALLS	Inspected
Material Type(s)	Concrete
Condition	2 - Between Good and Fair
Deficiency	No deficiencies recorded
ROOF STRUCTURE	Inspected
Condition	2 - Between Good and Fair
Deficiency	STEEL COLUMNS/BEAMS: DETERIORATED/MISSING SPRAY-ON FIREPROOFING
Deficiency Location/Instance	BH
Deficiency Quantity	10
Quantity Uom	S.F.
Potential Action	REPLACE

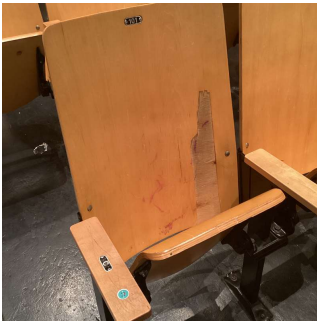
Seat C/101
Violations	No violations recorded.
Floor Finish	
Instance on 2nd Floor (399 Seats)	Inspected
Condition	2 - Between Good and Fair
Deficiency	SHEET VINYL: BROKEN/DETERIORATED
Deficiency Location/Instance	Near Seat A/4
Deficiency Quantity	10
Quantity Uom	S.F.
Potential Action	REPLACE
Urgency of Action	PRIORITY 3
Purpose of Action	LEVEL 2
Deficiency Photo1

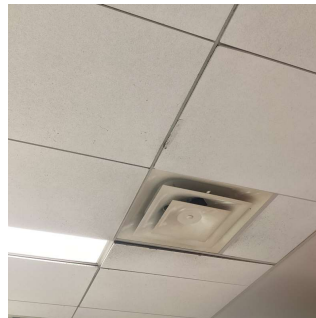
ACOUSTIC TILES: DAMAGED/MISSING

REPLACE

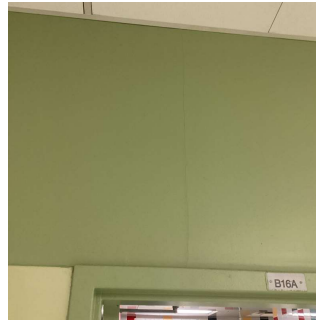
Question	Response
INTERIOR	
CAFETERIA	
Ceiling	
Violations	Near Stair B No violations recorded.
Door(s)	
Instance on Basement	Inspected
Condition	2 - Between Good and Fair
Deficiency	No deficiencies recorded
Fixed Equipment	
Instance on Basement	Does not Exist
Floor Finish	
Instance on Basement	Inspected
Condition	2 - Between Good and Fair
Deficiency	VINYL TILES: BROKEN/DETERIORATED/MISSING TILES
Deficiency Location/Instance	Near Serving Area, Center
Deficiency Quantity	15
Quantity Uom	S.F.
Potential Action	REPLACE
Urgency of Action	PRIORITY 3
Purpose of Action	LEVEL 2
Deficiency Photo1	 
Violations	Near Serving Area No violations recorded.
Sliding-folding Partition	
Instance on Basement	Does not Exist
Stage	
Instance on Basement	Does not Exist
Walls	
Instance on Basement	Inspected
Condition	2 - Between Good and Fair
Deficiency	GYPSUM BOARD: DETERIORATED
Deficiency Location/Instance	Near Kitchen Entrance
Deficiency Quantity	10

Quantity Uom	S.F.
Potential Action	REPLACE
Urgency of Action	PRIORITY 3
Purpose of Action	LEVEL 2

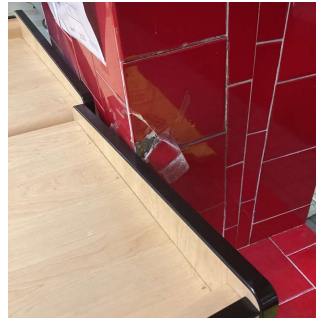
Serving Area

CERAMIC TILE: BROKEN/ MISSING

REPLACE

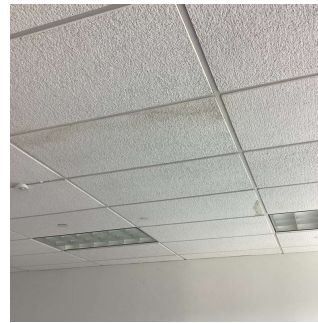
Room 509

ACOUSTIC TILES: DAMAGED/MISSING

REPLACE

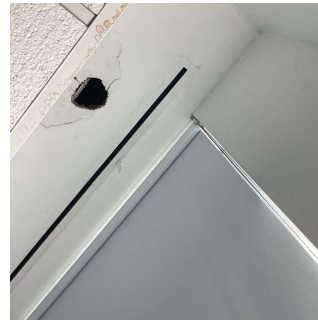
Room 516

GYPSUM BOARD: DAMAGED/DETERIORATED - ACTIVE LEAK

REPLACE

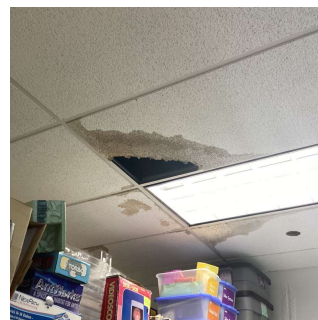
Room 505

ACOUSTIC TILES: DAMAGED/MISSING - ACTIVE LEAK

REPLACE

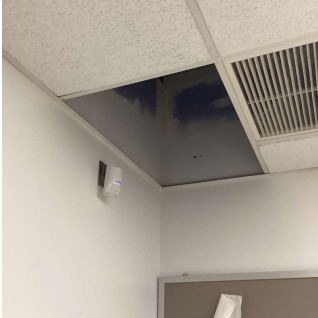
Question	Response
INTERIOR	
CLASSROOMS/CORRIDORS/ADMIN SPACES	
Ceiling	
Violations	No violations recorded.
Deficiency	ACOUSTIC TILES: DAMAGED/MISSING - ACTIVE LEAK
Deficiency Location/Instance	Rooms B19, 515, 516
Deficiency Quantity	45
Quantity Uom	S.F.
Potential Action	REPLACE
Urgency of Action	PRIORITY 5
Purpose of Action	LEVEL 4
Deficiency Photo1

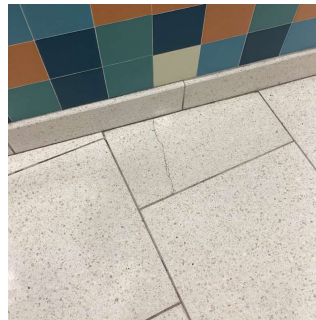
Corridor near Room B14

CERAMIC TILE: BROKEN/MISSING TILES

REPLACE

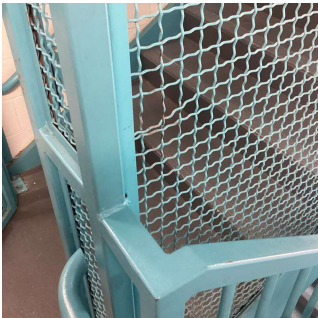
Question	Response
INTERIOR	
INTERIOR GUARDS	Inspected
Condition	2 - Between Good and Fair
Deficiency	DETERIORATED/TORN-OUT/MISSING
Deficiency Location/Instance	Stair A/5
Deficiency Quantity	10
Quantity Uom	S.F.
Potential Action	REPLACE
Urgency of Action	PRIORITY 3
Purpose of Action	LEVEL 2
Deficiency Photo1

Violations	Stair A/5 No violations recorded.
KITCHEN	Inspected
Instance on Basement	Inspected
Ceiling	Inspected
Instance on Basement	Inspected
Condition	2 - Between Good and Fair
Deficiency	METAL PAN: DAMAGED/MISSING
Deficiency Location/Instance	Serving Area
Deficiency Quantity	10
Quantity Uom	S.F.
Potential Action	REPLACE
Urgency of Action	PRIORITY 3
Purpose of Action	LEVEL 2
Deficiency Photo1

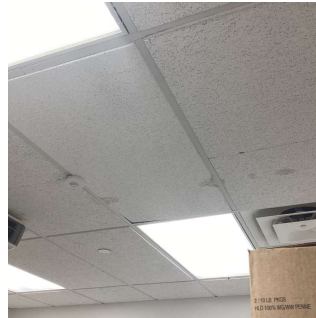
Violations	Serving Area No violations recorded.
Deficiency	ACOUSTIC TILES: DAMAGED/MISSING
Deficiency Location/Instance	Room B16A9
Deficiency Quantity	10
Quantity Uom	S.F.
Potential Action	REPLACE
Urgency of Action	PRIORITY 3

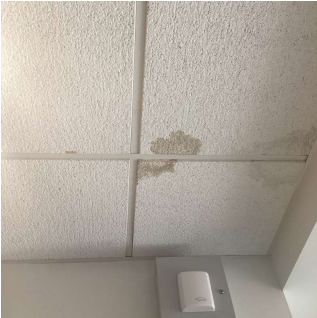
Violations	Right Side No violations recorded.
Deficiency	ACOUSTIC TILES: DAMAGED/MISSING - ACTIVE LEAK
Deficiency Location/Instance	Near Room 301A, Near Circulation Desk
Deficiency Quantity	20
Quantity Uom	S.F.
Potential Action	REPLACE
Urgency of Action	PRIORITY 5
Purpose of Action	LEVEL 4
Deficiency Photo1

Violations	Near Room 301A 35663297P
Deficiency	GYPSUM BOARD: DAMAGED/DETERIORATED - ACTIVE LEAK
Deficiency Location/Instance	Near Circulation Desk
Deficiency Quantity	15
Quantity Uom	S.F.
Potential Action	REPLACE
Urgency of Action	PRIORITY 5
Purpose of Action	LEVEL 4
Deficiency Photo1

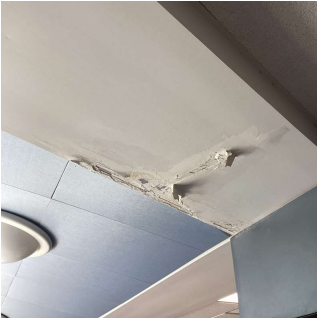
Violations	Near Circulation Desk 35663297P

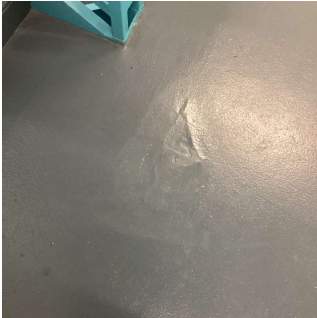
Question	Response
INTERIOR	
STAIRS/RAMPS: INTERIOR	
Stairs and Landings	
Deficiency	CONCRETE: CRACKS/SPALLING - MAJOR
Deficiency Location/Instance	Stair B/4, Auditorium Service Exit, Gymnasium Exit
Deficiency Quantity	30
Quantity Uom	S.F.
Potential Action	REPLACE
Urgency of Action	PRIORITY 3
Purpose of Action	LEVEL 2
Deficiency Photo1

Violations	Stair B/4 No violations recorded.
Walls	Inspected
Condition	2 - Between Good and Fair
Deficiency	No deficiencies recorded
TOILET ROOMS - STAFF	
Ceiling	Inspected
Condition	2 - Between Good and Fair
Deficiency	No deficiencies recorded
Door(s)	Inspected
Condition	2 - Between Good and Fair
Deficiency	No deficiencies recorded
Floor Finish	Inspected
Condition	2 - Between Good and Fair
Deficiency	No deficiencies recorded
Stalls	Does not Exist
Walls	Inspected
Condition	2 - Between Good and Fair
Deficiency	No deficiencies recorded
TOILET ROOMS - STUDENTS	
Ceiling	Inspected
Condition	2 - Between Good and Fair

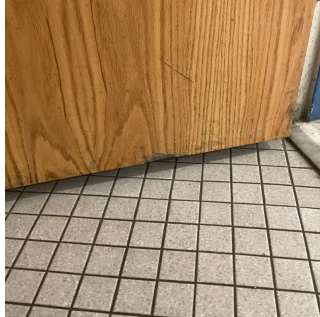
Deficiency	No deficiencies recorded
Door(s)	Inspected
Condition	5 - Poor
Deficiency	WOOD: DETERIORATED DOOR
Deficiency Location/Instance	Rooms B02C, B16D, 208, 408
Deficiency Quantity	4
Quantity Uom	EACH
Potential Action	MAINTENANCE
Urgency of Action	PRIORITY 3

Room B16D
Violations	No violations recorded.
Floor Finish	Inspected
Condition	2 - Between Good and Fair
Deficiency	CERAMIC TILE: DETERIORATED SUBSTRATE
Deficiency Location/Instance	Room B16D
Deficiency Quantity	10
Quantity Uom	S.F.
Potential Action	REPLACE
Urgency of Action	PRIORITY 3
Purpose of Action	LEVEL 2
Deficiency Photo1	 
	Room B16D
Violations	No violations recorded.
Deficiency	CERAMIC TILE: BROKEN/MISSING TILES
Deficiency Location/Instance	Rooms B02B, B16C
Deficiency Quantity	20
Quantity Uom	S.F.
Potential Action	REPLACE
Urgency of Action	PRIORITY 3
Purpose of Action	LEVEL 2

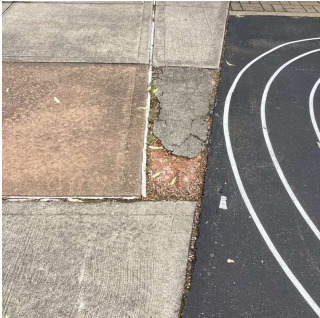
Question	Response
SITE	
PAVING	
Student Use	
Asphalt	Inspected
Violations	No violations recorded.
Concrete	Inspected
Condition	3 - Fair
Deficiency	DAMAGED/DETERIORATED/MISSING SECTIONS
Deficiency Location/Instance	Schoolyard
Deficiency Quantity	100
Quantity Uom	S.F.
Potential Action	REPLACE
Urgency of Action	PRIORITY 3
Purpose of Action	LEVEL 2
Deficiency Photo1

Violations	Schoolyard No violations recorded.
Pavers	Inspected
Condition	3 - Fair
Deficiency	HEAVING
Deficiency Location/Instance	Schoolyard
Deficiency Quantity	50
Quantity Uom	S.F.
Potential Action	REPLACE
Urgency of Action	PRIORITY 3
Purpose of Action	LEVEL 2
Deficiency Photo1

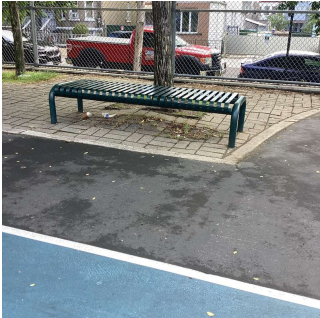
Violations	Schoolyard No violations recorded.
Site Sidewalks & Walkways	Inspected
Asphalt	Does not Exist
Concrete	Inspected
Condition	3 - Fair

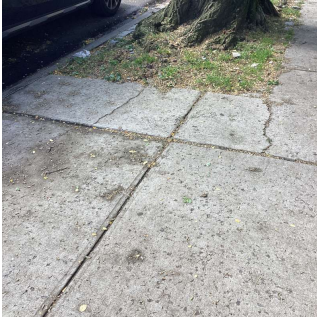
Question	Response
SITE	
PAVING	
Site Sidewalks & Walkways	
Concrete	
Deficiency	DAMAGED/DETERIORATED/MISSING SECTIONS
Deficiency Location/Instance	Near Exit 3
Deficiency Quantity	50
Quantity Uom	S.F.
Potential Action	REPLACE
Urgency of Action	PRIORITY 3
Purpose of Action	LEVEL 2
Deficiency Photo1	 
	Near Exit 3
Violations	No violations recorded.
Pavers	Does not Exist
DOT Sidewalk	Inspected
Asphalt	Does not Exist
Concrete	Inspected
Condition	4 - Between Fair and Poor
Deficiency	HEAVING
Deficiency Location/Instance	Richmond Street
Deficiency Quantity	50
Quantity Uom	S.F.
Potential Action	REPLACE
Urgency of Action	PRIORITY 3
Purpose of Action	LEVEL 2
Deficiency Photo1

Richmond Street
Violations	No violations recorded.
Deficiency	DAMAGED/DETERIORATED/MISSING SECTIONS
Deficiency Location/Instance	Jamaica Avenue, Richmond Street
Deficiency Quantity	550
Quantity Uom	S.F.
Potential Action	REPLACE

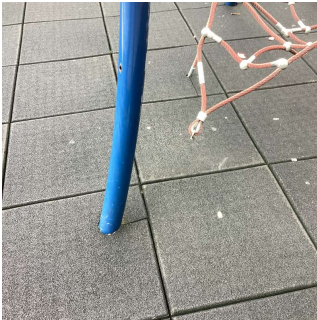
Question	Response
SITE	
PLAYGROUNDS	
Play Equipment	
Instance on Schoolyard - South	Inspected
Condition	5 - Poor
Deficiency	BROKEN/DETERIORATED/MISSING
Deficiency Location/Instance	Center
Deficiency Quantity	1
Quantity Uom	EACH
Potential Action	REPLACE
Urgency of Action	PRIORITY 3
Purpose of Action	LEVEL 2
Deficiency Photo1

Violations	Center No violations recorded.
Safety Surfacing	
Instance on Schoolyard - North	Inspected
Condition	3 - Fair
Deficiency	DETERIORATED/MISSING
Deficiency Location/Instance	Near School Building, Center, Near Outer Fence
Deficiency Quantity	50
Quantity Uom	S.F.
Potential Action	MAINTENANCE
Urgency of Action	PRIORITY 3
Purpose of Action	LEVEL 2
Deficiency Photo1

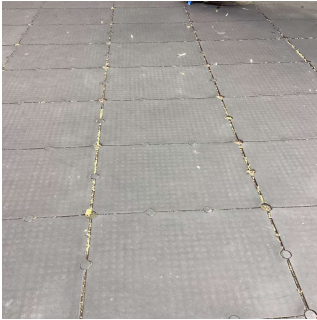
Violations	Near School Building No violations recorded.
Instance on Schoolyard - South	Inspected
Condition	2 - Between Good and Fair
Deficiency	DETERIORATED/MISSING
Deficiency Location/Instance	Near Fence
Deficiency Quantity	10
