**NYC Department of Education
Building Condition Assessment Survey 2023 - 2024**

Architectural Inspection

K802

Asset: CENT HEADQTRS (131 LIV) - K, 131 LIVINGSTON STREET, New York, 11201

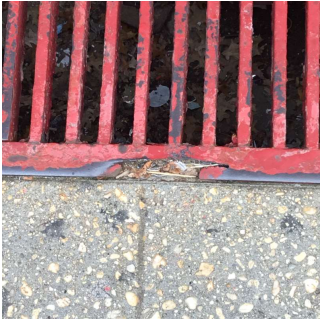
AREAWAY GRATINGS: MAJOR RUSTING / OR BROKEN

20
S.F.
REPLACE
PRIORITY 4
LEVEL 2

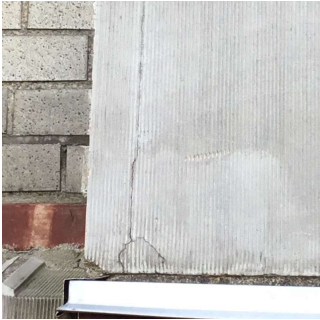
Violations	AW1 No violations recorded.
AWNINGS AND CANOPIES	Does not Exist
CHIMNEY	Inspected
Material Type(s)	Masonry
Condition	2 - Between Good and Fair
Deficiency	No deficiencies recorded
COPING	Inspected
Condition	3 - Fair
Deficiency	TERRA COTTA: CRACKED/BROKEN PIECES
Roof Plan reference

Deficiency Quantity	10
Quantity Uom	L.F.
Potential Action	REPLACE-IN-KIND
Urgency of Action	PRIORITY 4
Purpose of Action	LEVEL 2
Deficiency Photo1

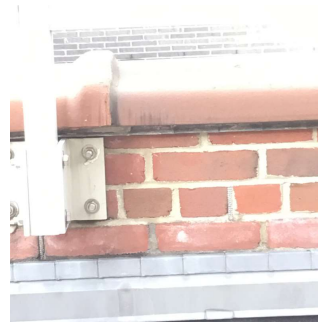
Violations	Roof 1 No violations recorded.
Deficiency	TERRA COTTA: DETERIORATED BED JOINT

15
L.F.
REPOINT
PRIORITY 3
LEVEL 2

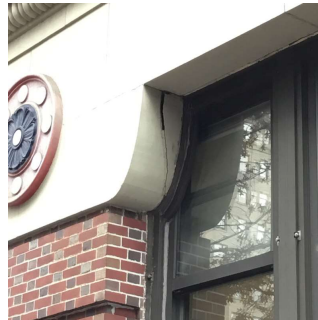
Facade A

STONE: CHIPPED/SPALLED/BROKEN PIECES - MAJOR

REPLACE

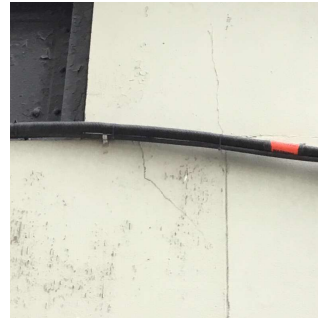
Facade D

STONE: CHIPPED/SPALLED/BROKEN PIECES - MINOR

REPAIR

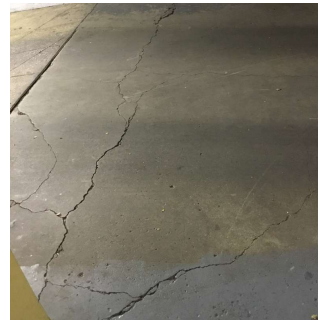
Loading Dock

DETERIORATED CONCRETE PLATFORM WITH CRACKED, SPALLED CONCRETE OR EXPOSED REINFORCING

100
S.F.
REPAIR
PRIORITY 4
LEVEL 2

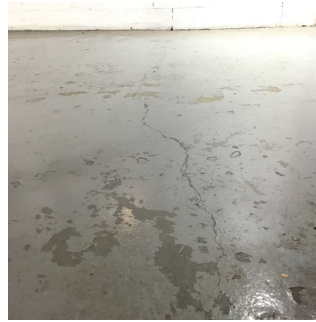
Loading Dock

DETERIORATED CONCRETE PLATFORM WITH CRACKED, SPALLED CONCRETE OR EXPOSED REINFORCING

50
S.F.
REPAIR
PRIORITY 3
LEVEL 2

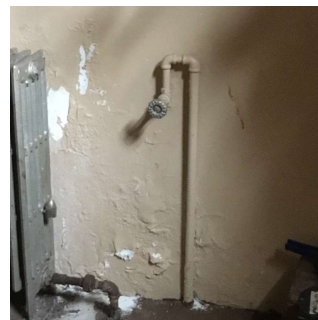
PH2
No violations recorded.

Source of Installation	Custodial Staff
Deficiency	No deficiencies recorded
ROOFING DRAINS	Inspected
Condition	2 - Between Good and Fair
Deficiency	No deficiencies recorded
Specialties	Inspected
BULKHEAD/PENTHOUSE	Inspected
Condition	3 - Fair
Deficiency	BULKHEAD/PENTHOUSE WALLS/INTERIOR: PLASTER CRACKS/SPALLING

20
S.F.
REPLACE
PRIORITY 4
LEVEL 2

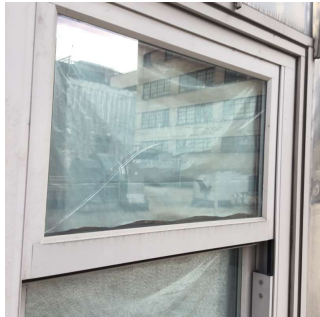
BULKHEAD/PENTHOUSE WINDOWS: DAMAGED, DETERIORATED WINDOWS

20
S.F.
REPLACE
PRIORITY 4
LEVEL 2

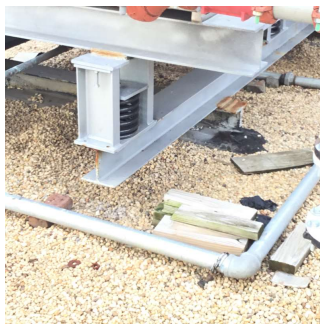
Violations	BH1 No violations recorded.
CUPOLA/ SPIRES/ TOWERS	Does not Exist
DORMER	Inspected
Condition	2 - Between Good and Fair
Deficiency	No deficiencies recorded
DUNNAGE STEEL	Inspected
Condition	2 - Between Good and Fair
Deficiency	HEIGHT LESS THAN 18"
Roof Plan reference

Deficiency Quantity	40
Quantity Uom	L.F.
Potential Action	REPLACE
Urgency of Action	PRIORITY 3
Purpose of Action	LEVEL 2
Deficiency Photo1

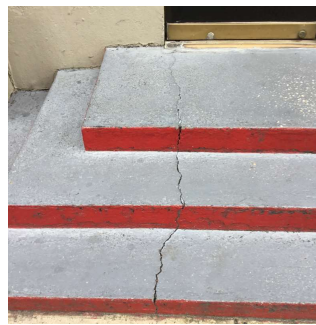
Facade A

Violations	<p>Loading Dock</p> <p>No violations recorded.</p>
RAILINGS	Inspected
Condition	2 - Between Good and Fair
Deficiency	No deficiencies recorded
STAIRS/RAMPS	Inspected
Condition	5 - Poor
Deficiency	CONCRETE: CRACKS/SPALLING - MAJOR

30
S.F.
REPLACE
PRIORITY 4
LEVEL 2

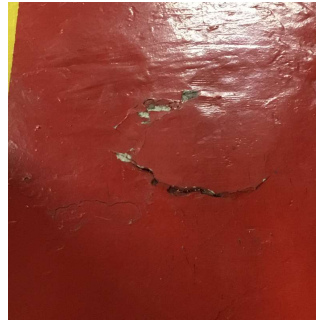
Boiler Room

CONCRETE SLAB ON GRADE: THRU CRACKS

REPLACE

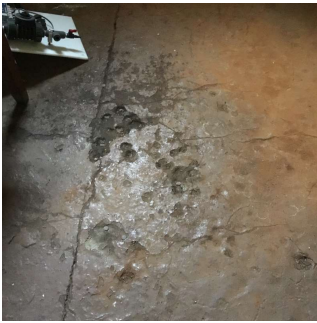
Question	Response
INTERIOR	
STRUCTURAL	
FLOOR STRUCTURE	
Violations	No violations recorded.
Deficiency	CINDER CONCRETE ARCH: METAL PAN DETERIORATED, SPALLED
Deficiency Location/Instance	Basement
Deficiency Quantity	250
Quantity Uom	S.F.
Potential Action	REPAIR
Urgency of Action	PRIORITY 4
Purpose of Action	LEVEL 5
Deficiency Photo1	 
Violations	No violations recorded.
Deficiency	CONCRETE: CRACKS/SPALLED/REINFORCEMENT EXPOSED
Deficiency Location/Instance	Parking Garage
Deficiency Quantity	200
Quantity Uom	S.F.
Potential Action	REPAIR
Urgency of Action	PRIORITY 3
Purpose of Action	LEVEL 5
Deficiency Photo1	 
Violations	No violations recorded.
Deficiency	CONCRETE: CRACKS/SPALLED/REINFORCEMENT EXPOSED
Deficiency Location/Instance	PH
Deficiency Quantity	20
Quantity Uom	S.F.
Potential Action	REPAIR
Urgency of Action	PRIORITY 4
Purpose of Action	LEVEL 5

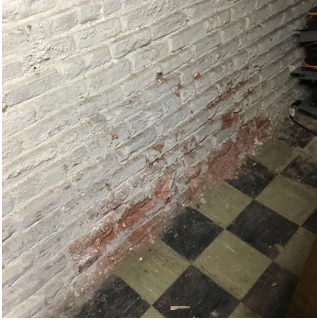
Violations	PH2 No violations recorded.
FOUNDATION WALLS	
Material Type(s)	Inspected Masonry
Condition	3 - Fair
Deficiency	BRICK: CRACKED/SPALLED
Deficiency Location/Instance	Basement
Deficiency Quantity	40
Quantity Uom	S.F.
Potential Action	RESTITCH
Urgency of Action	PRIORITY 4
Purpose of Action	LEVEL 5
Deficiency Photo1
