NYC Department of Education
Building Condition Assessment Survey 2023 - 2024

Architectural Inspection

K804

Asset: COBBLE HILL SCL OF AMR STD (OL6)-K, 347 BALTIC STREET, New York, 11201

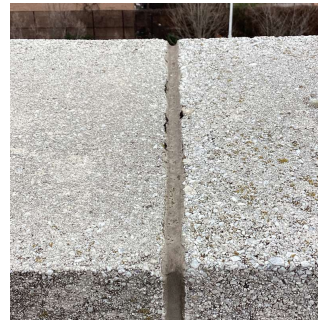
Roof 1 - Facade J

Violations	AW8 No violations recorded.
AWNINGS AND CANOPIES	Does not Exist
CHIMNEY	Inspected
Material Type(s)	Masonry
Condition	2 - Between Good and Fair
Deficiency	No deficiencies recorded
COPING	Inspected
Condition	3 - Fair
Deficiency	CAST STONE: DETERIORATED TRANSVERSE JOINTS

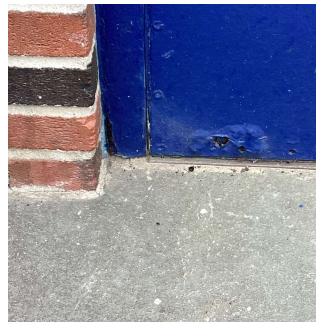
Facade C

Violations	Facade E - Exit 2 No violations recorded.
Deficiency	METAL CLAD: DETERIORATED DOOR AND FRAME - MAJOR DETERIORATION

2
EACH
REPLACE
PRIORITY 4
LEVEL 2

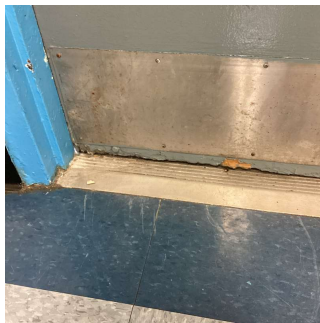
METAL CLAD: DETERIORATED DOOR - MAJOR DETERIORATION

5
EACH
REPLACE
PRIORITY 4
LEVEL 2

Violations	Facade L - Exit 4 No violations recorded.
DOOR HARDWARE	Inspected
Condition	3 - Fair
Deficiency	No deficiencies recorded
LINTELS	Inspected
Condition	2 - Between Good and Fair
Deficiency	No deficiencies recorded
TRANSOM/SIDE LIGHT	Inspected
Condition	3 - Fair
Deficiency	WOOD: BROKEN GLASS
Roof Plan reference	 
Deficiency Quantity	20
Quantity Uom	S.F.
Potential Action	MAINTENANCE
Urgency of Action	PRIORITY 3
Purpose of Action	LEVEL 2
Deficiency Photo1

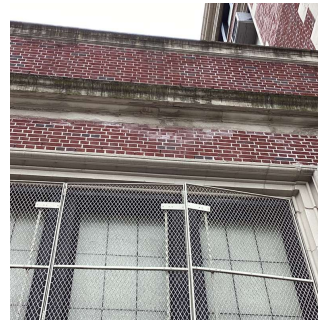
Facade E

Violations	Facade J No violations recorded.
Deficiency	BRICK: EFFLORESCENCE

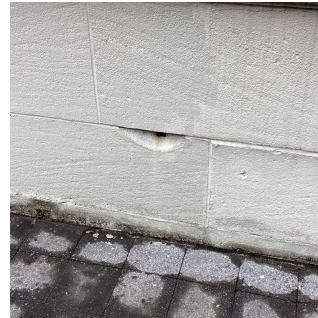
Facade B

STONE: CHIPPED/SPALLED/BROKEN PIECES - MAJOR

PRIORITY 4
LEVEL 2

REPLACE

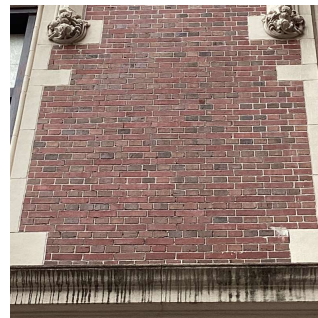
Facade B

BRICK: DETERIORATED JOINTS

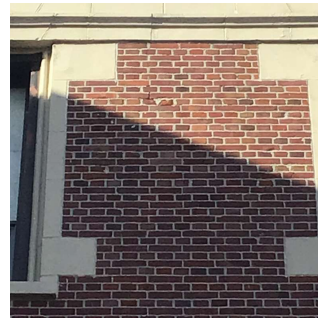
Facade F

BRICK: MINOR CRACKS AND SPALLING

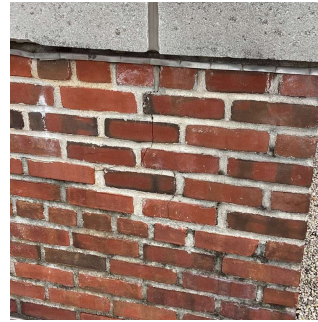
Facade D

Question	Response
EXTERIOR	
EXTERIOR WALLS	
Urgency of Action	PRIORITY 5
Purpose of Action	LEVEL 2
Deficiency Photo1	 
	Facade G - Room 410 (shown), Facade F - Room 306, Facade H - Room 411, Facade J - Stairs GH/4, N/1, 1st Floor Corridor near Room 103 (similar)
Violations	No violations recorded.
EXTERIOR SOFFITS	Does not Exist
LOADING DOCK	Does not Exist
LOUVER	Inspected
Condition	2 - Between Good and Fair
Deficiency	No deficiencies recorded
PARAPETS	Inspected
Material Type(s)	Masonry
Replacement Quantity	8,000
Replacement Uom	C.F.
Instance on All Parapets	Inspected
Instance Condition	4 - Between Fair and Poor
Instance Quantity	8,000
Instance Quantity Uom	C.F.
Deficiency	BRICK: MINOR CRACKS, SPALLING
Roof Plan reference	 
Deficiency Quantity	40
Quantity Uom	S.F.
Potential Action	REPAIR
Urgency of Action	PRIORITY 3
Purpose of Action	LEVEL 2

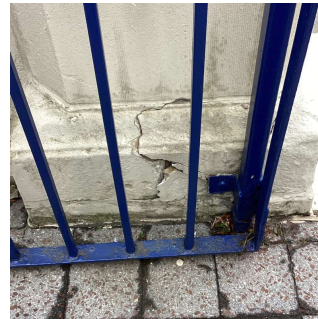
Roof 3 - Baltic Street

STONE: MAJOR DETERIORATION/CRACKS

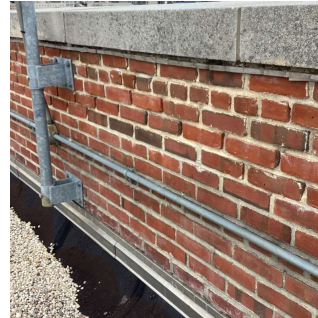
Facade B

BRICK: DETERIORATED JOINTS

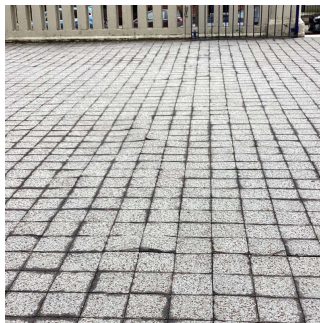
Question	Response
EXTERIOR	
PLAZA DECK	
Purpose of Action	LEVEL 2
Deficiency Photo1

Violations	Roof 3 No violations recorded.
Deficiency	PAVERS: MAJOR ACTIVE PLAZA DECK LEAKS IN INSTRUCTIONAL SPACE
Roof Plan reference

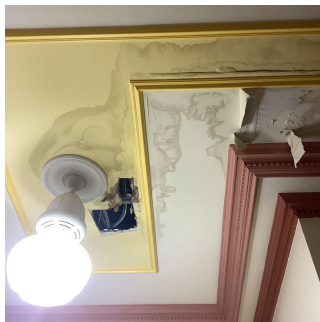
Deficiency Quantity	300
Quantity Uom	S.F.
Potential Action	REPLACE
Urgency of Action	PRIORITY 5
Purpose of Action	LEVEL 2
Deficiency Photo1

Violations	Roof 3 - Plaza Deck - Auditorium (3 locations) No violations recorded.
ROOF	
Roofing	Inspected
Replacement Quantity	23,000
Replacement Uom	S.F.
ROOF HATCH/SMOKE HATCH	Does not Exist
LEADERS, GUTTERS, DOWNSPOUTS, SCUPPERS	
Condition	2 - Between Good and Fair
Deficiency	No deficiencies recorded

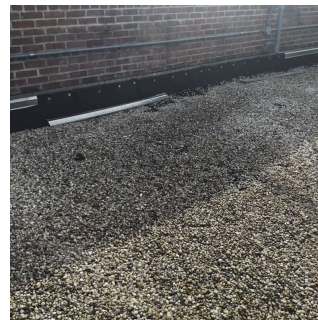
Roof 1 - Facade B

BUILT-UP: FLASHING: CAP FLASHING MISSING

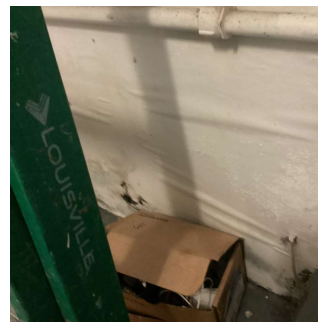
Violations	Roof 1 No violations recorded.
Specialties	Inspected
BULKHEAD/PENTHOUSE	Inspected
Condition	3 - Fair
Deficiency	BULKHEAD/PENTHOUSE WALLS/EXTERIOR: WATER INFILTRATION

50
S.F.
REPAIR
PRIORITY 5
LEVEL 2

BH
No violations recorded.

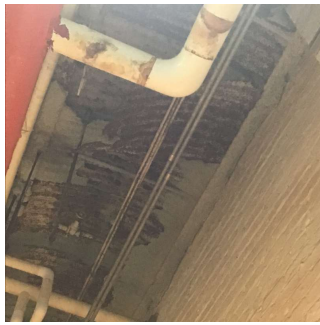
Facade L - Room 100
Violations	No violations recorded.
Instance on Steel: Boiler Room	Inspected
Instance Condition	5 - Poor
Instance Quantity	100
Instance Quantity Uom	S.F.
Are these windows insulated	No
Installation Year	1905
Source of Installation	Custodial Staff
Deficiency	STEEL: DETERIORATED
Roof Plan reference

Question	Response
INTERIOR	
STRUCTURAL	
FLOOR STRUCTURE	
Deficiency Photo1	<p>Inspected</p>

<p>Boiler Room</p> <p>No violations recorded.</p>
Violations	
FOUNDATION WALLS	
Material Type(s)	Inspected Masonry
Condition	4 - Between Fair and Poor
Deficiency	BRICK: WATER INFILTRATION IN INSTRUCTIONAL SPACE
Deficiency Location/Instance	Basement - Auditorium (2 locations)
Deficiency Quantity	200
Quantity Uom	S.F.
Potential Action	INSTALL WATERPROOFING
Urgency of Action	PRIORITY 5
Purpose of Action	LEVEL 5
Deficiency Photo1

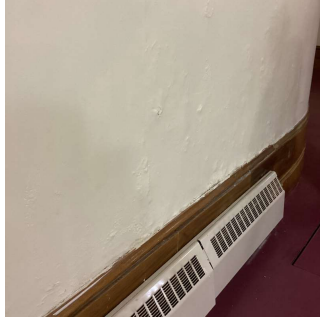
<p>Auditorium</p> <p>No violations recorded.</p>
Violations	
Deficiency	BRICK: WATER INFILTRATION IN NON- INSTRUCTIONAL SPACE
Deficiency Location/Instance	Basement - Boiler Room
Deficiency Quantity	200
Quantity Uom	S.F.
Potential Action	INSTALL WATERPROOFING
Urgency of Action	PRIORITY 5
Purpose of Action	LEVEL 5

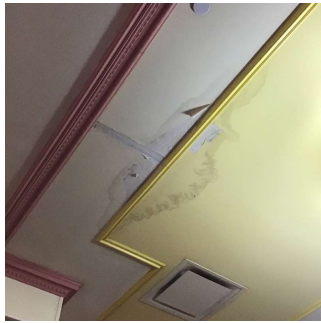
Near Stair N

Deficiency	GYP SUM BOARD: DAMAGED/DETERIORATED - ACTIVE LEAK
Deficiency Location/Instance	Near Stair N, Near Stair M
Deficiency Quantity	60
Quantity Uom	S.F.
Potential Action	REPLACE
Urgency of Action	PRIORITY 5
Purpose of Action	LEVEL 2
Deficiency Photo1

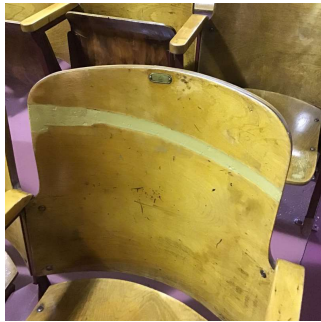
Seat D/2

Instance on Basement (842 Seats)	Inspected
Condition	3 - Fair
Deficiency	DAMAGED/BROKEN/INOPERABLE
Deficiency Location/Instance	Seats C/10, D/2,8, E/8,16, and others
Deficiency Quantity	35
Quantity Uom	EACH
Potential Action	REPLACE
Urgency of Action	PRIORITY 3
Purpose of Action	LEVEL 2
Deficiency Photo1

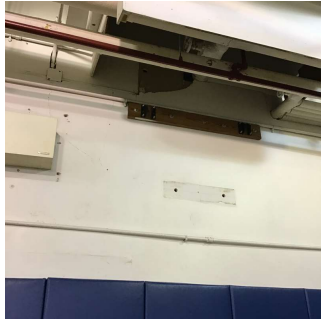
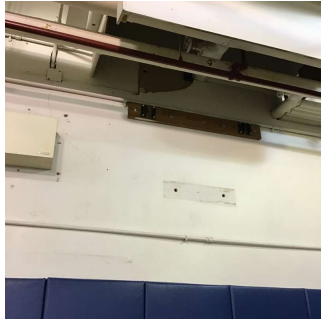
Near Girls Locker Room
No violations recorded.

Instance on Basement	Inspected
Condition	5 - Poor
Deficiency	DAMAGED/MISSING
Deficiency Location/Instance	Near Girls Locker Room
Deficiency Quantity	1
Quantity Uom	EACH
Potential Action	REPLACE
Urgency of Action	PRIORITY 3
Purpose of Action	LEVEL 2
Deficiency Photo1

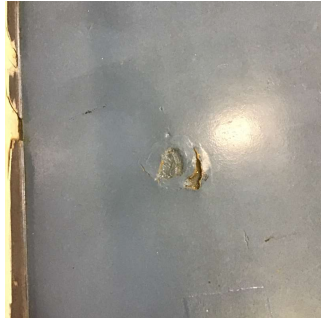
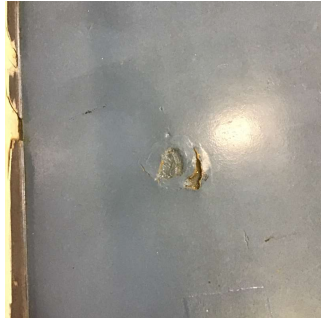
Near Windows
No violations recorded.

Instance on Basement	Inspected
Condition	2 - Between Good and Fair
Deficiency	SHEET VINYL: BROKEN/DETERIORATED
Deficiency Location/Instance	Near Windows
Deficiency Quantity	10
Quantity Uom	S.F.
Potential Action	REPLACE
Urgency of Action	PRIORITY 3
Purpose of Action	LEVEL 2
Deficiency Photo1

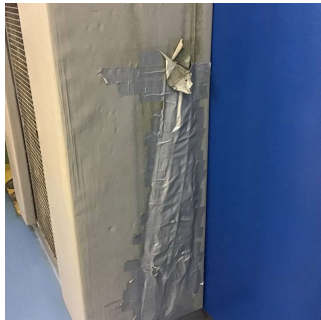
Question	Response
INTERIOR	
GYMNASIUM	
Walls	
Instance on Basement	Inspected
Condition	3 - Fair
Deficiency	GYPSUM BOARD: DETERIORATED
Deficiency Location/Instance	Opposite the Locker Rooms
Deficiency Quantity	20
Quantity Uom	S.F.
Potential Action	REPLACE
Urgency of Action	PRIORITY 3
Purpose of Action	LEVEL 2
Deficiency Photo1	 
Violations	Opposite the Locker Rooms No violations recorded.
Deficiency	WALL PADDING: DETERIORATED
Deficiency Location/Instance	Right Side, Left Side
Deficiency Quantity	180
Quantity Uom	S.F.
Potential Action	REPLACE
Urgency of Action	PRIORITY 3
Purpose of Action	LEVEL 2
Deficiency Photo1

Violations	Right Side No violations recorded.
Window Curtains/Shades/Blinds	
Instance on Basement	Does not Exist
INTERIOR DOOR HARDWARE	
Condition	Inspected
Condition	3 - Fair
Deficiency	No deficiencies recorded
INTERIOR GUARDS	
Condition	Inspected
Condition	2 - Between Good and Fair
Deficiency	DETERIORATED/TORN-OUT/MISSING

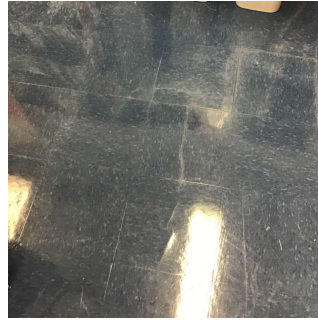
Near Entrance

Deficiency Quantity	20
Quantity Uom	S.F.
Potential Action	REPLACE
Urgency of Action	PRIORITY 3
Purpose of Action	LEVEL 2
Deficiency Photo1

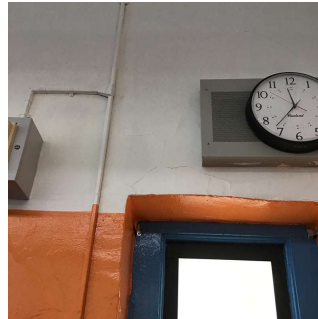
Instance on Room 404	Inspected
Condition	2 - Between Good and Fair
Deficiency	PLASTER: CRACKS/SPALLING
Deficiency Location/Instance	Near Windows
Deficiency Quantity	10
Quantity Uom	S.F.
Potential Action	REPLACE
Urgency of Action	PRIORITY 3
Purpose of Action	LEVEL 2
Deficiency Photo1

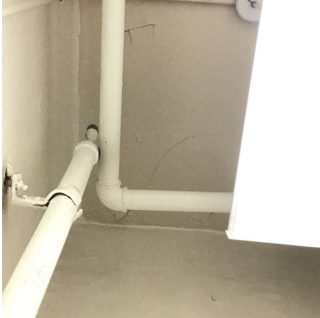
Question	Response
INTERIOR	
TOILET ROOMS - STAFF	Inspected
Ceiling	Inspected
Condition	2 - Between Good and Fair
Deficiency	PLASTER: CRACKS/SPALLING
Deficiency Location/Instance	In Room 400
Deficiency Quantity	10
Quantity Uom	S.F.
Potential Action	REPLACE
Urgency of Action	PRIORITY 3
Purpose of Action	LEVEL 2
Deficiency Photo1

In Room 400
Violations	No violations recorded.
Door(s)	Inspected
Condition	5 - Poor
Deficiency	WOOD: DETERIORATED DOOR
Deficiency Location/Instance	In Rooms 101, 212, 218, 300, Rooms 110H, 200
Deficiency Quantity	6
Quantity Uom	EACH
Potential Action	MAINTENANCE
Urgency of Action	PRIORITY 3
Purpose of Action	LEVEL 2
Deficiency Photo1

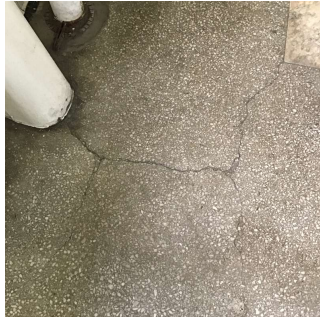
Violations	In Room 318 No violations recorded.
Deficiency	TERRAZZO: CRACKS
Deficiency Location/Instance	In Room 101
Deficiency Quantity	15
Quantity Uom	S.F.
Potential Action	REPLACE
Urgency of Action	PRIORITY 3
Purpose of Action	LEVEL 2
Deficiency Photo1

Violations	In Room 101 No violations recorded.
Stalls	Inspected
Condition	2 - Between Good and Fair
Deficiency	No deficiencies recorded
Walls	Inspected
Condition	2 - Between Good and Fair
Deficiency	PLASTER: CRACKS/SPALLING
Deficiency Location/Instance	In Room 101
Deficiency Quantity	10
Quantity Uom	S.F.
Potential Action	REPLACE
Urgency of Action	PRIORITY 3
Purpose of Action	LEVEL 2

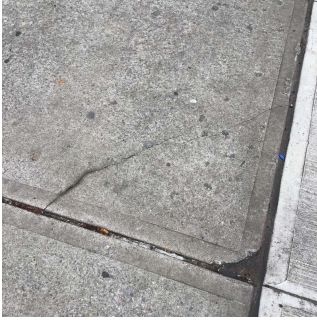
Violations	Baltic Street No violations recorded.
Deficiency	DAMAGED/DETERIORATED/MISSING SECTIONS
Deficiency Location/Instance	Baltic Street
Deficiency Quantity	25
Quantity Uom	S.F.
Potential Action	REPLACE
Urgency of Action	PRIORITY 3
Purpose of Action	LEVEL 2
Deficiency Photo1

Violations	Baltic Street No violations recorded.
Pavers	Inspected
Condition	2 - Between Good and Fair
Deficiency	DAMAGED/MISSING
Deficiency Location/Instance	Baltic Street
Deficiency Quantity	25
Quantity Uom	S.F.
Potential Action	REPLACE
Urgency of Action	PRIORITY 3
