NYC Department of Education
Building Condition Assessment Survey 2023 - 2024

Architectural Inspection

K805

Asset: WATERS EDGE EDUCATIONAL COMPLEX - K, 49 FLATBUSH AVENUE EXT., New York, 11201

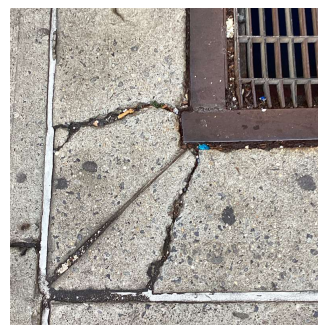
AW1
No violations recorded.

AREAWAY WALLS: CRACKS AND SPALLING

20
S.F.
REPLACE
PRIORITY 4
LEVEL 2

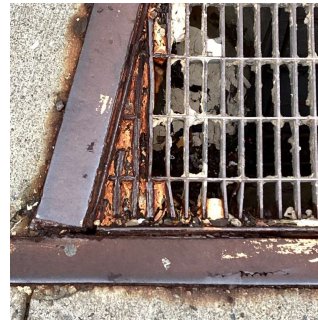
AW2

AREAWAY GRATINGS: MAJOR RUSTING AND / OR BROKEN SUPPORTS

30
L.F.
REPLACE
PRIORITY 4
LEVEL 2

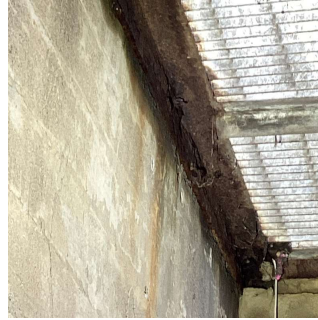
AW1

AREAWAY GRATINGS: MAJOR RUSTING AND / OR BROKEN SUPPORTS

30
L.F.
REPLACE
PRIORITY 5
LEVEL 6

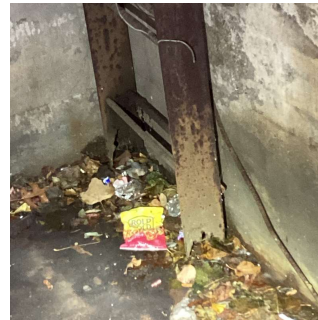
AW1

AREAWAY LADDER: DETERIORATED

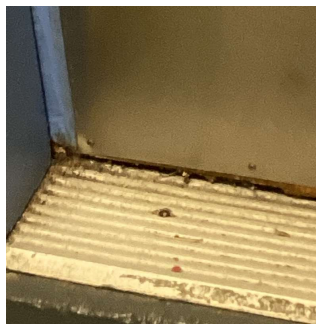
Facade B - Exit 3
No violations recorded.

METAL CLAD: DETERIORATED DOOR - MINOR DETERIORATION

2
EACH
MAINTENANCE
PRIORITY 3
LEVEL 2

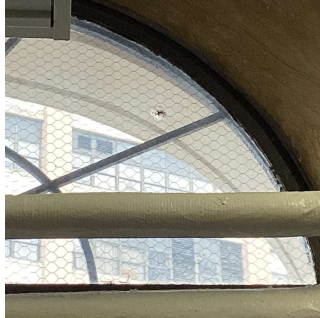
| Question | Response |
|---|--|
| | Facade D |

METAL: BROKEN GLASS

20
S.F.
MAINTENANCE

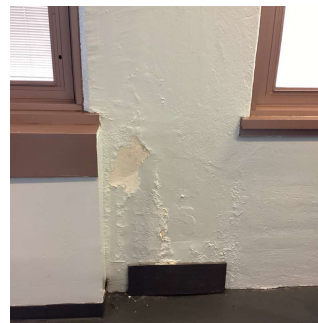
STUCCO CEMENT SURFACE: WATER INFILTRATION IN INSTRUCTIONAL SPACE

Facade B - Stairwell B/8 (Facade C - Stairwell A/7, Corridor near 6th Floor Girls Toilet Room, Corridor near 1st Floor Boys Toilet Room similar)

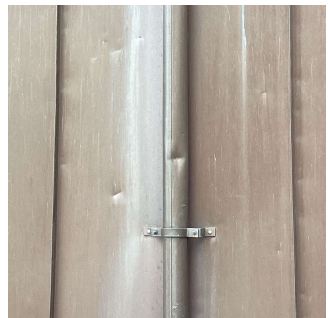
| Question | Response |
|---|--|
| Deficiency | DAMAGED/MISSING |
| Potential Action | REPLACE |

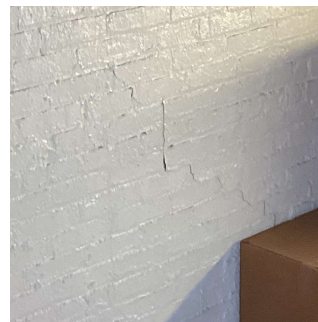
BH1
No violations recorded.

BULKHEAD/PENTHOUSE WALLS/INTERIOR: BRICK
CRACKS/SPALLING

35
S.F.
REPLACE
PRIORITY 3
LEVEL 2

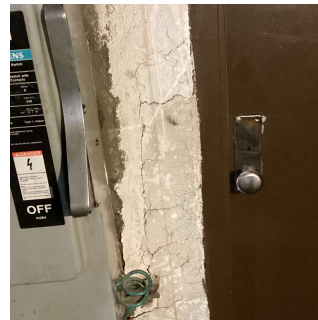
Elevator Machine Room

**BULKHEAD/PENTHOUSE WALLS/INTERIOR: PLASTER
CRACKS/SPALLING**

40
S.F.
REPLACE
PRIORITY 4
LEVEL 2

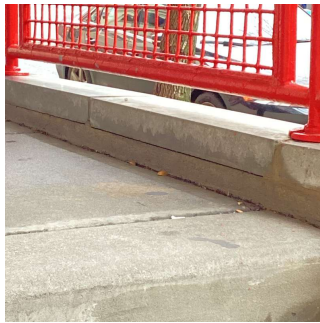
CAST IN PLACE CONCRETE: DETERIORATED JOINTS AT COPING STONES

10
L.F.
MAINTENANCE
PRIORITY 3
LEVEL 2

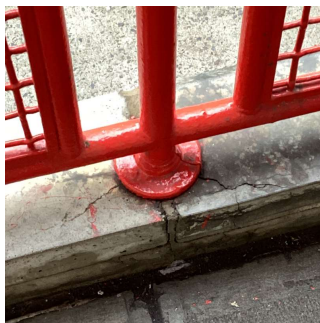
| Question | Response |
|---|--|
| Deficiency | CAST IN PLACE CONCRETE: DETERIORATED COPING STONE |
| Potential Action | REPLACE |

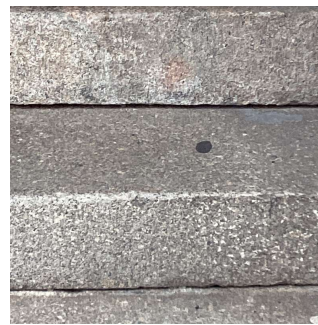
Facade D

| Question | Response |
|---|--|
| Deficiency | STONE: DETERIORATED JOINTS |

15
 L.F.
 REPOINT
 PRIORITY 4
 LEVEL 2

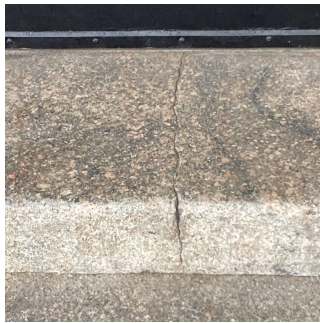
STONE: CRACKS/SPALLING - MINOR

10
 S.F.
 REPAIR
 PRIORITY 3
 LEVEL 2

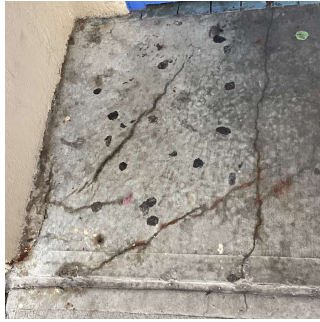
| Question | Response |
|---|--|
| Deficiency | CONCRETE: CRACKS/SPALLING - MINOR |
| Potential Action | REPAIR |

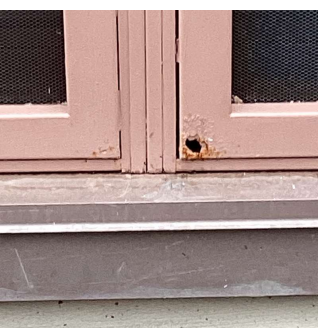
| Question | Response |
|---|--|
| | RUST - MAJOR |

| Question | Response |
|---|--|
| Potential Action | REPLACE |
