**NYC Department of Education**  
**Building Condition Assessment Survey 2023 - 2024**

Architectural Inspection

**K813**

**Asset: DIST. OFFICE #13 (OLD 9 AX)-K, 355 PARK PLACE, New York, 11238**

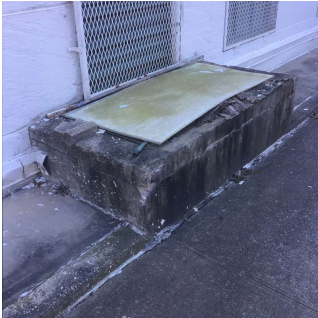
Question	Response
<b>Architectural</b>	
<b>EXTERIOR</b>	Inspected
<b>AREAWAY</b>	Inspected
Instance on AW1	Inspected
Instance Condition	3 - Fair
Instance Quantity	1
Instance Quantity Uom	EACH
Deficiency	AREAWAY WALLS: CRACKS AND SPALLING
Roof Plan reference	
Deficiency Quantity	30
Quantity Uom	S.F.
Potential Action	REPAIR
Urgency of Action	PRIORITY 3
Purpose of Action	LEVEL 2

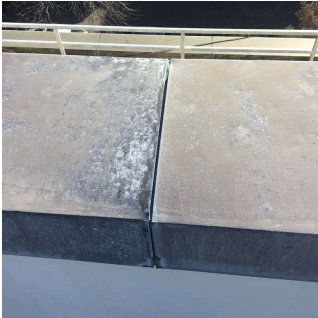
Violations	AW1 No violations recorded.
<b>AWNINGS AND CANOPIES</b>	Does not Exist
<b>CHIMNEY</b>	Inspected
Material Type(s)	Concrete
Condition	2 - Between Good and Fair
Deficiency	No deficiencies recorded
<b>COPING</b>	Inspected
Condition	3 - Fair
Deficiency	METAL: DETERIORATED JOINTS
Roof Plan reference	K813

Deficiency Quantity	40
Quantity Uom	L.F.
Potential Action	REPAIR
Urgency of Action	PRIORITY 3
Purpose of Action	LEVEL 2
Deficiency Photo1

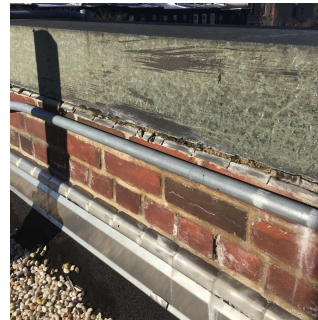
Roof 1 - Facade C

Violations	Roof 2 - Facade E No violations recorded.
Deficiency	STONE: DETERIORATED BED JOINT

Deficiency Quantity

40

Quantity Uom

L.F.

REPOINT

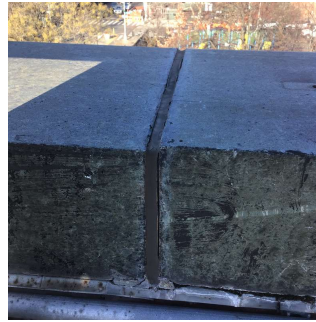
Roof 1 - Facade C

STONE: DETERIORATED TRANSVERSE JOINTS

Deficiency Quantity

30

MAINTENANCE

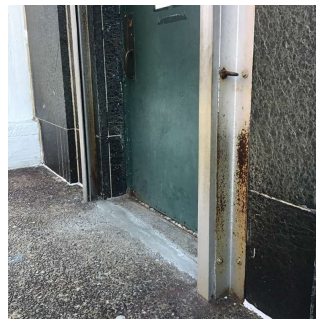
Facade D - Exit 2

ROLL-UP DOOR: DETERIORATED DOOR AND FRAME - MINOR DETERIORATION

Deficiency Quantity

60

MAINTENANCE

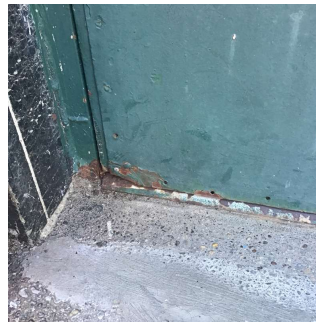
Facade D - Exit 2

METAL CLAD: DETERIORATED DOOR AND FRAME - MAJOR DETERIORATION

1  
 EACH  
 REPLACE  
 PRIORITY 4  
 LEVEL 2

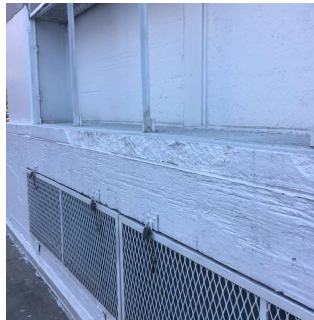
Facade C

STONE: CHIPPED/SPALLED/BROKEN PIECES - MINOR

Deficiency Quantity

40

REPAIR

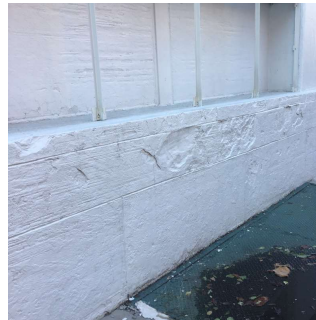
Facade D

STONE: CHIPPED/SPALLED/BROKEN PIECES - MAJOR

Deficiency Quantity

40

REPLACE

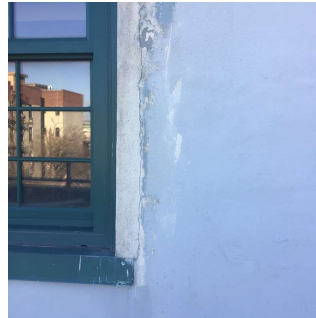
Facade G

STUCCO CEMENT SURFACE: CRACKS, SPALLING

Deficiency Quantity

100

PRIORITY 4  
 LEVEL 2

REPLACE

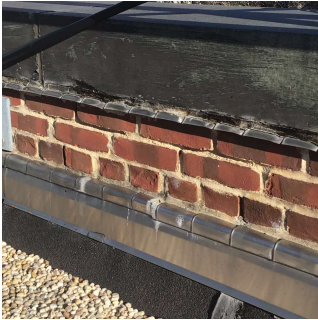
BRICK: DETERIORATED JOINTS

Deficiency Quantity

30

Violations	Roof 1 - Facade D No violations recorded.
<b>PLAZA DECK</b>	Does not Exist
<b>ROOF</b>	Inspected
<b>Roofing</b>	Inspected
Replacement Quantity	4,800
Replacement Uom	S.F.
<b>ROOF HATCH/SMOKE HATCH</b>	Inspected
Condition	2 - Between Good and Fair
Deficiency	No deficiencies recorded
<b>LEADERS, GUTTERS, DOWNSPOUTS, SCUPPERS</b>	Does not Exist
<b>ROOF BARRIER/FENCE</b>	Inspected
Condition	2 - Between Good and Fair
Deficiency	No deficiencies recorded
<b>ROOF CAGE</b>	Does not Exist
<b>ROOFING</b>	Inspected
Instance on Built-Up: Roof 1	Inspected
Instance Condition	3 - Fair
Instance Photo

REPOINT

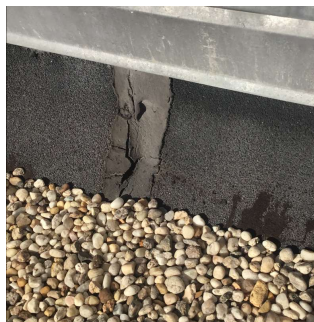
Roof 1 - Facade E

Is/Are the roof(s) suitable for Solar Panel installation?	No
Installation Year	2010
Source of Installation	Custodial Staff
Deficiency	BUILT-UP: FLASHING: BASE FLASHING DETERIORATED

K813  
10  
S.F.  
REMOVE AND REPLACE  
PRIORITY 4  
LEVEL 2

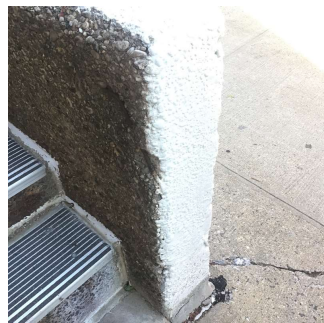
Question	Response
<b>EXTERIOR</b>	
<b>ROOF</b>	Inspected
<b>Roofing</b>	Inspected
<b>ROOFING DRAINS</b>	
Condition	2 - Between Good and Fair
Deficiency	No deficiencies recorded
<b>Specialties</b>	Does not Exist
<b>STAIRS/RAMPS: EXTERIOR</b>	Inspected
<b>BUILDING CHEEK/FLANK WALLS</b>	Inspected
Condition	2 - Between Good and Fair
Deficiency	CAST IN PLACE CONCRETE: CRACKS/SPALLING - MINOR
Roof Plan reference	<p>K813</p>

Deficiency Quantity	10
Quantity Uom	S.F.
Potential Action	REPAIR
Urgency of Action	PRIORITY 3
Purpose of Action	LEVEL 2
Deficiency Photo1

Violations	<p>Facade D - Exit 2</p> <p>No violations recorded.</p>

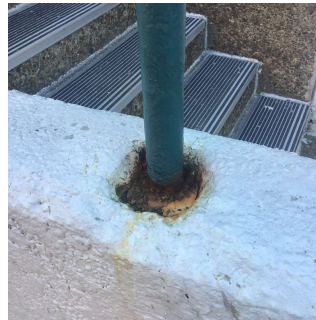
Facade D - Exit 2

<b>RAILINGS</b>	Inspected
Condition	3 - Fair
Deficiency	RUST - MAJOR
Roof Plan reference	<p>K813</p>

10  
 L.F.  
 REPLACE  
 PRIORITY 4  
 LEVEL 2

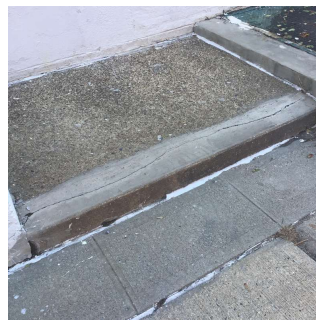
Facade D - Exit 2

CONCRETE: CRACKS/SPALLING - MAJOR

10  
 S.F.  
 REPLACE  
 PRIORITY 4  
 LEVEL 2

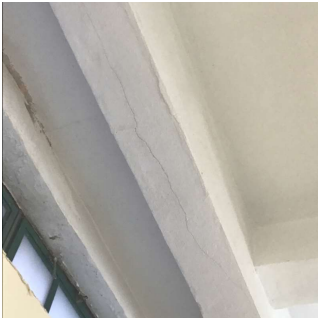
Room B3A

<b>COLUMNS/BEAMS/BEARING WALLS</b>	
Condition	3 - Fair
Deficiency	STEEL COLUMNS/BEAMS: DETERIORATED CONCRETE FIREPROOFING
Deficiency Location/Instance	Basement - Room B3A, Gas Meter Room
Deficiency Quantity	30
Quantity Uom	S.F.
Potential Action	REPLACE
Urgency of Action	PRIORITY 3
Purpose of Action	LEVEL 5
Deficiency Photo1

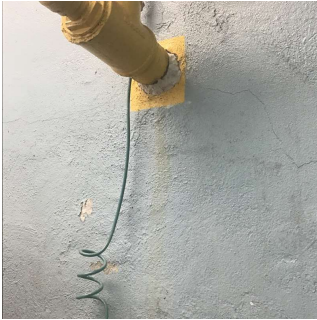
Question	Response
<b>INTERIOR</b>	
<b>STRUCTURAL</b>	
<b>COLUMNS/BEAMS/BEARING WALLS</b>	Inspected
Violations	No violations recorded.
<b>FLOOR STRUCTURE</b>	Inspected
Condition	2 - Between Good and Fair
Deficiency	No deficiencies recorded
<b>FOUNDATION WALLS</b>	Inspected
Material Type(s)	Concrete
Condition	4 - Between Fair and Poor
Deficiency	CONCRETE: WATER INFILTRATION IN NON- INSTRUCTIONAL SPACE
Deficiency Location/Instance	Basement - Gas Meter Room
Deficiency Quantity	100
Quantity Uom	S.F.
Potential Action	INSTALL WATERPROOFING
Urgency of Action	PRIORITY 5
Purpose of Action	LEVEL 5
Deficiency Photo1

Violations	Gas Meter Room No violations recorded.
Deficiency	CONCRETE: CRACKED/SPALLED/REINFORCEMENT EXPOSED
Deficiency Location/Instance	Basement - Gas Meter Room
Deficiency Quantity	50
Quantity Uom	S.F.
Potential Action	REPAIR
Urgency of Action	PRIORITY 3
Purpose of Action	LEVEL 5
Deficiency Photo1	 
Violations	Gas Meter Room No violations recorded.

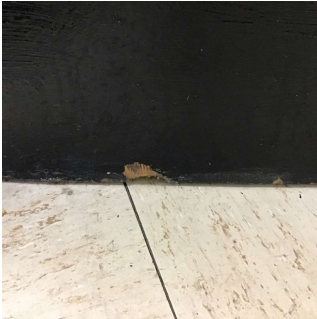
<b>Question</b>	<b>Response</b>
<b>INTERIOR</b>	
<b>CLASSROOMS/CORRIDORS/ADMIN SPACES</b>	
<b>Ceiling</b>	Inspected
Violations	No violations recorded.
<b>Door(s)</b>	Inspected
Condition	5 - Poor
Deficiency	WOOD: DETERIORATED DOOR
Deficiency Location/Instance	Room 202A, 114
Deficiency Quantity	2
Quantity Uom	EACH
Potential Action	MAINTENANCE
Urgency of Action	PRIORITY 3
Purpose of Action	LEVEL 2
Deficiency Photo1

Violations	Room 202A No violations recorded.
Deficiency	METAL: DETERIORATED DOOR
Deficiency Location/Instance	Room 201
Deficiency Quantity	1
Quantity Uom	EACH
Potential Action	MAINTENANCE
Urgency of Action	PRIORITY 3
Purpose of Action	LEVEL 2
Deficiency Photo1

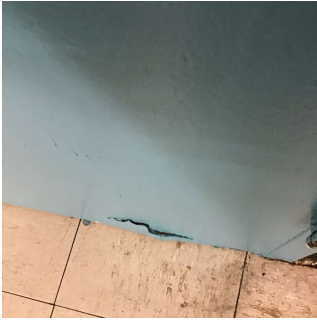
Violations	Room 201 No violations recorded.
<b>Floor Finish</b>	Inspected
Condition	2 - Between Good and Fair
Deficiency	VINYL TILES: DETERIORATED SUBSTRATE
Deficiency Location/Instance	Room 116,115,201A,201B,201C, and others
Deficiency Quantity	100

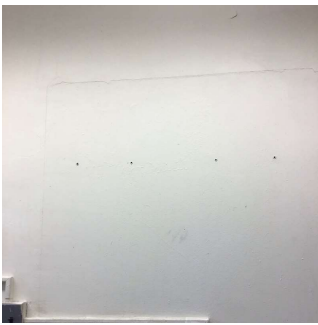
Violations	Corridor near Room 203 No violations recorded.
<b>Walls</b>	Inspected
Condition	2 - Between Good and Fair
Deficiency	PLASTER: CRACKS/SPALLING
Deficiency Location/Instance	3rd Floor near west stair, Room 201B,201
Deficiency Quantity	30
Quantity Uom	S.F.
Potential Action	REPLACE
Urgency of Action	PRIORITY 3
Purpose of Action	LEVEL 2

Violations	Room 201 No violations recorded.
<b>Specialties</b>	Does not Exist
<b>GYMNASIUM</b>	Does not Exist
<b>INTERIOR DOOR HARDWARE</b>	Inspected
Condition	3 - Fair
Deficiency	No deficiencies recorded
<b>INTERIOR GUARDS</b>	Does not Exist
<b>KITCHEN</b>	Does not Exist
<b>LIBRARY</b>	Does not Exist
<b>LOCKER ROOM</b>	Does not Exist
<b>MULTI-PURPOSE ROOM</b>	Does not Exist
<b>SCIENCE DEMO ROOM</b>	Does not Exist
<b>SCIENCE LAB</b>	Does not Exist
<b>SCIENCE PREP ROOM</b>	Does not Exist
<b>SHOWER ROOM</b>	Does not Exist
<b>STAIRS/RAMPS: INTERIOR</b>	Inspected
Do Letter Stair Signs Exist?	No
<b>Ceiling</b>	Inspected
Condition	2 - Between Good and Fair
Deficiency	PLASTER: CRACKS/SPALLING
Deficiency Location/Instance	Stair East/2
Deficiency Quantity	10
Quantity Uom	S.F.
Potential Action	REPLACE
Urgency of Action	PRIORITY 3

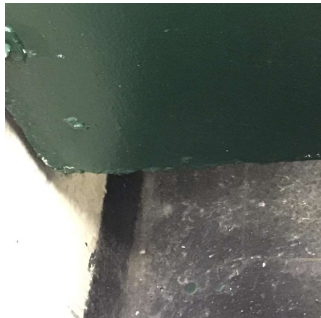
Room B6
Violations	No violations recorded.
<b>Stalls</b>	Inspected
Condition	5 - Poor
Deficiency	RUST - MAJOR
Deficiency Location/Instance	Room 101, B6
Deficiency Quantity	2
Quantity Uom	EACH
Potential Action	REPLACE
Urgency of Action	PRIORITY 3
Purpose of Action	LEVEL 2
Deficiency Photo1

Room 101
Violations	No violations recorded.
<b>Walls</b>	Inspected
Condition	2 - Between Good and Fair
Deficiency	GLAZED BLOCK: CRACKS/SPALLING
Deficiency Location/Instance	Room B6, 101
Deficiency Quantity	20
Quantity Uom	S.F.
Potential Action	REPLACE
Urgency of Action	PRIORITY 3
Purpose of Action	LEVEL 2

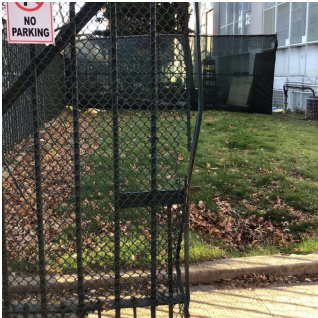
Violations	Along Underhill Avenue No violations recorded.
Deficiency	WROUGHT IRON: DAMAGED/DETERIORATED

Question	Response
<b>SITE</b>	
<b>FENCES</b>	
Deficiency Location/Instance	Along Park Place, Underhill Avenue
Deficiency Quantity	80
Quantity Uom	S.F.
Potential Action	REPLACE
Urgency of Action	PRIORITY 3
Purpose of Action	LEVEL 2
Deficiency Photo1

Violations	Along Park Place No violations recorded.
Deficiency	CHAIN LINK: RUST - MAJOR
Deficiency Location/Instance	Driveway
Deficiency Quantity	200
Quantity Uom	S.F.
Potential Action	REPLACE
Urgency of Action	PRIORITY 3
Purpose of Action	LEVEL 2
Deficiency Photo1

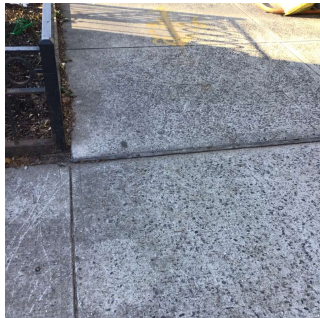
Question	Response
<b>SITE</b>	
<b>PAVING</b>	
<b>Student Non-Use</b>	
<b>Concrete</b>	
Purpose of Action	LEVEL 2
Deficiency Photo1	 
	Driveway
Violations	No violations recorded.
<b>Pavers</b>	Does not Exist
<b>Student Use</b>	Does not Exist
<b>Site Sidewalks &amp; Walkways</b>	Inspected
<b>Asphalt</b>	Does not Exist
<b>Concrete</b>	Under Construction
<b>Pavers</b>	Does not Exist
<b>DOT Sidewalk</b>	Inspected
<b>Asphalt</b>	Does not Exist
<b>Concrete</b>	Inspected
Condition	4 - Between Fair and Poor
Deficiency	HEAVING
Deficiency Location/Instance	Along Park Place
Deficiency Quantity	175
Quantity Uom	S.F.
Potential Action	REPLACE
Urgency of Action	PRIORITY 4
Purpose of Action	LEVEL 4
Deficiency Photo1

Along Park Place
Violations	56279
Deficiency	HEAVING
Deficiency Location/Instance	Along Park Place
Deficiency Quantity	50
Quantity Uom	S.F.
Potential Action	REPLACE

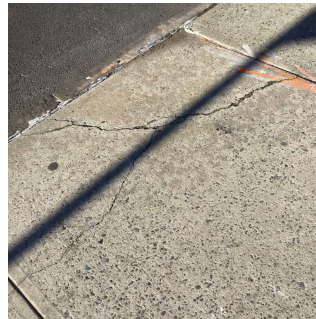
Along Underhill Avenue  
56279

DAMAGED/DETERIORATED/MISSING SECTIONS  
Along Park Place, Underhill Avenue  
600  
S.F.  
REPLACE  
PRIORITY 4  
LEVEL 4

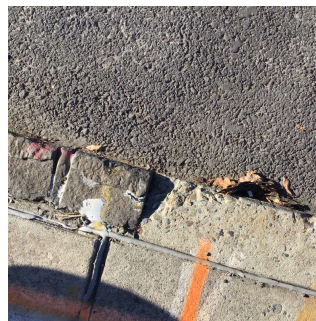
DAMAGED CURBS  
Along Park Place, Underhill Avenue  
55  
L.F.  
REPLACE  
PRIORITY 4  
LEVEL 4

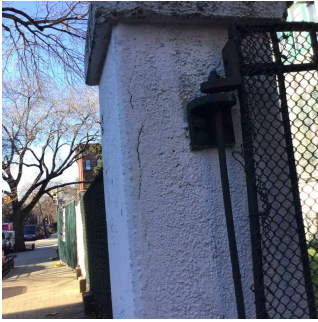
<b>Question</b>	<b>Response</b>
<b>SITE</b>	
<b>PAVING</b>	Inspected
<b>DOT Sidewalk</b>	
<b>Concrete</b>	Inspected
Violations	Along Underhill Avenue 56279
<b>Pavers</b>	Does not Exist
<b>PLAYGROUNDS</b>	Does not Exist
<b>PLAYING SURFACE</b>	Does not Exist
<b>RETAINING WALLS</b>	Does not Exist
<b>SEATING</b>	Does not Exist
<b>SITE WALLS (NOT RETAINING WALLS)</b>	Inspected
Condition	2 - Between Good and Fair
Deficiency	CAST IN PLACE CONCRETE: CRACKS/SPALLING - MAJOR
Deficiency Location/Instance	Along Park Place
Deficiency Quantity	10
Quantity Uom	S.F.
Potential Action	REPLACE
Urgency of Action	PRIORITY 3
Purpose of Action	LEVEL 2
Deficiency Photo1

Violations	Along Park Place No violations recorded.
<b>STAIRS/RAMPS: EXTERIOR</b>	Does not Exist
<b>ARTWORK</b>	Does not Exist
