NYC Department of Education
Building Condition Assessment Survey 2023 - 2024

Architectural Inspection

K814

Asset: CYPRESS HILLS COMMUNITY SCHOOL - BROOKLYN, 265 WARWICK STREET, New York, 11207

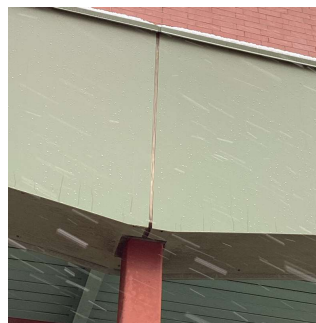
Facade A

Deficiency	METAL PANEL: DETERIORATED JOINTS
Roof Plan reference	K814

Deficiency Quantity	10
Quantity Uom	L.F.
Potential Action	REPAIR
Urgency of Action	PRIORITY 3
Purpose of Action	LEVEL 2
Deficiency Photo1

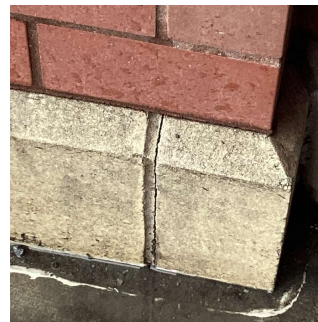
Facade J

Deficiency	CAST IN PLACE / PRE-CAST CONCRETE: DETERIORATED JOINTS
------------	--

20

REPOINT

PRIORITY 3

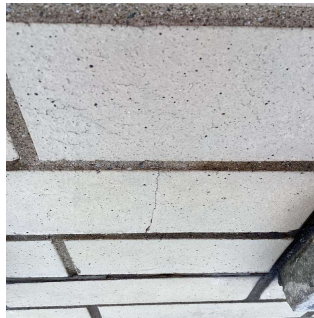
Facade H

BRICK: MINOR CRACKS AND SPALLING

10

RESTITCH

PRIORITY 3

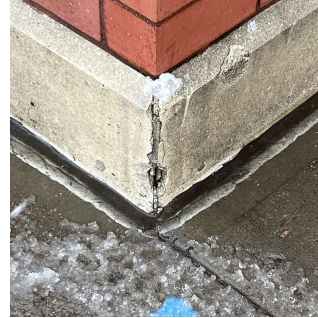
Facade J

CAST IN PLACE / PRE-CAST CONCRETE: MAJOR CRACKS/SPALLING

REPLACE
PRIORITY 4
LEVEL 2

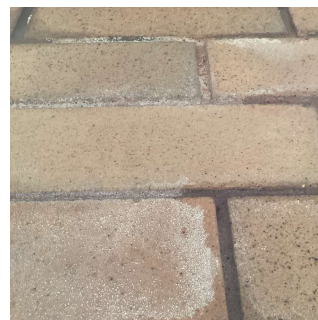
BRICK: DETERIORATED JOINTS

20
S.F.
REPOINT
PRIORITY 3
LEVEL 2

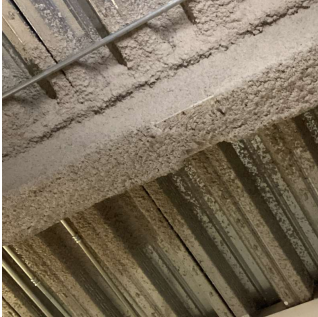
Material Type(s)	Aluminum
Instance on Aluminum - Other: All Facades	Inspected
Instance Condition	2 - Between Good and Fair
Instance Quantity	5,000
Instance Quantity Uom	S.F.
Are these windows insulated	Yes
Installation Year	2010
Source of Installation	Custodial Staff
Deficiency	No deficiencies recorded
INTERIOR	Inspected
POOLS	Does not Exist
STRUCTURAL	Inspected
COLUMNS/BEAMS/BEARING WALLS	Inspected
Condition	2 - Between Good and Fair
Deficiency	STEEL COLUMNS/BEAMS: DETERIORATED CONCRETE FIREPROOFING

Question	Response
INTERIOR	
STRUCTURAL	
COLUMNS/BEAMS/BEARING WALLS	
Deficiency Location/Instance	Basement - Room C03
Deficiency Quantity	10
Quantity Uom	S.F.
Potential Action	REPLACE
Urgency of Action	PRIORITY 3
Purpose of Action	LEVEL 5
Deficiency Photo1

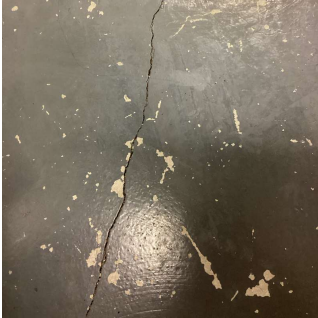
Basement - Room C03
Violations	No violations recorded.
FLOOR STRUCTURE	
Condition	Inspected
	3 - Fair
Deficiency	CONCRETE SLAB ON GRADE: THRU CRACKS
Deficiency Location/Instance	Basement - Rooms C08, C01, C03
Deficiency Quantity	50
Quantity Uom	S.F.
Potential Action	REPLACE
Urgency of Action	PRIORITY 4
Purpose of Action	LEVEL 5
Deficiency Photo1

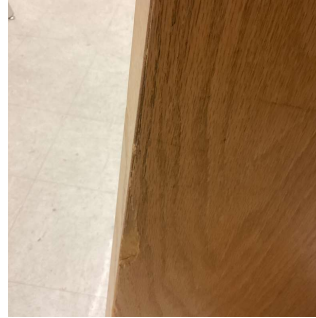
Room 404

Question	Response
INTERIOR	
CAFETERIA	
Walls	
Condition	2 - Between Good and Fair
Deficiency	GYPSUM BOARD: DETERIORATED
Deficiency Location/Instance	Right Side
Deficiency Quantity	20
Quantity Uom	S.F.
Potential Action	REPLACE
Urgency of Action	PRIORITY 3
Purpose of Action	LEVEL 2
Deficiency Photo1	 
Violations	Right Side No violations recorded.
Window Curtains/Shades/Blinds	
Instance on Basement (2000 SF)	Does not Exist
CLASSROOMS/CORRIDORS/ADMIN SPACES	
Ceiling	Inspected
Condition	2 - Between Good and Fair
Deficiency	ACOUSTIC TILES: DAMAGED/MISSING
Deficiency Location/Instance	Corridor near Rooms 420, 410, 406, 401, C14 and others
Deficiency Quantity	150
Quantity Uom	S.F.
Potential Action	REPLACE
Urgency of Action	PRIORITY 3
Purpose of Action	LEVEL 2
Deficiency Photo1	 
Violations	Corridor near Room C14 No violations recorded.
Door(s)	
Condition	Inspected
Condition	5 - Poor
Deficiency	WOOD: DETERIORATED DOOR
Deficiency Location/Instance	Rooms 411, 404, 402, 310, 216 and others

Quantity Uom	EACH
Potential Action	MAINTENANCE
Urgency of Action	PRIORITY 3
Purpose of Action	LEVEL 2
Deficiency Photo1

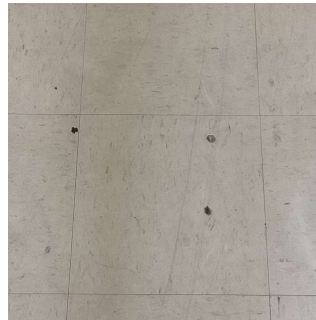
Corridor near Room 402

Deficiency	VINYL TILES: BROKEN/DETERIORATED/MISSING TILES
Deficiency Location/Instance	Corridor near Rooms 402, C15
Deficiency Quantity	20
Quantity Uom	S.F.
Potential Action	REPLACE
Urgency of Action	PRIORITY 3
Purpose of Action	LEVEL 2
Deficiency Photo1

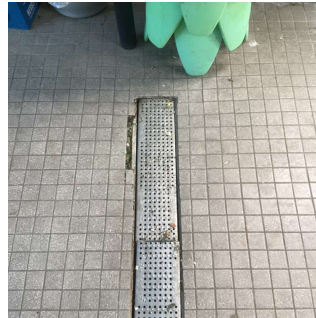
Room 413 Green House

CERAMIC TILE: BROKEN/MISSING TILES

Room 413 Green House, Main Entrance - Vestibule

REPLACE

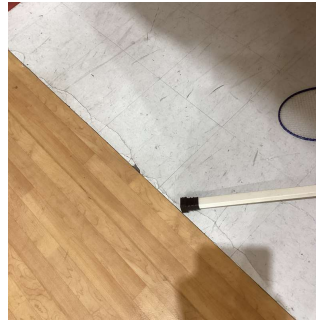
Question	Response
INTERIOR	
GYMNASIUM	
Ceiling	
Deficiency Photo1	 
Violations	Near Stair C/3 No violations recorded.
Door(s)	
Instance on 3rd Floor	Inspected
Condition	2 - Between Good and Fair
Deficiency	No deficiencies recorded
Fixed Equipment	
Instance on 3rd Floor	Inspected
Condition	2 - Between Good and Fair
Deficiency	No deficiencies recorded
Floor Finish	
Instance on 3rd Floor	Inspected
Condition	2 - Between Good and Fair
Deficiency	VINYL TILES: DETERIORATED SUBSTRATE
Deficiency Location/Instance	Room 302
Deficiency Quantity	10
Quantity Uom	S.F.
Potential Action	REPLACE
Urgency of Action	PRIORITY 3
Purpose of Action	LEVEL 2
Deficiency Photo1	 
Violations	Room 302 No violations recorded.
Deficiency	VINYL TILES: BROKEN/DETERIORATED/MISSING TILES
Deficiency Location/Instance	Near Room 315
Deficiency Quantity	10
Quantity Uom	S.F.
Potential Action	REPLACE
Urgency of Action	PRIORITY 3
Purpose of Action	LEVEL 2

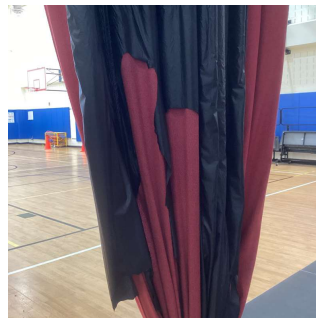
WORN/DETERIORATED

Right and Left Side

REPLACE

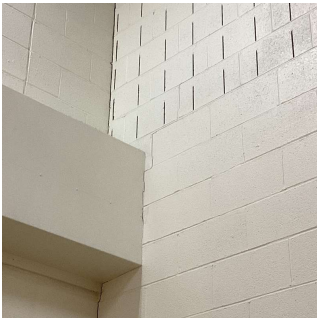
Question	Response
INTERIOR	
GYMNASIUM	
Stage	
Stage Curtains	
Violations	No violations recorded.
Walls	
Instance on 3rd Floor	Inspected
Condition	3 - Fair
Deficiency	MASONRY: CRACKS/SPALLING
Deficiency Location/Instance	Right Side
Deficiency Quantity	10
Quantity Uom	S.F.
Potential Action	REPLACE
Urgency of Action	PRIORITY 3
Purpose of Action	LEVEL 2
Deficiency Photo1

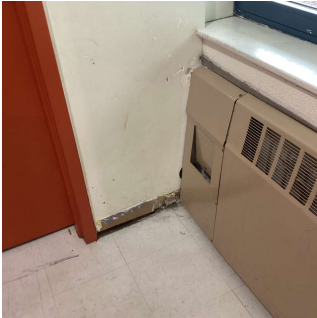
Violations	Right Side No violations recorded.
Deficiency	GYPSUM BOARD: DETERIORATED
Deficiency Location/Instance	Near Rooms 314A, 315
Deficiency Quantity	20
Quantity Uom	S.F.
Potential Action	REPLACE
Urgency of Action	PRIORITY 3
Purpose of Action	LEVEL 2
Deficiency Photo1

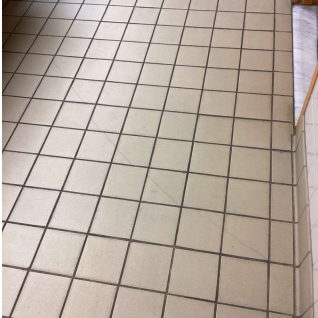
Question	Response
INTERIOR	
KITCHEN	
Floor Finish	
Instance on Basement	Inspected
Condition	2 - Between Good and Fair
Deficiency	QUARRY TILE: DETERIORATED SUBSTRATE
Deficiency Location/Instance	Near Office Room, Preparation Area
Deficiency Quantity	20
Quantity Uom	S.F.
Potential Action	REPLACE
Urgency of Action	PRIORITY 3
Purpose of Action	LEVEL 2
Deficiency Photo1

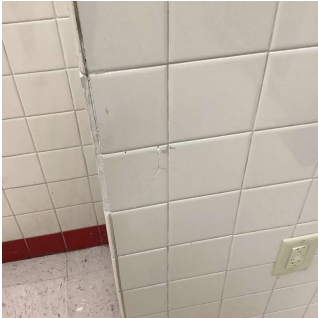
Violations	Preparation Area No violations recorded.
Walls	
Instance on Basement	Inspected
Condition	2 - Between Good and Fair
Deficiency	CERAMIC TILE: BROKEN/ MISSING
Deficiency Location/Instance	Servery
Deficiency Quantity	10
Quantity Uom	S.F.
Potential Action	REPLACE
Urgency of Action	PRIORITY 3
Purpose of Action	LEVEL 2
Deficiency Photo1

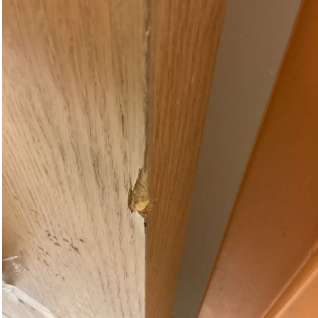
Question	Response
INTERIOR	
TOILET ROOMS - STUDENTS	
Door(s)	Inspected
Condition	3 - Fair
Deficiency	WOOD: DETERIORATED DOOR
Deficiency Location/Instance	Room C15
Deficiency Quantity	1
Quantity Uom	EACH
Potential Action	MAINTENANCE
Urgency of Action	PRIORITY 3
Purpose of Action	LEVEL 2
Deficiency Photo1

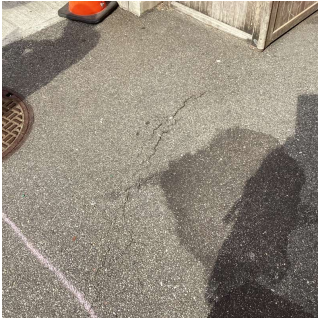
Question	Response
SITE	
PAVING	Inspected
DOT Sidewalk	
Concrete	Inspected
Violations	No violations recorded.
Pavers	Does not Exist
PLAYGROUNDS	Inspected
Instance on Along Atlantic Avenue	Inspected
Benches	
Instance on Along Atlantic Avenue	Does not Exist
Fence	
Instance on Along Atlantic Avenue	Does not Exist
Pavement	
Instance on Along Atlantic Avenue	Inspected
Condition	3 - Fair
Deficiency	ASPHALT: CRACKS - MAJOR
Deficiency Location/Instance	Near Entrance, center
Deficiency Quantity	50
Quantity Uom	S.F.
Potential Action	REPLACE
Urgency of Action	PRIORITY 3
Purpose of Action	LEVEL 2
Deficiency Photo1
