NYC Department of Education
Building Condition Assessment Survey 2023 - 2024

Architectural Inspection

K819

Asset: EAST NY FAMILY ACADEMY - K, 2057 LINDEN BLVD, New York, 11207

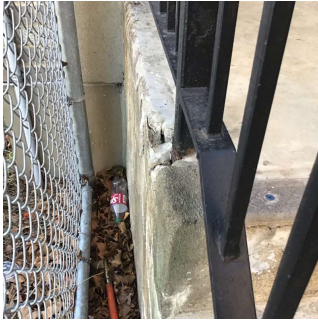
Question	Response
EXTERIOR	
STAIRS/RAMPS: EXTERIOR	
STAIRS/RAMPS	Inspected
Condition	3 - Fair
Deficiency	CONCRETE: CRACKS/SPALLING - MAJOR
Roof Plan reference

Deficiency Quantity	10
Quantity Uom	S.F.
Potential Action	REPLACE
Urgency of Action	PRIORITY 4
Purpose of Action	LEVEL 2
Deficiency Photo1

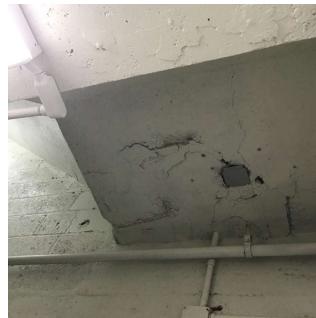
Question	Response
INTERIOR	Inspected
POOLS	Inspected
Instance on 1st Floor	Inspected
CEILING	
Instance on 1st Floor	Inspected
Condition	1 - Good
Deficiency	No deficiencies recorded
DECK/FLOOR	
Instance on 1st Floor	Inspected
Condition	1 - Good
Deficiency	No deficiencies recorded
DIVING BOARD/PLATFORM	
Instance on 1st Floor	Does not Exist
POOL LINING	
Instance on 1st Floor	Inspected
Condition	1 - Good
Deficiency	No deficiencies recorded
POOL STRUCTURE	
Instance on 1st Floor	Inspected
Condition	1 - Good
Deficiency	No deficiencies recorded
SEATING	
Instance on 1st Floor	Does not Exist
WALLS	
Instance on 1st Floor	Inspected
Condition	1 - Good
Deficiency	No deficiencies recorded
STRUCTURAL	Inspected
COLUMNS/BEAMS/BEARING WALLS	Inspected
Condition	2 - Between Good and Fair
Deficiency	No deficiencies recorded
FLOOR STRUCTURE	Inspected
Condition	3 - Fair
Deficiency	CONCRETE: CRACKS/SPALLED/REINFORCEMENT EXPOSED
Deficiency Location/Instance	Basement Pool Mechanical Equipment Room

Deficiency Quantity	50
Quantity Uom	S.F.
Potential Action	REPAIR
Urgency of Action	PRIORITY 3
Purpose of Action	LEVEL 5
Deficiency Photo1

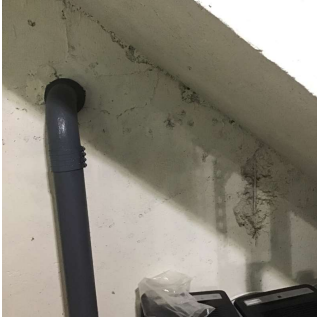
Question	Response
INTERIOR	
STRUCTURAL	
FLOOR STRUCTURE	Inspected
Violations	No violations recorded.
FOUNDATION WALLS	Inspected
Material Type(s)	Concrete
Condition	3 - Fair
Deficiency	CONCRETE: CRACKED/SPALLED/REINFORCEMENT EXPOSED
Deficiency Location/Instance	Basement Pool Mechanical Room
Deficiency Quantity	50
Quantity Uom	S.F.
Potential Action	REPAIR
Urgency of Action	PRIORITY 3
Purpose of Action	LEVEL 5
Deficiency Photo1

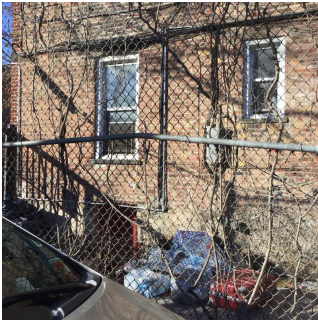
Violations	Parking lot No violations recorded.

Question	Response
LIFE SAFETY	Inspected
F.D. HOLDING AREA	Does not Exist
STEEL STAIRS	Does not Exist
SITE	Inspected
CONTAINERIZATION	Does not Exist
Drainage System for Asphalt	Inspected
Catch Basins/Manhole - Surrounded by asphalt	Inspected
Condition	1 - Good
Deficiency	No deficiencies recorded
Culverts - Asphalt Covering	Does not Exist
Drainage System for Concrete	Inspected
Catch Basins/Manhole - Surrounded by concrete	Inspected
Condition	1 - Good
Deficiency	No deficiencies recorded
Culverts - Concrete Covering	Does not Exist
Drainage System for Soil	Does not Exist
DRINKING FOUNTAINS	Does not Exist
FENCES	Inspected
Condition	2 - Between Good and Fair
Deficiency	CHAIN LINK: DAMAGED POST/RAIL
Deficiency Location/Instance	Parking lot
Deficiency Quantity	10
Quantity Uom	L.F.
Potential Action	REPLACE
Urgency of Action	PRIORITY 3
Purpose of Action	LEVEL 2
Deficiency Photo1

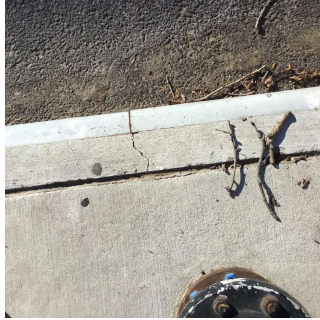
Question	Response
SITE	
PAVING	
DOT Sidewalk	
Concrete	
Deficiency Photo1
