**NYC Department of Education**  
**Building Condition Assessment Survey 2023 - 2024**

Architectural Inspection

**Asset: SOUTH BROOKLYN COMM. HS - K, 173 CONOVER STREET, New York, 11231**

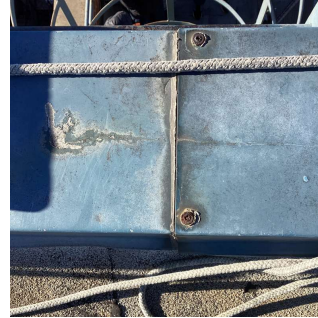
Roof 1

Question	Response
<b>Architectural</b>	
<b>EXTERIOR</b>	Inspected
<b>AREAWAY</b>	Does not Exist
<b>AWNINGS AND CANOPIES</b>	Does not Exist
<b>CHIMNEY</b>	Inspected
Material Type(s)	Metal
Condition	2 - Between Good and Fair
Deficiency	No deficiencies recorded
<b>COPING</b>	Inspected
Condition	3 - Fair
Deficiency	METAL: DETERIORATED TRANSVERSE JOINTS
Roof Plan reference

40  
 L.F.

MAINTENANCE  
PRIORITY 3  
LEVEL 2

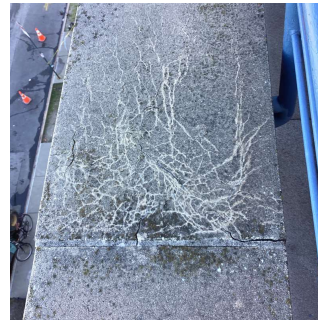
Roof 3

CAST STONE: DISINTEGRATING / FREEZE THAW

10  
L.F.  
REPLACE-IN-KIND  
PRIORITY 4  
LEVEL 2

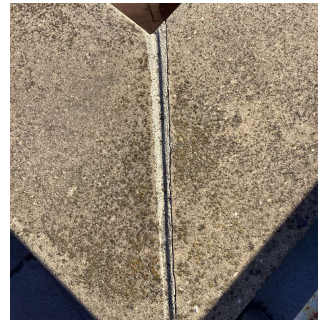
Roof 2  
No violations recorded.

CAST STONE: DETERIORATED TRANSVERSE JOINTS

160  
L.F.  
MAINTENANCE  
PRIORITY 3  
LEVEL 2

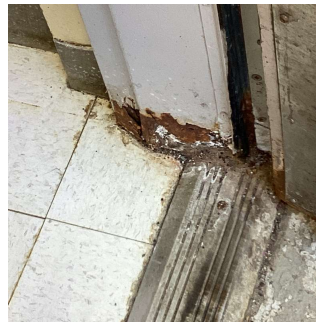
Facade F

METAL: DETERIORATED DOOR AND FRAME - MAJOR DETERIORATION

2  
EACH  
REPLACE  
PRIORITY 4  
LEVEL 2

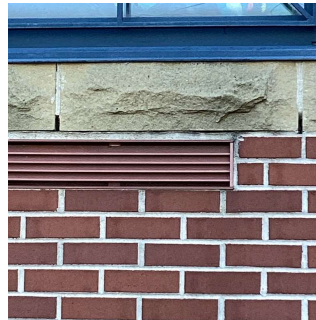
Facade A

STONE: DETERIORATED JOINTS

35

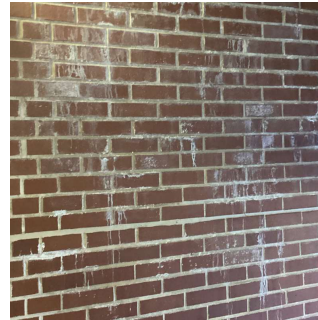
Facade B - Stairwell A/3 (Facade B - Stairwell A/2 similar)

BRICK: WATER INFILTRATION IN INSTRUCTIONAL SPACE

200

REPAIR

PRIORITY 5  
LEVEL 2

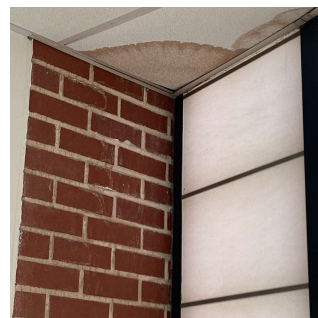
**GLASS BLOCK: WATER INFILTRATION IN INSTRUCTIONAL SPACE**

200  
S.F.  
REPAIR  
PRIORITY 5  
LEVEL 2

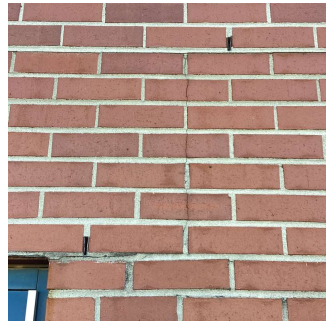
Question	Response
<b>EXTERIOR</b>	
<b>EXTERIOR WALLS</b>	
Violations	Facade C - Corridor near Stairwell A/3 (Facade C - Corridor near Stairwell A/2 similar) - Kalwall Material No violations recorded.
Deficiency	<b>BRICK: MINOR CRACKS AND SPALLING</b>
Roof Plan reference

Deficiency Quantity	30
Quantity Uom	S.F.
Potential Action	RESTITCH
Urgency of Action	PRIORITY 3
Purpose of Action	LEVEL 2
Deficiency Photo1

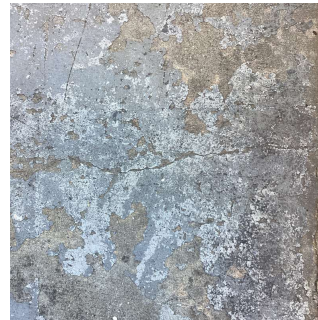
Loading Dock

Violations	Facade A No violations recorded.
<b>EXTERIOR SOFFITS</b>	
Condition	Inspected
Deficiency	2 - Between Good and Fair
Deficiency	No deficiencies recorded
<b>LOADING DOCK</b>	
Condition	Inspected
Deficiency	3 - Fair DETERIORATED CONCRETE PLATFORM WITH CRACKED, SPALLED CONCRETE OR EXPOSED REINFORCING

25  
S.F.  
REPAIR  
PRIORITY 3  
LEVEL 2

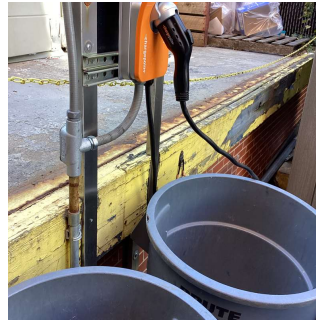
Loading Dock

**BAD BUMPERS**

1  
EACH  
REPLACE  
PRIORITY 4  
LEVEL 2

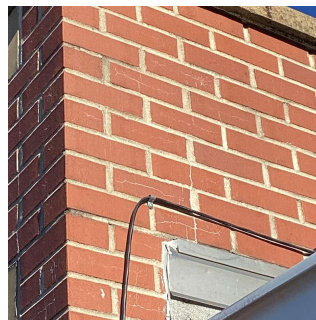
BH

BRICK: MINOR CRACKS, SPALLING

35

REPAIR

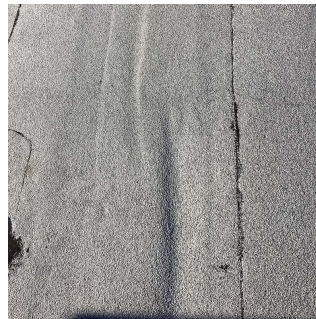
Roof 1  
No violations recorded.

Does the roof have major mechanical equipment sitting on Dunnage Steel less than 18" above the Roofing?	Yes
Does this roof instance have a Sustainable Roof System?	No
Do solar panels exist on these roofs?	No
Is/Are the roof(s) suitable for Solar Panel installation?	No
Installation Year	2001
Source of Installation	Custodial Staff
Deficiency	MODIFIED BITUMEN: ROOFING: DELAMINATION

120  
S.F.  
REPLACE ROOFING WITHOUT MAJOR EQUIPMENT  
REMOVAL  
PRIORITY 4  
LEVEL 2

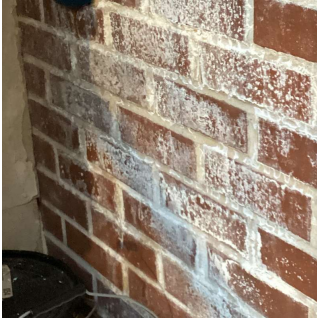
BULKHEAD/PENTHOUSE WALLS/EXTERIOR: WATER  
INFILTRATION

100  
S.F.

Question	Response
<b>EXTERIOR</b>	
<b>ROOF</b>	
<b>Specialties</b>	
<b>BULKHEAD/PENTHOUSE</b>	
Potential Action	REPAIR
Urgency of Action	PRIORITY 5
Purpose of Action	LEVEL 2
Deficiency Photo1

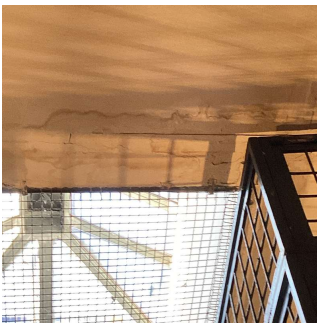
Violations	BH No violations recorded.
Deficiency	BULKHEAD/PENTHOUSE CEILING: GYPSUM BOARD DAMAGED/DETERIORATED
Roof Plan reference

Deficiency Quantity	25
Quantity Uom	S.F.
Potential Action	REPLACE
Urgency of Action	PRIORITY 4
Purpose of Action	LEVEL 2
Deficiency Photo1

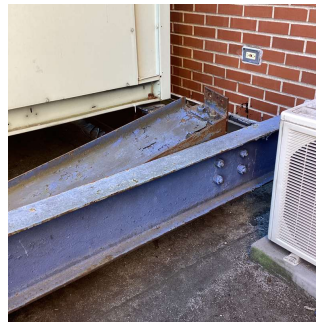
Roof 5  
 No violations recorded.

HEIGHT LESS THAN 18"

90  
 L.F.  
 REPLACE  
 PRIORITY 3  
 LEVEL 2

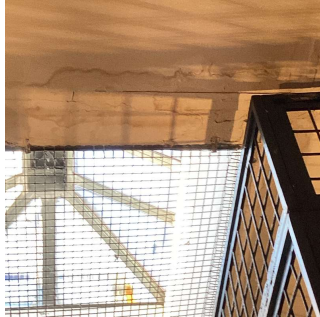
WATER INFILTRATION

20  
 S.F.  
 MAINTENANCE  
 PRIORITY 3  
 LEVEL 2

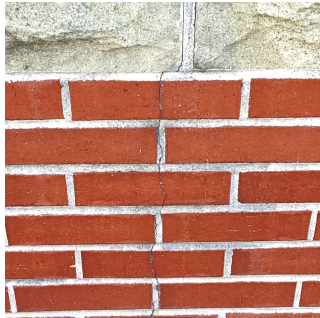
Violations	SK2 No violations recorded.
<b>ROOF/GRAVITY TANK</b>	Does not Exist
<b>STAIRS/RAMPS: EXTERIOR</b>	Inspected
<b>BUILDING CHEEK/FLANK WALLS</b>	Inspected
Condition	4 - Between Fair and Poor
Deficiency	BRICK: CRACKS/SPALLING - MINOR
Roof Plan reference

Deficiency Quantity	50
Quantity Uom	S.F.
Potential Action	REPAIR
Urgency of Action	PRIORITY 3
Purpose of Action	LEVEL 2
Deficiency Photo1

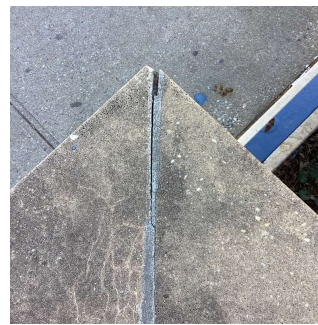
Violations	Facade A No violations recorded.
Deficiency	BRICK: DETERIORATED JOINTS AT COPING STONES

35  
 L.F.  
 MAINTENANCE  
 PRIORITY 3  
 LEVEL 2

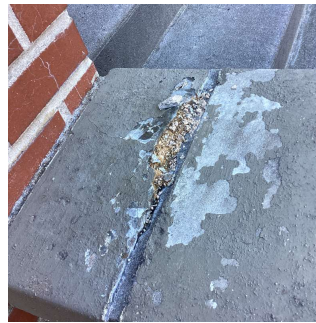
Facade A

**BRICK: DETERIORATED COPING STONE**

20  
 S.F.  
 REPLACE  
 PRIORITY 4  
 LEVEL 2

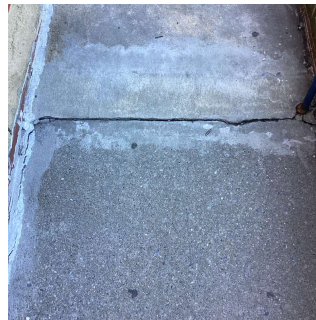
Facade A

CONCRETE: CRACKS/SPALLING - MAJOR

15

REPLACE

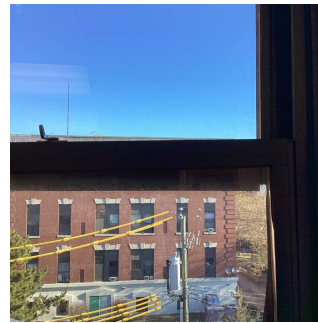
Facade C

ALUMINUM - DOUBLE HUNG: INOPERABLE BALANCE

4

REPLACE BALANCES

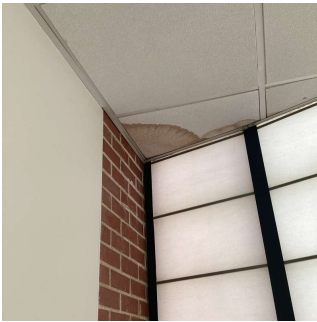
Question	Response
<b>INTERIOR</b>	
<b>CAFETERIA</b>	
<b>Door(s)</b>	
Deficiency	No deficiencies recorded
<b>Fixed Equipment</b>	
Instance on 1st Floor (2,000SF)	Does not Exist
<b>Floor Finish</b>	
Instance on 1st Floor (2,000SF)	Inspected
Condition	2 - Between Good and Fair
Deficiency	No deficiencies recorded
<b>Sliding-folding Partition</b>	
Instance on 1st Floor (2,000SF)	Does not Exist
<b>Stage</b>	
Instance on 1st Floor (2,000SF)	Does not Exist
<b>Walls</b>	
Instance on 1st Floor (2,000SF)	Inspected
Condition	2 - Between Good and Fair
Deficiency	No deficiencies recorded
<b>Window Curtains/Shades/Blinds</b>	
Instance on 1st Floor (2,000SF)	Does not Exist
<b>CLASSROOMS/CORRIDORS/ADMIN SPACES</b>	Inspected
<b>Ceiling</b>	Inspected
Condition	2 - Between Good and Fair
Deficiency	ACOUSTIC TILES: DAMAGED/MISSING - ACTIVE LEAK
Deficiency Location/Instance	Corridor near Stairwell A/3 and A/2
Deficiency Quantity	20
Quantity Uom	S.F.

Potential Action	REPLACE
Urgency of Action	PRIORITY 5
Purpose of Action	LEVEL 2
Deficiency Photo1

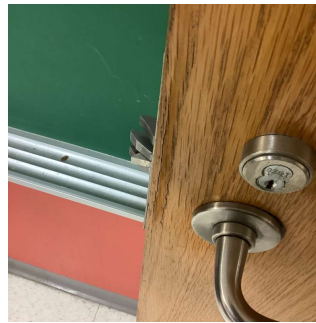
Room 307

Violations	Corridor near Stair A/3 No violations recorded.
<b>Door(s)</b>	Inspected
Condition	5 - Poor
Deficiency	WOOD: DETERIORATED DOOR
Deficiency Location/Instance	Rooms 307, 303, 203, 202, 201
Deficiency Quantity	5
Quantity Uom	EACH
Potential Action	MAINTENANCE
Urgency of Action	PRIORITY 3
Purpose of Action	LEVEL 2

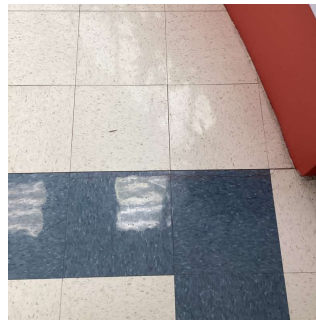
Corridor near Stair A/2

VINYL TILES: DETERIORATED SUBSTRATE

REPLACE

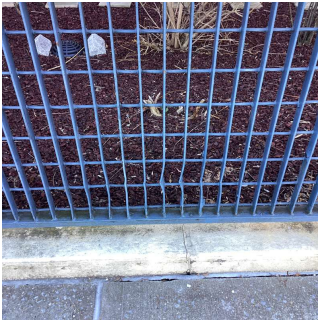
<b>FENCES</b>	Inspected
Condition	3 - Fair
Deficiency	WROUGHT IRON: DAMAGED/DETERIORATED
Deficiency Location/Instance	Conover Street
Deficiency Quantity	40
Quantity Uom	S.F.
Potential Action	REPLACE
Urgency of Action	PRIORITY 3
Purpose of Action	LEVEL 2
Deficiency Photo1

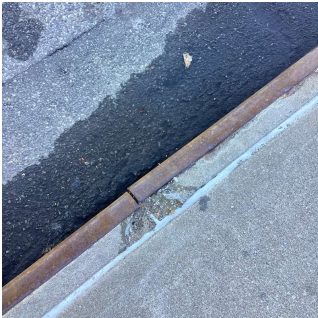
Violations	Near Entrance No violations recorded.
<b>Student Use</b>	Does not Exist
<b>Site Sidewalks &amp; Walkways</b>	Inspected
<b>Asphalt</b>	Does not Exist
<b>Concrete</b>	Inspected
Condition	2 - Between Good and Fair
Deficiency	No deficiencies recorded
<b>Pavers</b>	Does not Exist
<b>DOT Sidewalk</b>	Inspected
<b>Asphalt</b>	Does not Exist
<b>Concrete</b>	Inspected
Condition	2 - Between Good and Fair
Deficiency	DAMAGED CURBS
Deficiency Location/Instance	Conover Street, Wolcott Street
Deficiency Quantity	10
Quantity Uom	L.F.
Potential Action	REPLACE
Urgency of Action	PRIORITY 3
Purpose of Action	LEVEL 2
Deficiency Photo1

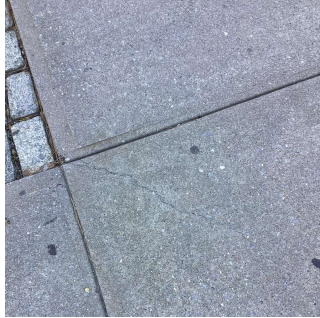
Violations	Conover Street No violations recorded.
Deficiency	DAMAGED/DETERIORATED/MISSING SECTIONS
Deficiency Location/Instance	Conover Street
Deficiency Quantity	25
Quantity Uom	S.F.
Potential Action	REPLACE

Question	Response
<b>SITE</b>	
<b>PAVING</b>	
<b>DOT Sidewalk</b>	
<b>Concrete</b>	
Urgency of Action	PRIORITY 3
Purpose of Action	LEVEL 2
Deficiency Photo1
