NYC Department of Education
Building Condition Assessment Survey 2023 - 2024

Architectural Inspection

Asset: P.S. 39 ANNEX (GYM) - BROOKLYN, 339 8TH STREET, New York, 11215

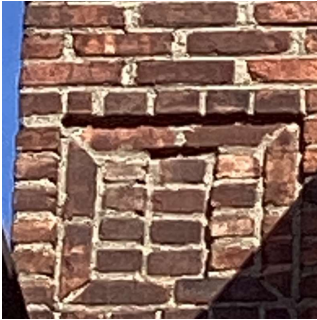
Deficiency
 Roof Plan reference
 BRICK: DETERIORATED JOINTS

Deficiency Quantity	30
Quantity Uom	S.F.
Potential Action	REPOINT
Urgency of Action	PRIORITY 3
Purpose of Action	LEVEL 2

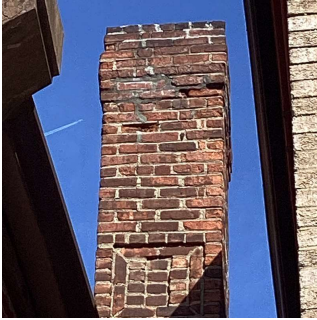
Violations	CH No violations recorded.
Deficiency	BRICK: MAJOR / THRU CRACKS
Roof Plan reference	K830

Deficiency Quantity	10
Quantity Uom	S.F.
Potential Action	REMOVE AND REBUILD
Urgency of Action	PRIORITY 4
Purpose of Action	LEVEL 2
Deficiency Photo1

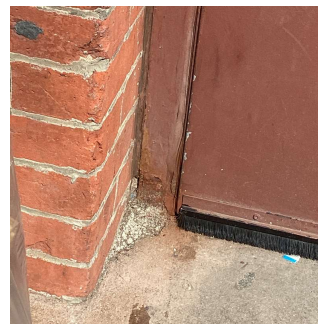
Facade A - Main Entrance
No violations recorded.

Violations	CH No violations recorded.
COPING	Inspected
Condition	2 - Between Good and Fair
Deficiency	No deficiencies recorded
CORNICE	Does not Exist
DOORS	Inspected
DOORS AND FRAMES	Inspected
Condition	5 - Poor
Deficiency	METAL: DETERIORATED DOOR - MINOR DETERIORATION

1
EACH
MAINTENANCE
PRIORITY 3
LEVEL 2

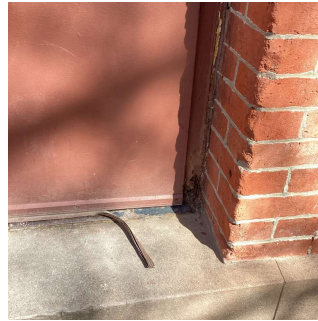
Facade A - West Entrance

METAL: DETERIORATED DOOR AND FRAME - MAJOR DETERIORATION

1
EACH
REPLACE
PRIORITY 4
LEVEL 2

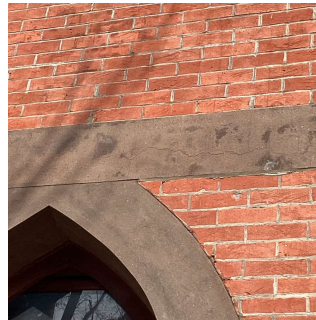
Facade A

STONE: CHIPPED/SPALLED/BROKEN PIECES - MINOR

REPAIR

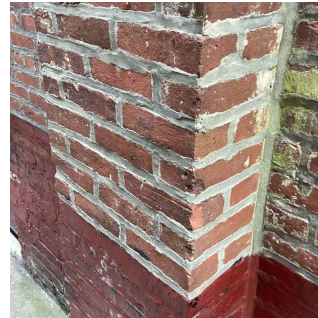
Facade B

BRICK: MINOR CRACKS AND SPALLING

RESTITCH

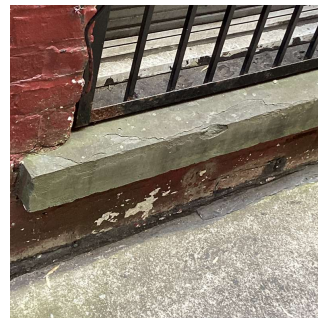
Facade B

BRICK: DETERIORATED MASONRY SILLS - MINOR

REPAIR

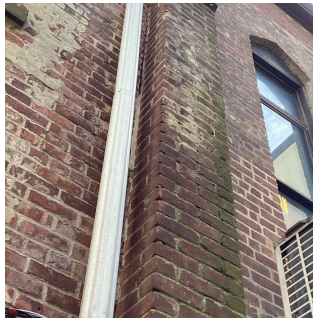
Facade B

BRICK: DETERIORATED JOINTS

REPOINT

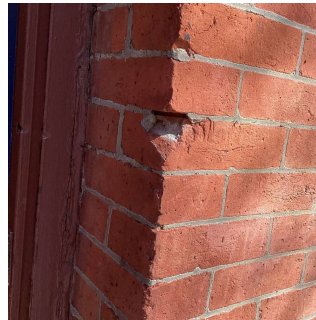
Facade A

BRICK: MAJOR / THRU CRACKS

REMOVE AND REBUILD

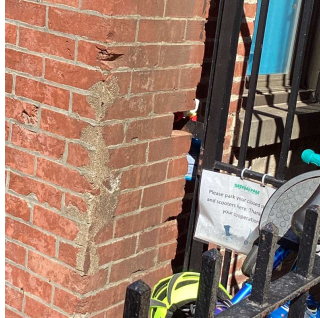
BRICK: CRACKS/DISPLACED/SPALLED BRICK AT BUILDING CORNERS

Violations	Corner of Facade A and Facade D No violations recorded.
EXTERIOR SOFFITS	
Condition	Inspected 2 - Between Good and Fair
Deficiency	No deficiencies recorded
LOADING DOCK	
Does not Exist	
LOUVER	
Does not Exist	
PARAPETS	
Does not Exist	
PLAZA DECK	
Does not Exist	
ROOF	
Inspected	
Roofing	
Inspected	
Replacement Quantity	4,000
Replacement Uom	S.F.
ROOF HATCH/SMOKE HATCH	
Does not Exist	
LEADERS, GUTTERS, DOWNSPOUTS, SCUPPERS	
Inspected	
Condition	2 - Between Good and Fair
Deficiency	No deficiencies recorded
ROOF BARRIER/FENCE	
Does not Exist	
ROOF CAGE	
Does not Exist	
ROOFING	
Inspected	
Instance on Asphalt Shingle: Roof 1	Inspected
Instance Condition	2 - Between Good and Fair
Instance Photo

Question	Response
EXTERIOR	
EXTERIOR WALLS	
Potential Action	REMOVE AND REBUILD
Urgency of Action	PRIORITY 4
Purpose of Action	LEVEL 2
Deficiency Photo1

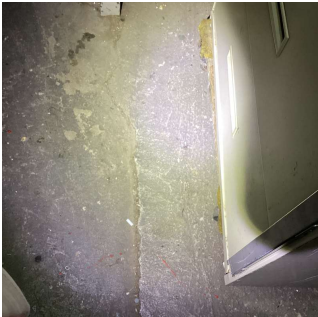
Question	Response
INTERIOR	
STRUCTURAL	
COLUMNS/BEAMS/BEARING WALLS	Inspected
Deficiency	No deficiencies recorded
FLOOR STRUCTURE	Inspected
Condition	2 - Between Good and Fair
Deficiency	CONCRETE SLAB ON GRADE: THRU CRACKS
Deficiency Location/Instance	Basement - Boiler Room
Deficiency Quantity	20
Quantity Uom	S.F.
Potential Action	REPAIR
Urgency of Action	PRIORITY 3
Purpose of Action	LEVEL 5
Deficiency Photo1

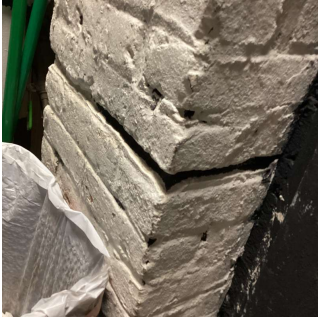
Violations	Basement - Boiler Room No violations recorded.
FOUNDATION WALLS	
	Inspected
Material Type(s)	Concrete, Masonry
Condition	3 - Fair
Deficiency	BRICK: DETERIORATED JOINTS
Deficiency Location/Instance	Basement - Boiler Room Entrance
Deficiency Quantity	10
Quantity Uom	S.F.
Potential Action	REPOINT
Urgency of Action	PRIORITY 4
Purpose of Action	LEVEL 5
Deficiency Photo1

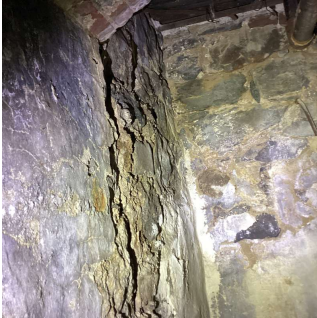
Violations	Basement - Boiler Room Entrance No violations recorded.
Deficiency	STONE RUBBLE: CRACKED/SPALLED
Deficiency Location/Instance	Basement - Boiler Room

Deficiency Quantity	20
Quantity Uom	S.F.
Potential Action	RESTITCH

Question	Response
INTERIOR	
STRUCTURAL	
FOUNDATION WALLS	
Urgency of Action	PRIORITY 4
Purpose of Action	LEVEL 5
Deficiency Photo1

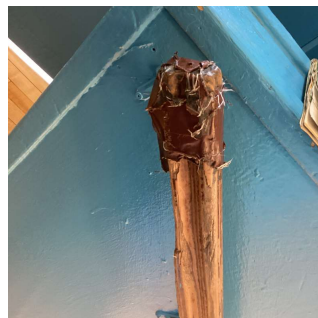
Deficiency	WOOD: DAMAGED
Deficiency Location/Instance	Gymnasium
Deficiency Quantity	10
Quantity Uom	L.F.
Potential Action	REPLACE
Urgency of Action	PRIORITY 3
Purpose of Action	LEVEL 2
Deficiency Photo1

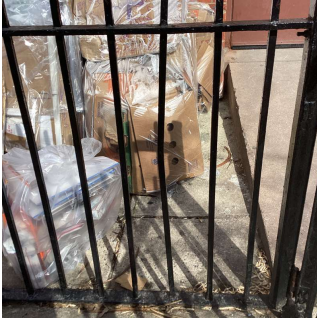
Drainage System for Concrete	Does not Exist
Drainage System for Soil	Does not Exist
DRINKING FOUNTAINS	Does not Exist
FENCES	Inspected
Condition	3 - Fair
Deficiency	WROUGHT IRON: DAMAGED/DETERIORATED
Deficiency Location/Instance	Along 8th Street
Deficiency Quantity	40
Quantity Uom	S.F.
Potential Action	REPLACE
Urgency of Action	PRIORITY 3
Purpose of Action	LEVEL 2

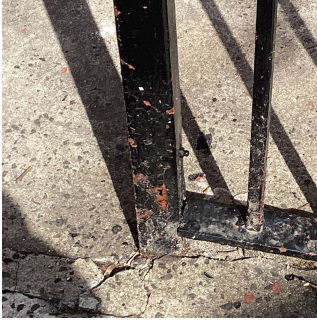
Violations	Along 8th Street No violations recorded.
Deficiency	WROUGHT IRON: RUST - MAJOR
Deficiency Location/Instance	Along 8th Street
Deficiency Quantity	40
Quantity Uom	S.F.
Potential Action	REPLACE
Urgency of Action	PRIORITY 3
Purpose of Action	LEVEL 2
Deficiency Photo1

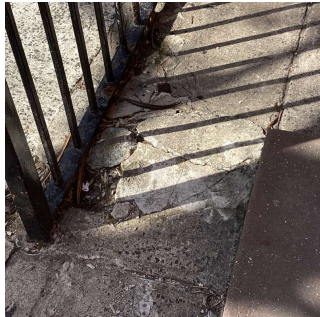
Violations	Along 8th Street No violations recorded.
IRRIGATION SYSTEM	Does not Exist
PAVING	Inspected
Student Non-Use	Does not Exist
Student Use	Does not Exist
Site Sidewalks & Walkways	Inspected
Asphalt	Does not Exist
Concrete	Inspected
Condition	3 - Fair
Deficiency	DAMAGED/DETERIORATED/MISSING SECTIONS
Deficiency Location/Instance	Along 8th Street
Deficiency Quantity	75
Quantity Uom	S.F.
Potential Action	REPLACE
Urgency of Action	PRIORITY 3
Purpose of Action	LEVEL 2

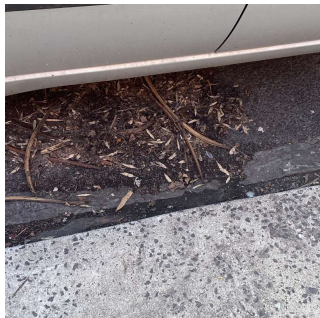
Violations	Along 8th Street No violations recorded.
Pavers	Does not Exist
DOT Sidewalk	Inspected
Asphalt	Does not Exist
Concrete	Inspected
Condition	3 - Fair
Deficiency	DAMAGED CURBS
Deficiency Location/Instance	Along 8th Street
Deficiency Quantity	10
Quantity Uom	L.F.
Potential Action	REPLACE
Urgency of Action	PRIORITY 3
Purpose of Action	LEVEL 2
Deficiency Photo1

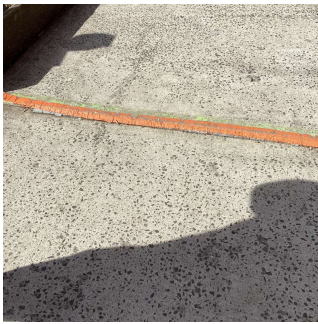
Violations	Along 8th Street No violations recorded.
Deficiency	HEAVING
Deficiency Location/Instance	Along 8th Street
Deficiency Quantity	50
Quantity Uom	S.F.
Potential Action	REPLACE
Urgency of Action	PRIORITY 3
Purpose of Action	LEVEL 2
