NYC Department of Education
Building Condition Assessment Survey 2023 - 2024

Architectural Inspection

K834

Asset: P.S. 372 (OUR LADY OF PEACE)-K, 512 CARROLL STREET, New York, 11215

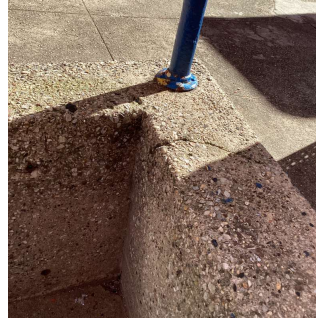
AW1

**AREAWAY STAIRS: DETERIORATED
TREADS/RISERS/NOSINGS**

REPLACE

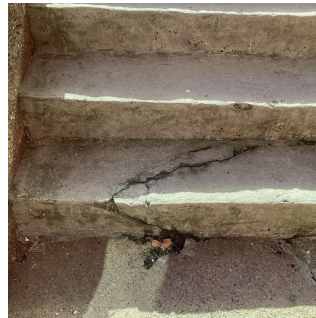
AW1

AREAWAY SLAB: CRACKS AND SPALLING

30
S.F.
REPAIR
PRIORITY 3
LEVEL 2

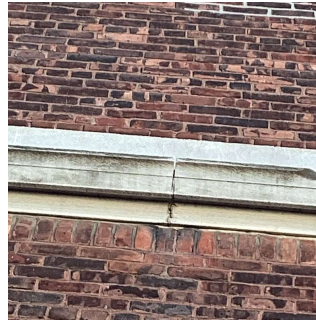
Facade D - Near Exit 9

STONE: MINOR CRACKS, SPALLING

REPAIR

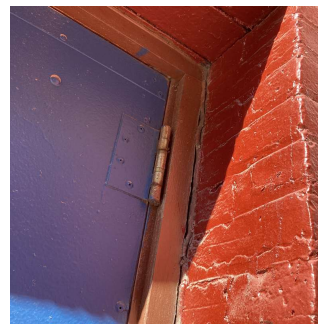
Facade B - Exit 4

METAL: DETERIORATED DOOR AND FRAME - MAJOR DETERIORATION

2
EACH
REPLACE
PRIORITY 4
LEVEL 2

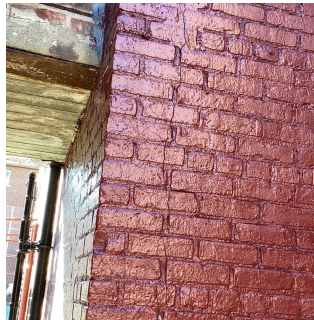
Facade B - Near Exit 6

BRICK: DETERIORATED MASONRY SILLS - MINOR

REPAIR

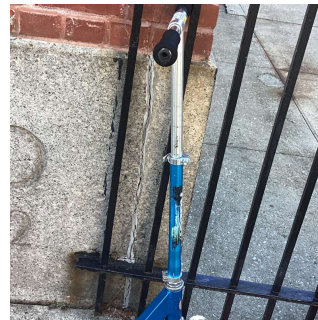
Corner of Facade A and Facade D
No violations recorded.

STONE: DETERIORATED JOINTS

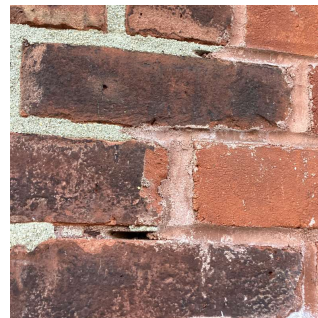
Facade A - Main Entrance

BRICK: MINOR CRACKS AND SPALLING

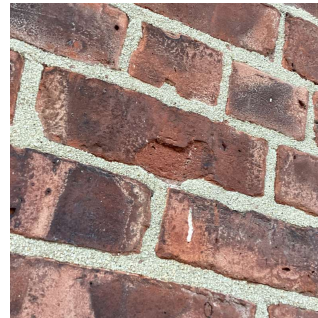
Facade A - Main Entrance

BRICK: DETERIORATED JOINTS

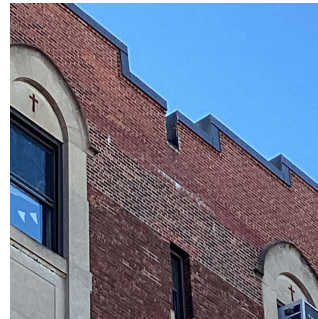
Facade D

BRICK: DETERIORATED JOINTS

600
S.F.
REPOINT
PRIORITY 3
LEVEL 2

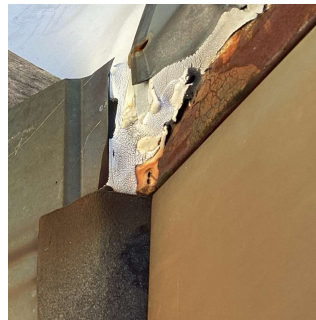
BH2
No violations recorded.

**BULKHEAD/PENTHOUSE WALLS/INTERIOR: GLAZED BLOCK
CRACKS/SPALLING**

10
S.F.
REPLACE
PRIORITY 3
LEVEL 2

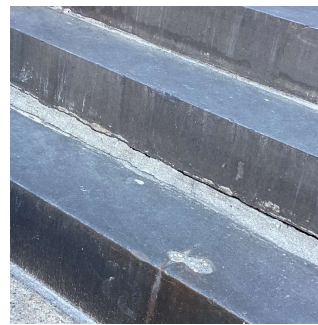
Facade D - Exit 8

STONE: CRACKS/SPALLING - MAJOR

50
S.F.
REPLACE
PRIORITY 4
LEVEL 2

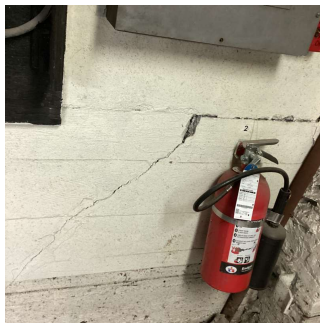
Violations	Basement - Boiler Room No violations recorded.
Deficiency	CONCRETE: WATER INFILTRATION IN NON- INSTRUCTIONAL SPACE
Deficiency Location/Instance	Basement - Corridor near the Oil Tank Room
Deficiency Quantity	100
Quantity Uom	S.F.
Potential Action	INSTALL WATERPROOFING
Urgency of Action	PRIORITY 5
Purpose of Action	LEVEL 5
Deficiency Photo1

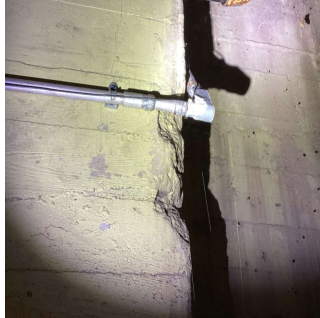
Violations	Basement - Vaults-Bunkers No violations recorded.
Slab Structure	Inspected
Condition	2 - Between Good and Fair
Deficiency	CONCRETE: CRACKS/SPALLED/REINFORCEMENT EXPOSED
Deficiency Location/Instance	Basement - Vaults-Bunkers
Deficiency Quantity	10
Quantity Uom	S.F.
Potential Action	REPAIR
Urgency of Action	PRIORITY 3
Purpose of Action	LEVEL 5
Deficiency Photo1

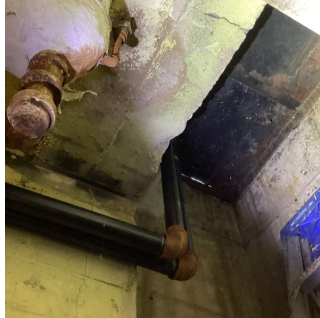
Violations	Basement - Vaults-Bunkers No violations recorded.
Vault/Ash Hoist Doors and Framing	Inspected
Condition	5 - Poor
Deficiency	DETERIORATED/DAMAGED VAULT/ASH HOIST DOORS AND FRAMING
Deficiency Location/Instance	Basement - Vaults-Bunkers
Deficiency Quantity	2
Quantity Uom	EACH
Potential Action	REPLACE
Urgency of Action	PRIORITY 4
Purpose of Action	LEVEL 2
