NYC Department of Education
Building Condition Assessment Survey 2023 - 2024

Architectural Inspection

Asset: P.S. 235 MINISCHOOL - BROOKLYN, 525 LENOX ROAD, New York, 11203

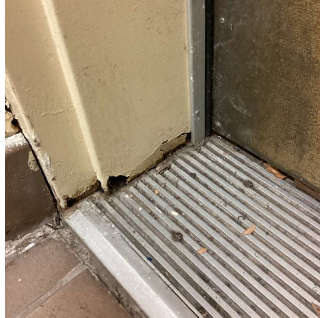
Question	Response
EXTERIOR	
DOORS	
DOORS AND FRAMES	
Purpose of Action	LEVEL 2
Deficiency Photo1

Violations	Facade C No violations recorded.
Deficiency	METAL: DETERIORATED DOOR AND FRAME - MINOR DETERIORATION
Roof Plan reference	K835   E. 39th Street
Deficiency Quantity	3
Quantity Uom	EACH
Potential Action	MAINTENANCE
Urgency of Action	PRIORITY 3
Purpose of Action	LEVEL 2
Deficiency Photo1	 
Violations	Facade A No violations recorded.
DOOR HARDWARE	Inspected
Condition	3 - Fair
Deficiency	No deficiencies recorded
LINTELS	Does not Exist
TRANSOM/SIDE LIGHT	Inspected
Condition	2 - Between Good and Fair
Deficiency	No deficiencies recorded

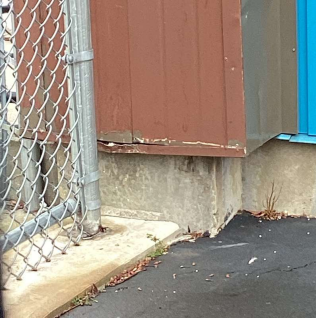
Question	Response
EXTERIOR	
EXTERIOR WALLS	Inspected
Material Type(s)	Steel
Replacement Quantity	9,000
Replacement Uom	S.F.
Instance on All Facades	Inspected
Instance Condition	4 - Between Fair and Poor
Instance Quantity	9,000
Instance Quantity Uom	S.F.
Deficiency	METAL PANEL: DAMAGED TRIM
Roof Plan reference	<p>K835</p>

Deficiency Quantity	30
Quantity Uom	L.F.
Potential Action	REPLACE
Urgency of Action	PRIORITY 4
Purpose of Action	LEVEL 2
Deficiency Photo1

<p>Facade A</p>
Violations	No violations recorded.
Deficiency	METAL PANEL: SEVERE DENTS

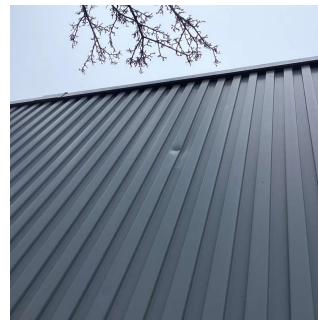
Facade A

80

REPLACE

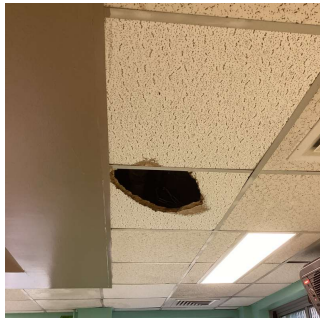
Roof 1
Instance Quantity	2,500
Instance Quantity Uom	S.F.
Does the roof have major mechanical equipment sitting on Dunnage Steel less than 18" above the Roofing?	No
Does this roof instance have a Sustainable Roof System?	No
Do solar panels exist on these roofs?	No
Is/Are the roof(s) suitable for Solar Panel installation?	No
Installation Year	1991
Source of Installation	Custodial Staff
Deficiency	IRMA: ROOFING: MAJOR ACTIVE ROOF LEAKS IN INSTRUCTIONAL SPACE
Roof Plan reference

<p align="center">K835</p> <p align="center">E. 39th Street</p>
Deficiency Quantity	100
Quantity Uom	S.F.
Potential Action	REPLACE ROOFING WITHOUT MAJOR EQUIPMENT REMOVAL
Urgency of Action	PRIORITY 5
Purpose of Action	LEVEL 2
Deficiency Photo1

Roof 2 - Cafeteria
Violations	No violations recorded.
Deficiency	IRMA: ROOFING: DAMAGED INSULATION

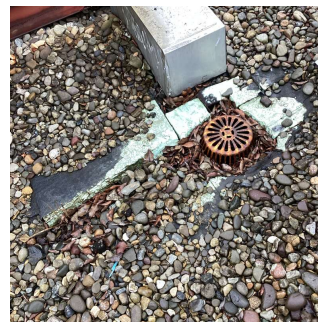
Roof 1
No violations recorded.

120
S.F.
REPLACE
PRIORITY 4
LEVEL 2

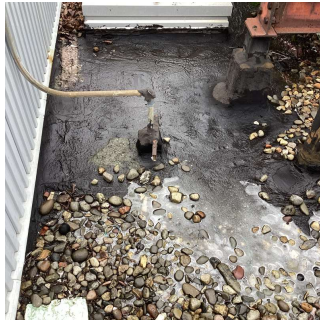
IRMA: ROOFING: LOSS OF GRAVEL

200
S.F.
MAINTENANCE
PRIORITY 3
LEVEL 2

Roof 1
Violations	No violations recorded.
Instance on Metal: Roofs 5 - 7	Inspected
Instance Condition	5 - Poor
Instance Photo

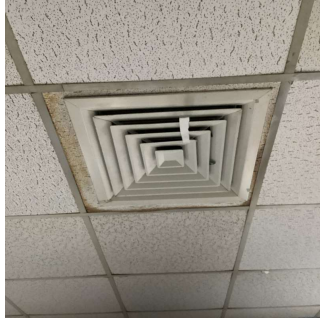
Roof 5
Instance Quantity	7,000
Instance Quantity Uom	S.F.
Does the roof have major mechanical equipment sitting on Dunnage Steel less than 18" above the Roofing?	No
Does this roof instance have a Sustainable Roof System?	No
Do solar panels exist on these roofs?	No
Is/Are the roof(s) suitable for Solar Panel installation?	No
Installation Year	1991
Source of Installation	Custodial Staff
Deficiency	METAL: ROOFING: MAJOR ACTIVE ROOF LEAKS IN INSTRUCTIONAL SPACE
Roof Plan reference

<p>K835</p> <p>E. 39th Street</p> <p>Lenox Road</p>
Deficiency Quantity	100
Quantity Uom	S.F.
Potential Action	REPLACE
Urgency of Action	PRIORITY 5
Purpose of Action	LEVEL 2

Violations	Roof 5 - Staff Lounge Room No violations recorded.
Deficiency	METAL: ROOFING: MAJOR ACTIVE ROOF LEAKS IN NON-INSTRUCTIONAL SPACE
Roof Plan reference	K835

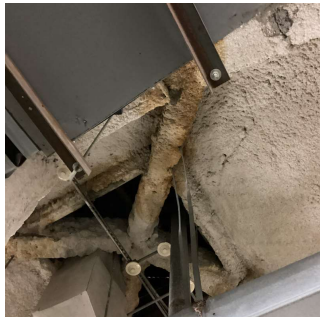
E. 39th Street Lenox Road
Deficiency Quantity	200
Quantity Uom	S.F.
Potential Action	REPLACE
Urgency of Action	PRIORITY 5
Purpose of Action	LEVEL 2
Deficiency Photo1

Violations	Roof 5 - Mechanical Room 300, Roof 7 - Mechanical Room 301 No violations recorded.
ROOFING DRAINS	Inspected
Condition	2 - Between Good and Fair
Deficiency	No deficiencies recorded
Specialties	Inspected
BULKHEAD/PENTHOUSE	Does not Exist
CUPOLA/ SPIRES/ TOWERS	Does not Exist
DORMER	Does not Exist

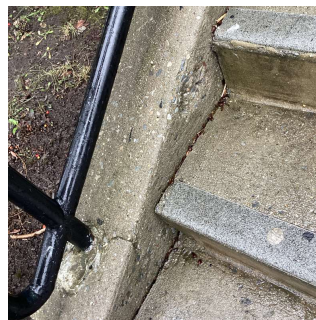
Facade B

CAST IN PLACE CONCRETE: DETERIORATED CONTROL/EXPANSION JOINT

20
L.F.
REPLACE
PRIORITY 3
LEVEL 2

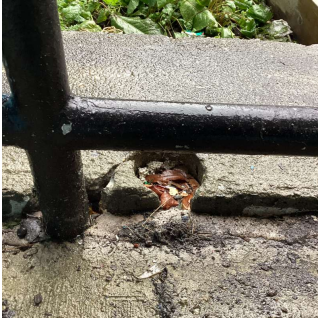
STONE: CRACKS/SPALLING - MAJOR

Question	Response
EXTERIOR	
STAIRS/RAMPS: EXTERIOR	
BUILDING CHEEK/FLANK WALLS	
Quantity Uom	S.F.
Potential Action	REPLACE
Urgency of Action	PRIORITY 4
Purpose of Action	LEVEL 2
Deficiency Photo1

Violations	Facade C No violations recorded.
RAILINGS	Inspected
Condition	2 - Between Good and Fair
Deficiency	No deficiencies recorded
STAIRS/RAMPS	Inspected
Condition	4 - Between Fair and Poor
Deficiency	CONCRETE: CRACKS/SPALLING - MAJOR
Roof Plan reference

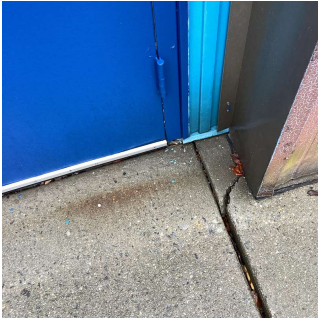
K835 HC Ramp HC Entrance C RH1 RH2 RH3 Main Entrance HC Ramps A D K296 Parcel Asset Lenox Road N E. 39th Street
Deficiency Quantity	20
Quantity Uom	S.F.
Potential Action	REPLACE
Urgency of Action	PRIORITY 4
Purpose of Action	LEVEL 2
Deficiency Photo1

Violations	Facade C No violations recorded.

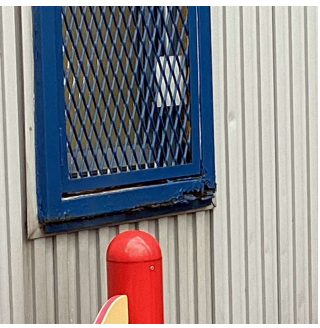
Question	Response
EXTERIOR	
WINDOWS	Inspected
Replacement Quantity	1,300
Replacement Uom	S.F.
EXTERIOR GUARDS	Inspected
Condition	3 - Fair
Deficiency	RUST - MAJOR
Roof Plan reference	<p>K835</p>

Deficiency Quantity	30
Quantity Uom	S.F.
Potential Action	REPLACE
Urgency of Action	PRIORITY 4
Purpose of Action	LEVEL 2
Deficiency Photo1

Violations	Facade A No violations recorded.
LINTELS	Does not Exist
WINDOWS	Inspected
Material Type(s)	Aluminum
Instance on Aluminum - Double Hung: All Facades	Inspected
Instance Condition	3 - Fair
Instance Quantity	1,300
Instance Quantity Uom	S.F.
Are these windows insulated	No

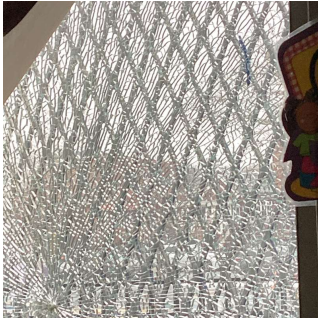
Question	Response
EXTERIOR	
WINDOWS	
WINDOWS	
Installation Year	1991
Source of Installation	Custodial Staff
Deficiency	ALUMINUM - DOUBLE HUNG: BROKEN PANE
Roof Plan reference

Deficiency Quantity	30
Quantity Uom	S.F.
Potential Action	MAINTENANCE
Urgency of Action	PRIORITY 3
Purpose of Action	LEVEL 2
Deficiency Photo1

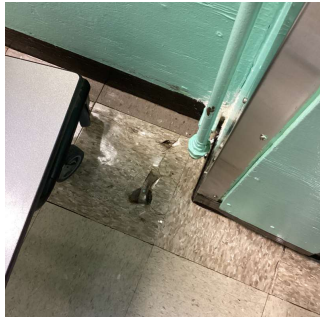
Question	Response
INTERIOR	
CAFETERIA	
Door(s)	
Instance on 1st Floor (1,000 SF)	Inspected
Condition	2 - Between Good and Fair
Deficiency	No deficiencies recorded
Fixed Equipment	
Instance on 1st Floor (1,000 SF)	Does not Exist
Floor Finish	
Instance on 1st Floor (1,000 SF)	Inspected
Condition	3 - Fair
Deficiency	VINYL TILES: BROKEN/DETERIORATED/MISSING TILES
Deficiency Location/Instance	Near Kitchen, by Main Entrance, next to Windows
Deficiency Quantity	30
Quantity Uom	S.F.
Potential Action	REPLACE
Urgency of Action	PRIORITY 3
Purpose of Action	LEVEL 2
Deficiency Photo1

Violations	Next to Windows No violations recorded.
Deficiency	VINYL TILES: DETERIORATED SUBSTRATE
Deficiency Location/Instance	Near Windows
Deficiency Quantity	20
Quantity Uom	S.F.
Potential Action	REPLACE
Urgency of Action	PRIORITY 3
Purpose of Action	LEVEL 2
Deficiency Photo1	 
Violations	Near Windows No violations recorded.
Sliding-folding Partition

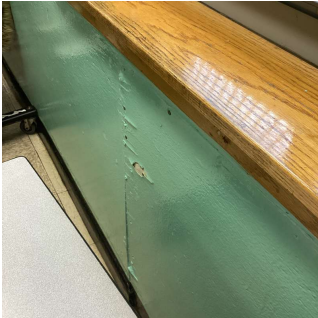
Question	Response
INTERIOR	
CAFETERIA	
Stage	
Instance on 1st Floor (1,000 SF)	Does not Exist
Walls	
Instance on 1st Floor (1,000 SF)	Inspected
Condition	2 - Between Good and Fair
Deficiency	GYPSUM BOARD: DETERIORATED
Deficiency Location/Instance	Near Windows
Deficiency Quantity	20
Quantity Uom	S.F.
Potential Action	REPLACE
Urgency of Action	PRIORITY 3
Purpose of Action	LEVEL 2
Deficiency Photo1

Near Windows
Violations	No violations recorded.
Window Curtains/Shades/Blinds	
Instance on 1st Floor (1,000 SF)	Does not Exist
CLASSROOMS/CORRIDORS/ADMIN SPACES	
Ceiling	Inspected
Condition	2 - Between Good and Fair
Deficiency	ACOUSTIC TILES: DAMAGED/MISSING - ACTIVE LEAK
Deficiency Location/Instance	Staff Lounge
Deficiency Quantity	10
Quantity Uom	S.F.
Potential Action	REPLACE
Urgency of Action	PRIORITY 5
Purpose of Action	LEVEL 2
Deficiency Photo1

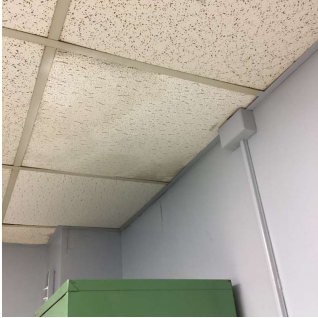
Staff Lounge
Violations	No violations recorded.
Deficiency	ACOUSTIC TILES: DAMAGED/MISSING

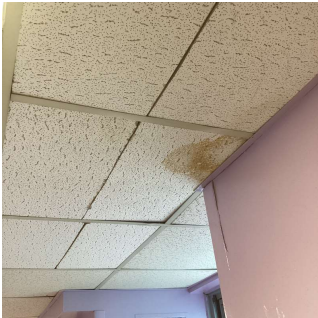
Deficiency Location/Instance	Room 213, Corridor near Room 208

Question	Response
INTERIOR	
CLASSROOMS/CORRIDORS/ADMIN SPACES	
Ceiling	
Deficiency Quantity	20
Quantity Uom	S.F.
Potential Action	REPLACE
Urgency of Action	PRIORITY 3
Purpose of Action	LEVEL 2
Deficiency Photo1

Corridor near Room 208
Violations	No violations recorded.
Door(s)	Inspected
Condition	2 - Between Good and Fair
Deficiency	No deficiencies recorded
Floor Finish	Inspected
Condition	2 - Between Good and Fair
Deficiency	VINYL TILES: BROKEN/DETERIORATED/MISSING TILES
Deficiency Location/Instance	Rooms 210, 404, Corridor near Rooms 213, M212, by Elevator/2 and others
Deficiency Quantity	100
Quantity Uom	S.F.
Potential Action	REPLACE
Urgency of Action	PRIORITY 3
Purpose of Action	LEVEL 2
Deficiency Photo1

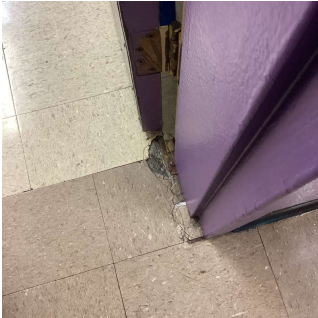
Corridor near Room M212
Violations	No violations recorded.
Deficiency	VINYL TILES: DETERIORATED SUBSTRATE
Deficiency Location/Instance	Corridor near Rooms 112, 102, 208, by Stairs G/1, H/1 and others
Deficiency Quantity	120

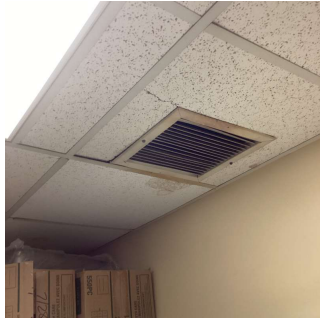
Question	Response
INTERIOR	
CLASSROOMS/CORRIDORS/ADMIN SPACES	
Walls	Inspected
Deficiency Photo1	 
	Corridor near Room M206
Violations	No violations recorded.
Specialties	Does not Exist
GYMNASIUM	Does not Exist
INTERIOR DOOR HARDWARE	Inspected
Condition	3 - Fair
Deficiency	No deficiencies recorded
INTERIOR GUARDS	Inspected
Condition	2 - Between Good and Fair
Deficiency	No deficiencies recorded
KITCHEN	Inspected
Instance on 1st Floor	Inspected
Ceiling	
Instance on 1st Floor	Inspected
Condition	2 - Between Good and Fair
Deficiency	ACOUSTIC TILES: DAMAGED/MISSING
Deficiency Location/Instance	Storage Room
Deficiency Quantity	10
Quantity Uom	S.F.
Potential Action	REPLACE
Urgency of Action	PRIORITY 3
Purpose of Action	LEVEL 2
Deficiency Photo1

Storage Room
Violations	No violations recorded.
Deficiency	METAL PAN: DAMAGED/MISSING
Deficiency Location/Instance	Near Windows
Deficiency Quantity	20
Quantity Uom	S.F.
Potential Action	REPLACE

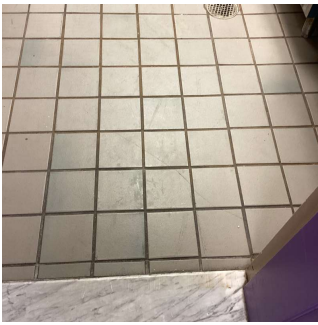
Question	Response
INTERIOR	
KITCHEN	
Floor Finish	
Deficiency Photo1

Violations	Near Main Entrance No violations recorded.
Walls	
Instance on 1st Floor	Inspected
Condition	2 - Between Good and Fair
Deficiency	No deficiencies recorded
LIBRARY	Does not Exist
LOCKER ROOM	Does not Exist
MULTI-PURPOSE ROOM	Does not Exist
SCIENCE DEMO ROOM	Does not Exist
SCIENCE LAB	Does not Exist
SCIENCE PREP ROOM	Does not Exist
SHOWER ROOM	Does not Exist
STAIRS/RAMPS: INTERIOR	Inspected
Do Letter Stair Signs Exist?	Yes
Ceiling	Inspected
Condition	2 - Between Good and Fair
Deficiency	No deficiencies recorded
Door(s)	Inspected
Condition	2 - Between Good and Fair
Deficiency	No deficiencies recorded
Partition	Does not Exist
Railings	Inspected
Condition	2 - Between Good and Fair
Deficiency	No deficiencies recorded
Stairs and Landings	Inspected
Condition	3 - Fair
Deficiency	STONE: BROKEN/MISSING
Deficiency Location/Instance	Stair G/1
Deficiency Quantity	30

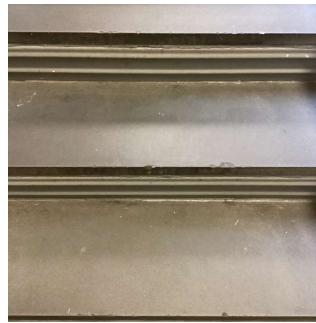
Stair G/1

Quantity Uom	S.F.
Potential Action	REPLACE
Urgency of Action	PRIORITY 3
Purpose of Action	LEVEL 2

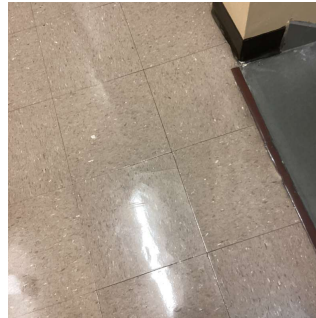
Stair H/2

VINYL TILES: BROKEN/DETERIORATED/MISSING TILES

Stairs G/2, 1, H/2, J/1, Exit 6

70

REPLACE

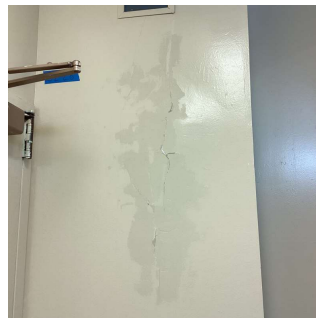
GYPSON BOARD: DETERIORATED

Stairs G/2, H/2, Exit 6

40

REPLACE

Question	Response
INTERIOR	
STAIRS/RAMPS: INTERIOR	Inspected
Walls	Inspected
Stair H/2	Stair H/2
Violations	No violations recorded.
TOILET ROOMS - STAFF	Inspected
Ceiling	Inspected
Condition	2 - Between Good and Fair
Deficiency	No deficiencies recorded
Door(s)	Inspected
Condition	2 - Between Good and Fair
Deficiency	No deficiencies recorded
Floor Finish	Inspected
Condition	5 - Poor
Deficiency	CERAMIC TILE: BROKEN/MISSING TILES
Deficiency Location/Instance	Room 214
Deficiency Quantity	10
Quantity Uom	S.F.
Potential Action	REPLACE
Urgency of Action	PRIORITY 3
Purpose of Action	LEVEL 2
Deficiency Photo1	 
Room 214	Room 214
Violations	No violations recorded.
Stalls	Inspected
Condition	5 - Poor
Deficiency	RUST - MAJOR
Deficiency Location/Instance	Room 123
Deficiency Quantity	1
Quantity Uom	EACH
Potential Action	REPLACE
Urgency of Action	PRIORITY 3
Purpose of Action	LEVEL 2
Deficiency Photo1

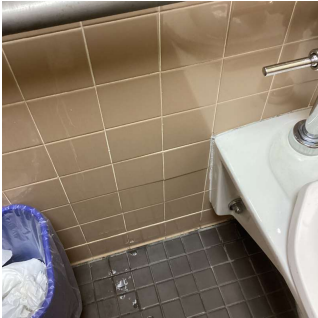
Question	Response
INTERIOR	
TOILET ROOMS - STAFF	Inspected
Stalls	Inspected
	Room 123
Violations	No violations recorded.
Walls	Inspected
Condition	2 - Between Good and Fair
Deficiency	CERAMIC TILE: BROKEN/ MISSING
Deficiency Location/Instance	Room 214
Deficiency Quantity	10
Quantity Uom	S.F.
Potential Action	REPLACE
Urgency of Action	PRIORITY 3
Purpose of Action	LEVEL 2
Deficiency Photo1

Room 214
Violations	No violations recorded.
TOILET ROOMS - STUDENTS	Inspected
Ceiling	Inspected
Condition	2 - Between Good and Fair
Deficiency	No deficiencies recorded
Door(s)	Inspected
Condition	5 - Poor
Deficiency	METAL: DETERIORATED DOOR
Deficiency Location/Instance	Room 113
Deficiency Quantity	1
Quantity Uom	EACH
Potential Action	MAINTENANCE
Urgency of Action	PRIORITY 3
Purpose of Action	LEVEL 2
Deficiency Photo1

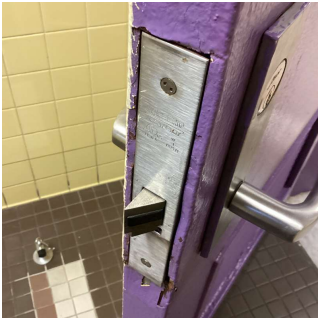
Room 113
Violations	No violations recorded.
Floor Finish	Inspected
