NYC Department of Education
Building Condition Assessment Survey 2023 - 2024

Architectural Inspection

K839

Asset: P.S. 134 MINISCHOOL - BROOKLYN, 4001 18TH AVENUE, New York, 11218

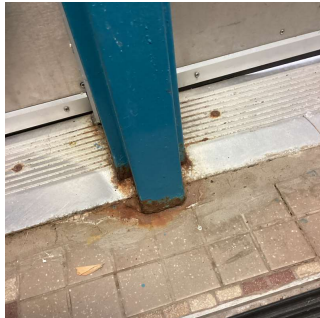
Question	Response
Architectural	
EXTERIOR	Inspected
AREAWAY	Does not Exist
AWNINGS AND CANOPIES	Inspected
Condition	2 - Between Good and Fair
Deficiency	No deficiencies recorded
CHIMNEY	Inspected
Material Type(s)	Metal
Condition	2 - Between Good and Fair
Deficiency	No deficiencies recorded
COPING	Does not Exist
CORNICE	Does not Exist
DOORS	Inspected
DOORS AND FRAMES	Inspected
Condition	5 - Poor
Deficiency	METAL: DETERIORATED DOOR - MINOR DETERIORATION
Roof Plan reference

2
EACH
MAINTENANCE
PRIORITY 3

Question	Response
EXTERIOR	
DOORS	
DOORS AND FRAMES	
Purpose of Action	LEVEL 2
Deficiency Photo1

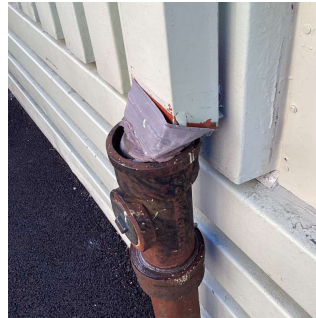
Facade C

LEADERS, GUTTERS, DOWNSPOUTS, SCUPPERS	Inspected
---	-----------

Condition	3 - Fair
-----------	----------

Deficiency	DAMAGED/MISSING
------------	-----------------

30

REPLACE

PRIORITY 4

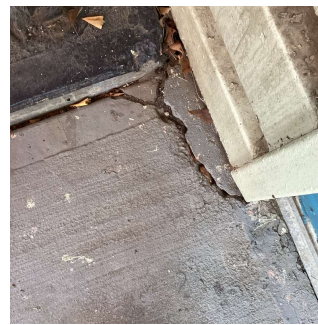
Facade B

Deficiency Photo1	
Violations	Facade D
Deficiency	No violations recorded.
	CONCRETE: CRACKS/SPALLING - MAJOR

10
S.F.
REPLACE
PRIORITY 4
LEVEL 2

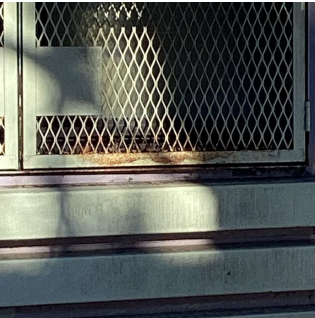
EXTERIOR GUARDS

3 - Fair

DETERIORATED/TORN-OUT/MISSING

Deficiency Quantity	60
Quantity Uom	S.F.
Potential Action	REPLACE
Urgency of Action	PRIORITY 4
Purpose of Action	LEVEL 2
Deficiency Photo1

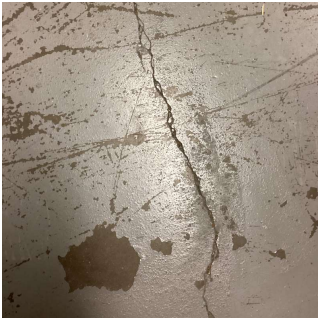
Violations	Facade A No violations recorded.
LINTELS	Does not Exist
WINDOWS	Inspected
Material Type(s)	Aluminum
Instance on Aluminum - Double Hung: Facade A and C	Inspected
Instance Condition	3 - Fair
Instance Quantity	700
Instance Quantity Uom	S.F.
Are these windows insulated	No
Installation Year	1983
Source of Installation	Custodial Staff
Deficiency	No deficiencies recorded
INTERIOR	Inspected
POOLS	Does not Exist
STRUCTURAL	Inspected
COLUMNS/BEAMS/BEARING WALLS	Inspected
Condition	2 - Between Good and Fair
Deficiency	No deficiencies recorded
FLOOR STRUCTURE	Inspected
Condition	3 - Fair
Deficiency	CONCRETE SLAB ON GRADE: THRU CRACKS
Deficiency Location/Instance	1st Floor - Mechanical Room 5

Question	Response
INTERIOR	
STRUCTURAL	
FLOOR STRUCTURE	
Deficiency Quantity	40
Quantity Uom	S.F.
Potential Action	REPLACE
Urgency of Action	PRIORITY 4
Purpose of Action	LEVEL 5
Deficiency Photo1

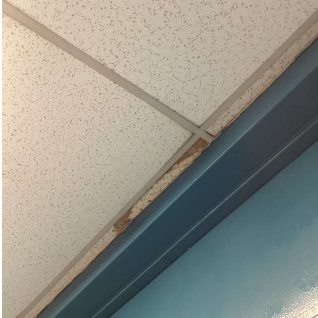
Question	Response
INTERIOR	
CAFETERIA	
Walls	
Condition	2 - Between Good and Fair
Deficiency	No deficiencies recorded
Window Curtains/Shades/Blinds	
Instance on 1st Floor (600 SF)	Does not Exist
CLASSROOMS/CORRIDORS/ADMIN SPACES	
Ceiling	Inspected
Condition	2 - Between Good and Fair
Deficiency	ACOUSTIC TILES: DAMAGED/MISSING
Deficiency Location/Instance	Exit 2 - Vestibule, Corridor near Exit 1, by Room 1M9
Deficiency Quantity	40
Quantity Uom	S.F.
Potential Action	REPLACE
Urgency of Action	PRIORITY 3
Purpose of Action	LEVEL 2
Deficiency Photo1

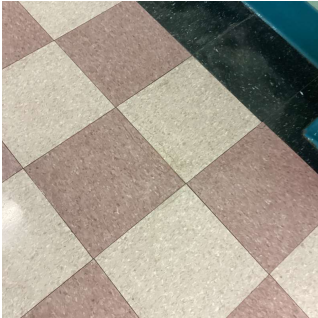
Corridor near Exit 1

Violations	Exit 2 - Vestibule No violations recorded.
Door(s)	Inspected
Condition	2 - Between Good and Fair
Deficiency	No deficiencies recorded
Floor Finish	
Condition	2 - Between Good and Fair
Deficiency	VINYL TILES: DETERIORATED SUBSTRATE
Deficiency Location/Instance	Corridor near Exit 1, by Room SS-M
Deficiency Quantity	20
Quantity Uom	S.F.
Potential Action	REPLACE
Urgency of Action	PRIORITY 3

Purpose of Action	LEVEL 2
Deficiency Photo1

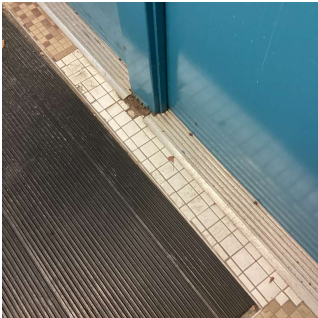
Question	Response
INTERIOR	
CLASSROOMS/CORRIDORS/ADMIN SPACES	
Floor Finish	
Violations	No violations recorded.
Deficiency	CERAMIC TILE: BROKEN/MISSING TILES
Deficiency Location/Instance	Exits 1, 2, 3 - Vestibules
Deficiency Quantity	30
Quantity Uom	S.F.
Potential Action	REPLACE
Urgency of Action	PRIORITY 3
Purpose of Action	LEVEL 2
Deficiency Photo1

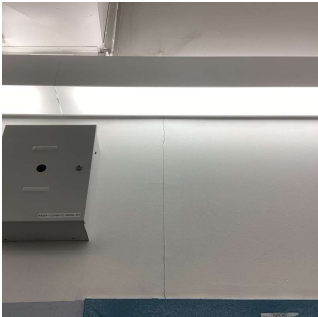
Violations	Exit 2 - Vestibule No violations recorded.
Walls	Inspected
Condition	2 - Between Good and Fair
Deficiency	GYPSUM BOARD: DETERIORATED
Deficiency Location/Instance	Corridor near Rooms M06, MC05, 7, 3
Deficiency Quantity	60
Quantity Uom	S.F.
Potential Action	REPLACE
Urgency of Action	PRIORITY 3
Purpose of Action	LEVEL 2
Deficiency Photo1

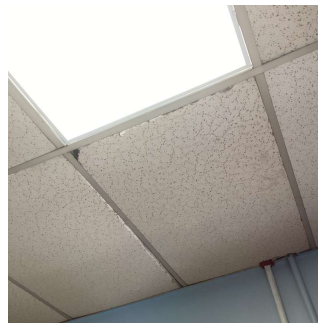
Condition	3 - Fair
-----------	----------

Deficiency	ACOUSTIC TILES: DAMAGED/MISSING
------------	---------------------------------

Deficiency Location/Instance	Near Servery
------------------------------	--------------

Deficiency Quantity	10
---------------------	----

Potential Action	REPLACE
------------------	---------

Urgency of Action	PRIORITY 3
-------------------	------------

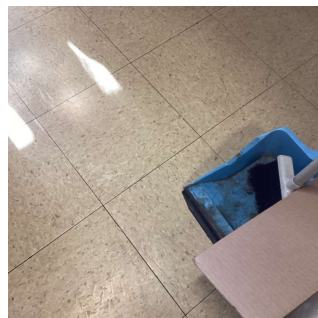
Condition	3 - Fair
-----------	----------

Deficiency	VINYL TILES: BROKEN/DETERIORATED/MISSING TILES
------------	--

Deficiency Location/Instance	Near Servery
------------------------------	--------------

Deficiency Quantity	10
---------------------	----

Potential Action	REPLACE
------------------	---------

Urgency of Action	PRIORITY 3
-------------------	------------

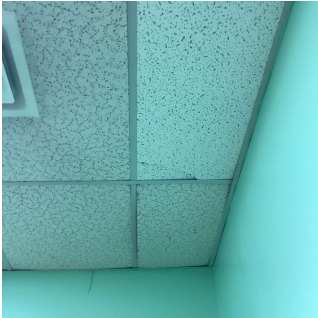
Question	Response
INTERIOR	
KITCHEN	Inspected
Walls	
Instance on 1st Floor (300 SF)	Inspected
Condition	2 - Between Good and Fair
Deficiency	No deficiencies recorded
LIBRARY	Does not Exist
LOCKER ROOM	Does not Exist
MULTI-PURPOSE ROOM	Does not Exist
SCIENCE DEMO ROOM	Does not Exist
SCIENCE LAB	Does not Exist
SCIENCE PREP ROOM	Does not Exist
SHOWER ROOM	Does not Exist
STAIRS/RAMPS: INTERIOR	Does not Exist
TOILET ROOMS - STAFF	Inspected
Ceiling	Inspected
Condition	5 - Poor
Deficiency	ACOUSTIC TILES: DAMAGED/MISSING
Deficiency Location/Instance	Rooms M06C, M06B
Deficiency Quantity	20
Quantity Uom	S.F.
Potential Action	REPLACE
Urgency of Action	PRIORITY 3
Purpose of Action	LEVEL 2
Deficiency Photo1

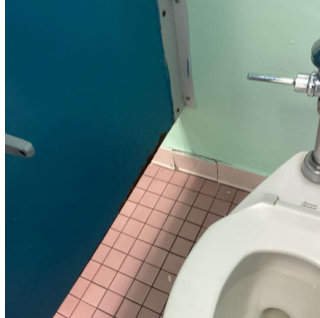
Question	Response
INTERIOR	
TOILET ROOMS - STAFF	
Walls	
Urgency of Action	PRIORITY 3
Purpose of Action	LEVEL 2
Deficiency Photo1	 
	Room M06B
Violations	No violations recorded.
TOILET ROOMS - STUDENTS	
	Inspected
Ceiling	Inspected
Condition	2 - Between Good and Fair
Deficiency	ACOUSTIC TILES: DAMAGED/MISSING
Deficiency Location/Instance	Room M06A
Deficiency Quantity	10
Quantity Uom	S.F.
Potential Action	REPLACE
Urgency of Action	PRIORITY 3
Purpose of Action	LEVEL 2
Deficiency Photo1	 
	Room M06A
Violations	No violations recorded.
Door(s)	Inspected
Condition	2 - Between Good and Fair
Deficiency	No deficiencies recorded
Floor Finish	Inspected
Condition	2 - Between Good and Fair
Deficiency	No deficiencies recorded
Stalls	Inspected
Condition	5 - Poor
Deficiency	RUST - MAJOR
Deficiency Location/Instance	Room M06A
Deficiency Quantity	4
Quantity Uom	EACH
Potential Action	REPLACE

Question	Response
INTERIOR	
TOILET ROOMS - STUDENTS	
Stalls	
Urgency of Action	PRIORITY 3
Purpose of Action	LEVEL 2
Deficiency Photo1

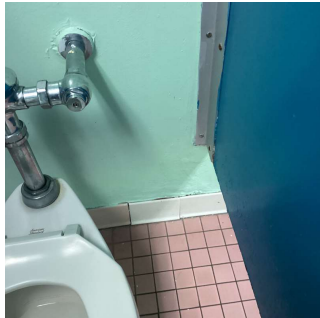
Violations	Room M06A No violations recorded.
Walls	
Condition	Inspected 2 - Between Good and Fair
Deficiency	GYPSUM BOARD: DETERIORATED
Deficiency Location/Instance	Room M06A
Deficiency Quantity	10
Quantity Uom	S.F.
Potential Action	REPLACE
Urgency of Action	PRIORITY 3
Purpose of Action	LEVEL 2
Deficiency Photo1
