NYC Department of Education
Building Condition Assessment Survey 2023 - 2024

Architectural Inspection

Asset: P.S. 241 MINISCHOOL - BROOKLYN, 976 PRESIDENT STREET, New York, 11225

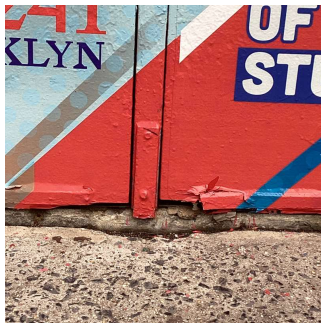
Question	Response
Architectural	
EXTERIOR	Inspected
AREAWAY	Does not Exist
AWNINGS AND CANOPIES	Does not Exist
CHIMNEY	Does not Exist
COPING	Does not Exist
CORNICE	Does not Exist
DOORS	Inspected
DOORS AND FRAMES	Inspected
Condition	5 - Poor

METAL: DETERIORATED DOOR - MAJOR DETERIORATION

Violations	Facade A - Main Entrance No violations recorded.
DOOR HARDWARE	Inspected
Condition	3 - Fair
Deficiency	No deficiencies recorded
LINTELS	Does not Exist
TRANSOM/SIDE LIGHT	Does not Exist
EXTERIOR WALLS	Inspected
Material Type(s)	Steel
Replacement Quantity	5,500
Replacement Uom	S.F.
Instance on All Facades	Inspected
Instance Condition	2 - Between Good and Fair
Instance Quantity	5,500
Instance Quantity Uom	S.F.
Deficiency	No deficiencies recorded
EXTERIOR SOFFITS	Inspected
Condition	2 - Between Good and Fair
Deficiency	No deficiencies recorded
LOADING DOCK	Does not Exist
LOUVER	Inspected
Condition	2 - Between Good and Fair
Deficiency	No deficiencies recorded
PARAPETS	Does not Exist
PLAZA DECK	Does not Exist
ROOF	Inspected
Roofing	Inspected
Replacement Quantity	8,300
Replacement Uom	S.F.
ROOF HATCH/SMOKE HATCH	Does not Exist
LEADERS, GUTTERS, DOWNSPOUTS, SCUPPERS	Inspected

Deficiency Quantity

2

Potential Action

REPLACE

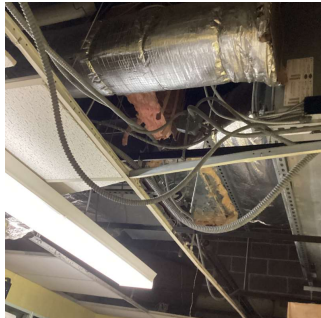
Question	Response
EXTERIOR	
ROOF	
Roofing	
ROOFING	
Instance Condition	4 - Between Fair and Poor
Instance Photo

Roof 1
Instance Quantity	8,300
Instance Quantity Uom	S.F.
Does the roof have major mechanical equipment sitting on Dunnage Steel less than 18" above the Roofing?	No
Does this roof instance have a Sustainable Roof System?	No
Do solar panels exist on these roofs?	No
Is/Are the roof(s) suitable for Solar Panel installation?	No
Installation Year	1969
Source of Installation	Custodial Staff
Deficiency	METAL: ROOFING: MAJOR ACTIVE ROOF LEAKS IN NON-INSTRUCTIONAL SPACE
Roof Plan reference	<p align="center">K840</p>

Violations	Roof 1 - MER Room 8 (2 locations) No violations recorded.
ROOFING DRAINS	Does not Exist
Specialties	Does not Exist

Deficiency Quantity	200
Quantity Uom	S.F.
Potential Action	REPLACE
Urgency of Action	PRIORITY 5
Purpose of Action	LEVEL 2
Deficiency Photo1

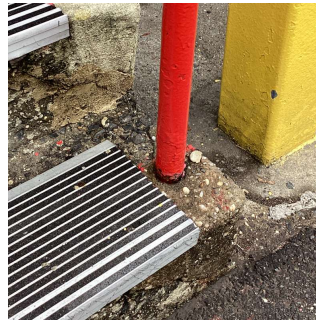
Facade A - Main Entrance

RAILINGS	Inspected
-----------------	-----------

Condition	3 - Fair
-----------	----------

Deficiency	RUST - MAJOR
------------	--------------

Potential Action

REPLACE

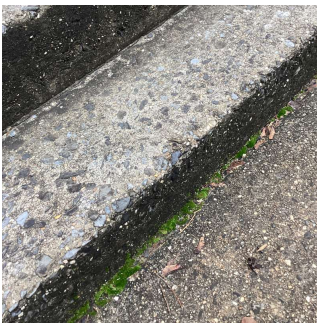
STAIRS/RAMPS	Inspected
---------------------	-----------

Condition	5 - Poor
-----------	----------

Deficiency	CONCRETE: WORN-OUT TREAD/RISER/NOSING
------------	---------------------------------------

Violations	Facade D - Exit 3 No violations recorded.
Deficiency	CONCRETE: CRACKS/SPALLING - MAJOR
Roof Plan reference	K840

Potential Action

REPLACE

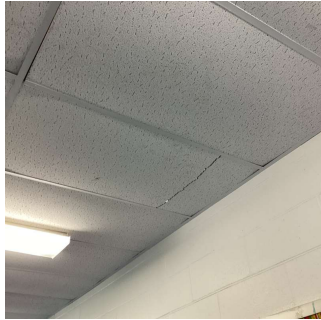
Condition	2 - Between Good and Fair
Deficiency	ACOUSTIC TILES: DAMAGED/MISSING
Deficiency Location/Instance	Room 18, Exit 3, Corridor near Room 15
Deficiency Quantity	15
Quantity Uom	S.F.
Potential Action	REPLACE
Urgency of Action	PRIORITY 3
Purpose of Action	LEVEL 2
Deficiency Photo1

Violations	Corridor near Room 15 No violations recorded.

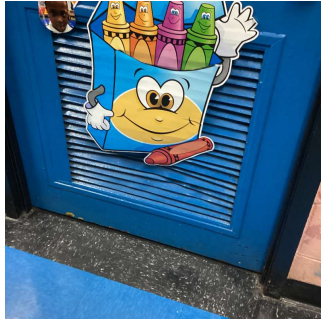
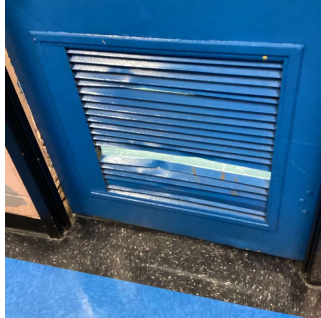
Room 20

Condition	Inspected 5 - Poor
Deficiency	METAL: DAMAGED LOUVER
Deficiency Location/Instance	Room 20, 18, 17, 16, 15, 14
Deficiency Quantity	6
Quantity Uom	EACH
Potential Action	MAINTENANCE
Urgency of Action	PRIORITY 3
Purpose of Action	LEVEL 2
Deficiency Photo1

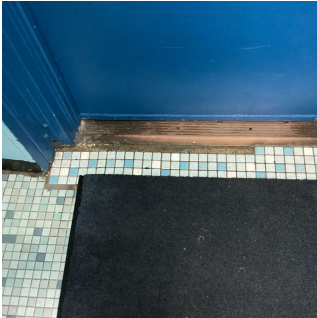
Question	Response
INTERIOR	
CLASSROOMS/CORRIDORS/ADMIN SPACES	
Door(s)	Inspected
	Room 15
Violations	No violations recorded.
Floor Finish	Inspected
Condition	2 - Between Good and Fair
Deficiency	CERAMIC TILE: BROKEN/MISSING TILES
Deficiency Location/Instance	Main Entrance Vestibule
Deficiency Quantity	10
Quantity Uom	S.F.
Potential Action	REPLACE
Urgency of Action	PRIORITY 3
Purpose of Action	LEVEL 2
Deficiency Photo1

Violations	Main Entrance Vestibule No violations recorded.
Deficiency	VINYL TILES: BROKEN/DETERIORATED/MISSING TILES
Deficiency Location/Instance	Room 20, 16, 14
Deficiency Quantity	10
Quantity Uom	S.F.
Potential Action	REPLACE
Urgency of Action	PRIORITY 3
Purpose of Action	LEVEL 2
Deficiency Photo1

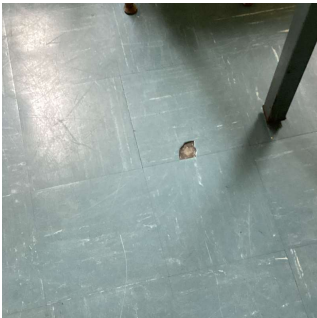
Violations	Room 16 No violations recorded.
Deficiency	VINYL TILES: DETERIORATED SUBSTRATE
Deficiency Location/Instance	Main Entrance Lobby, Room 2, Corridor near Room 2
Deficiency Quantity	50
Quantity Uom	S.F.

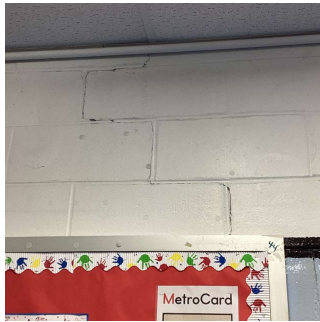
Room 2
Violations	No violations recorded.
Walls	Inspected
Condition	2 - Between Good and Fair
Deficiency	MASONRY: CRACKS/SPALLING
Deficiency Location/Instance	Corridor near Room 18
Deficiency Quantity	10
Quantity Uom	S.F.
Potential Action	REPLACE
Urgency of Action	PRIORITY 4
Purpose of Action	LEVEL 4
Deficiency Photo1

Corridor near Room 18
Violations	35672377J
Specialties	Does not Exist
GYMNASIUM	Does not Exist
INTERIOR DOOR HARDWARE	Inspected
Condition	3 - Fair
Deficiency	No deficiencies recorded
INTERIOR GUARDS	Does not Exist

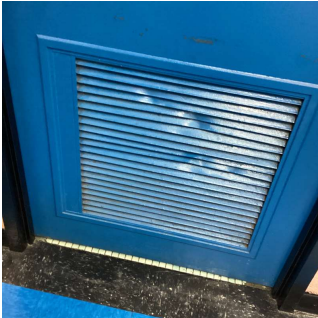
Question	Response
INTERIOR	
KITCHEN	Does not Exist
LIBRARY	Does not Exist
LOCKER ROOM	Does not Exist
MULTI-PURPOSE ROOM	Does not Exist
SCIENCE DEMO ROOM	Does not Exist
SCIENCE LAB	Does not Exist
SCIENCE PREP ROOM	Does not Exist
SHOWER ROOM	Does not Exist
STAIRS/RAMPS: INTERIOR	Does not Exist
TOILET ROOMS - STAFF	Inspected
Ceiling	Inspected
Condition	2 - Between Good and Fair
Deficiency	No deficiencies recorded
Door(s)	Inspected
Condition	5 - Poor
Deficiency	METAL: DAMAGED LOUVER
Deficiency Location/Instance	1st Floor - Women, Men's
Deficiency Quantity	2
Quantity Uom	EACH
Potential Action	MAINTENANCE
Urgency of Action	PRIORITY 3
Purpose of Action	LEVEL 2
Deficiency Photo1

Violations	1st Floor - Women No violations recorded.
Floor Finish	Inspected
Condition	4 - Between Fair and Poor
Deficiency	CERAMIC TILE: BROKEN/MISSING TILES
Deficiency Location/Instance	1st Floor - Women, Men's
Deficiency Quantity	10
Quantity Uom	S.F.
