**NYC Department of Education**  
**Building Condition Assessment Survey 2023 - 2024**

Architectural Inspection

**K842**

**Asset: P.S. 45 AX (OLD BS RDGWD ECC1)-K, 1160 DECATUR STREET, New York, 11207**

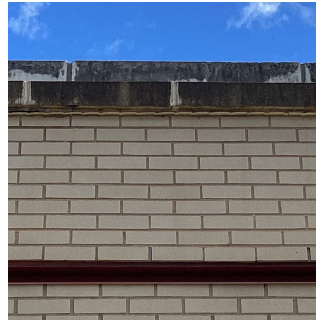
Facade

Question	Response
<b>Architectural</b>	
<b>EXTERIOR</b>	Inspected
<b>AREAWAY</b>	Does not Exist
<b>AWNINGS AND CANOPIES</b>	Inspected
Condition	2 - Between Good and Fair
Deficiency	No deficiencies recorded
<b>CHIMNEY</b>	Does not Exist
<b>COPING</b>	Inspected
Condition	3 - Fair
Deficiency	CAST STONE: DETERIORATED TRANSVERSE JOINTS
Roof Plan reference	K842

60  
 L.F.  
 MAINTENANCE  
 PRIORITY 3  
 LEVEL 2

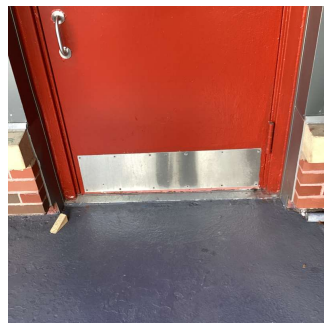
METAL CLAD: DETERIORATED DOOR AND FRAME - MINOR DETERIORATION

Deficiency Quantity	2
Quantity Uom	EACH
Potential Action	MAINTENANCE
Urgency of Action	PRIORITY 3
Purpose of Action	LEVEL 2
Deficiency Photo1

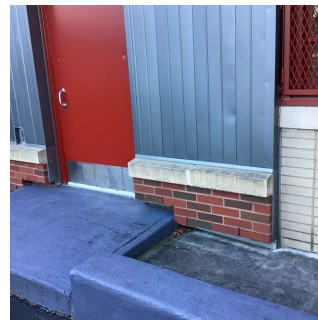
Facade G

Violations	Exit 2, 4 No violations recorded.
<b>DOOR HARDWARE</b>	Inspected
Condition	2 - Between Good and Fair
Deficiency	No deficiencies recorded
<b>LINTELS</b>	Inspected
Condition	2 - Between Good and Fair
Deficiency	No deficiencies recorded
<b>TRANSOM/SIDE LIGHT</b>	Inspected
Condition	2 - Between Good and Fair
Deficiency	No deficiencies recorded
<b>EXTERIOR WALLS</b>	Inspected
Material Type(s)	Masonry, Steel
Replacement Quantity	6,500
Replacement Uom	S.F.
Instance on All Facades	Inspected
Instance Condition	3 - Fair
Instance Quantity	6,500
Instance Quantity Uom	S.F.
Deficiency	METAL PANEL: SEVERE DENTS

REPLACE

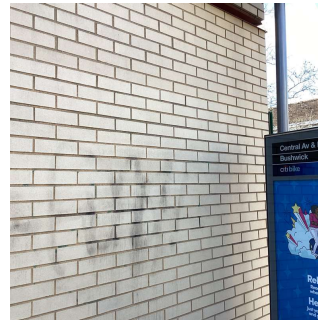
Facade C

BRICK: DETERIORATED JOINTS

REPOINT

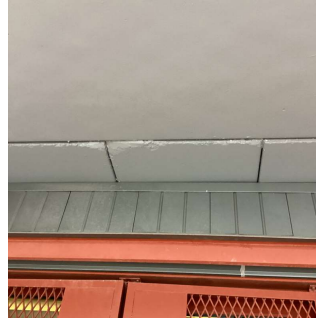
Facade H

STUCCO/PLASTER: MINOR CRACKS/SPALLING

Quantity Uom	S.F.
Potential Action	REPAIR
Urgency of Action	PRIORITY 3
Purpose of Action	LEVEL 2
Deficiency Photo1

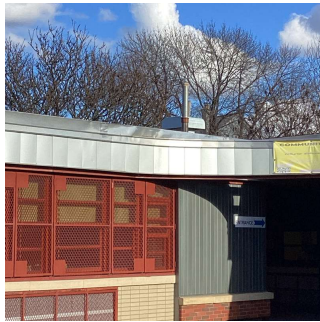
Question	Response
<b>EXTERIOR</b>	
<b>ROOF</b>	
<b>Roofing</b>	
<b>ROOFING</b>	
Deficiency	BUILT-UP: FLASHING: DRIP EDGE/GRAVEL STOP DAMAGED
Roof Plan reference	K842

Deficiency Quantity	10
Quantity Uom	L.F.
Potential Action	REPLACE
Urgency of Action	PRIORITY 4
Purpose of Action	LEVEL 2
Deficiency Photo1

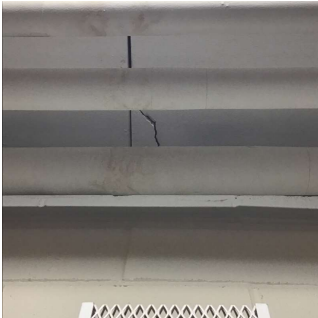
<b>VAULTS-BUNKERS</b>	Does not Exist
<b>AUDITORIUM</b>	Does not Exist
<b>CAFETERIA</b>	Does not Exist
<b>CLASSROOMS/CORRIDORS/ADMIN SPACES</b>	Inspected
<b>Ceiling</b>	Inspected
Condition	2 - Between Good and Fair
Deficiency	PLASTER: CRACKS/SPALLING
Deficiency Location/Instance	Room 108/109
Deficiency Quantity	10
Quantity Uom	S.F.
Potential Action	REPLACE
Urgency of Action	PRIORITY 3
Purpose of Action	LEVEL 2
Deficiency Photo1

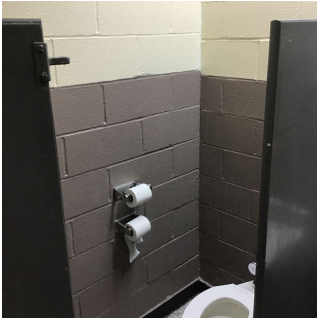
Question	Response
<b>INTERIOR</b>	
<b>TOILET ROOMS - STAFF</b>	
<b>Stalls</b>	
Deficiency	BROKEN/MISSING
Deficiency Location/Instance	1st Floor - Women
Deficiency Quantity	1
Quantity Uom	EACH
Potential Action	REPLACE
Urgency of Action	PRIORITY 3
Purpose of Action	LEVEL 2
Deficiency Photo1

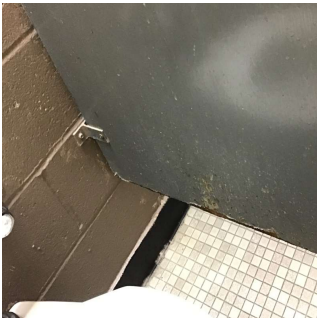
1st Floor - Women
Violations	No violations recorded.
Deficiency	RUST - MAJOR
Deficiency Location/Instance	1st Floor - Women
Deficiency Quantity	1
Quantity Uom	EACH
Potential Action	REPLACE
Urgency of Action	PRIORITY 3
Purpose of Action	LEVEL 2
Deficiency Photo1

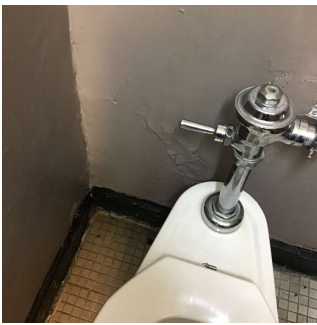
1st Floor - Women
Violations	No violations recorded.
<b>Walls</b>	Inspected
Condition	2 - Between Good and Fair
Deficiency	PLASTER: CRACKS/SPALLING
Deficiency Location/Instance	1st Floor - Gender Neutral
Deficiency Quantity	10
Quantity Uom	S.F.
Potential Action	REPLACE
Urgency of Action	PRIORITY 3
Purpose of Action	LEVEL 2

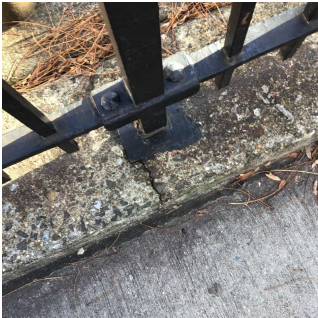
<b>DRINKING FOUNTAINS</b>	Does not Exist
<b>FENCES</b>	Inspected
Condition	2 - Between Good and Fair
Deficiency	CONCRETE CURB: DAMAGED/DETERIORATED

Question	Response
<b>SITE</b>	
<b>FENCES</b>	
Deficiency Location/Instance	Along Decatur Street
Deficiency Quantity	10
Quantity Uom	S.F.
Potential Action	REPLACE
Urgency of Action	PRIORITY 3
Purpose of Action	LEVEL 2
Deficiency Photo1

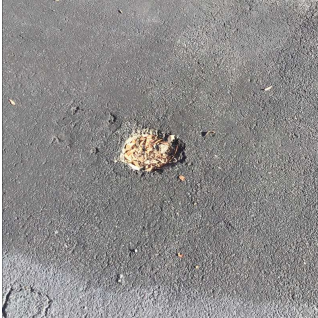
Violations	Along Decatur Street No violations recorded.
<b>IRRIGATION SYSTEM</b>	Does not Exist
<b>PAVING</b>	Inspected
<b>Student Non-Use</b>	Inspected
Gravel Exists?	No
<b>Asphalt</b>	Inspected
Condition	4 - Between Fair and Poor
Deficiency	POTHoles
Deficiency Location/Instance	Near exit 2
Deficiency Quantity	10
Quantity Uom	S.F.
Potential Action	REPAIR
Urgency of Action	PRIORITY 3
Purpose of Action	LEVEL 2
Deficiency Photo1

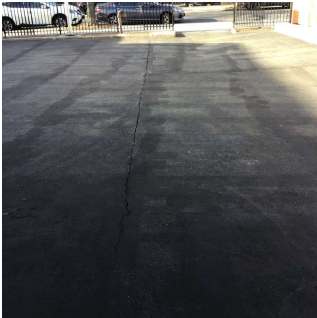
Violations	Near exit 2 No violations recorded.
Deficiency	CRACKS - MAJOR
Deficiency Location/Instance	Near exit 2
Deficiency Quantity	500
Quantity Uom	S.F.
Potential Action	REPLACE
Urgency of Action	PRIORITY 3
Purpose of Action	LEVEL 2

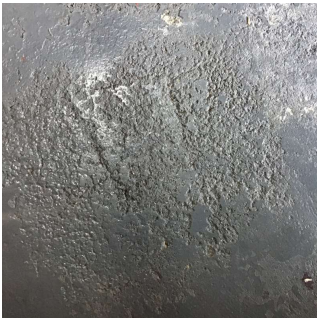
Violations	Near exit 2 No violations recorded.
<b>Concrete</b>	Inspected
Condition	2 - Between Good and Fair
Deficiency	No deficiencies recorded
<b>Pavers</b>	Does not Exist
<b>Student Use</b>	Does not Exist
<b>Site Sidewalks &amp; Walkways</b>	Inspected
<b>Asphalt</b>	Inspected
Condition	2 - Between Good and Fair
Deficiency	No deficiencies recorded
<b>Concrete</b>	Inspected
Condition	3 - Fair
Deficiency	DAMAGED/DETERIORATED/MISSING SECTIONS
Deficiency Location/Instance	Near exit 1, exit 3
Deficiency Quantity	50
Quantity Uom	S.F.
Potential Action	REPLACE
Urgency of Action	PRIORITY 3
Purpose of Action	LEVEL 2
Deficiency Photo1

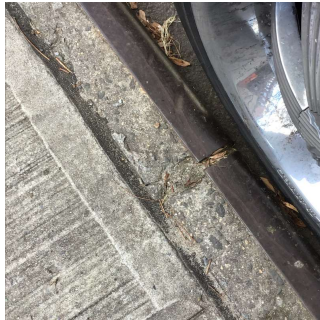
Question	Response
<b>SITE</b>	
<b>PAVING</b>	
<b>DOT Sidewalk</b>	
<b>Concrete</b>	
Deficiency	DAMAGED CURBS
Deficiency Location/Instance	Along Central Avenue
Deficiency Quantity	25
Quantity Uom	L.F.
Potential Action	REPLACE
Urgency of Action	PRIORITY 4
Purpose of Action	LEVEL 4
Deficiency Photo1

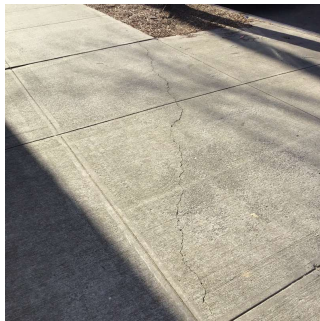
Violations	Along Central Avenue 48528
Deficiency	DAMAGED/DETERIORATED/MISSING SECTIONS
Deficiency Location/Instance	Along Decatur Street, Central Avenue
Deficiency Quantity	425
Quantity Uom	S.F.
Potential Action	REPLACE
Urgency of Action	PRIORITY 4
Purpose of Action	LEVEL 4
Deficiency Photo1
