NYC Department of Education
Building Condition Assessment Survey 2023 - 2024

Architectural Inspection

Asset: P.S. 149 ANNEX - BROOKLYN, 373 PENNSYLVANIA AVENUE, New York, 11207

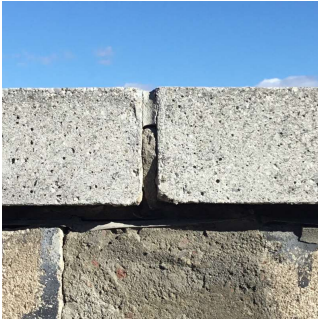
| Question | Response |
|---|--|
| Condition | 3 - Fair |
| Deficiency | CAST STONE: DETERIORATED TRANSVERSE JOINTS |

| Potential Action | MAINTENANCE |
| Urgency of Action | PRIORITY 3 |

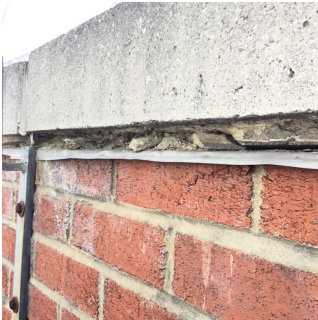
| Question | Response |
|---|--|
| Deficiency | CAST STONE: DETERIORATED BED JOINT |

| Question | Response |
|---|--|
| Potential Action | REPOINT |
| Urgency of Action | PRIORITY 3 |

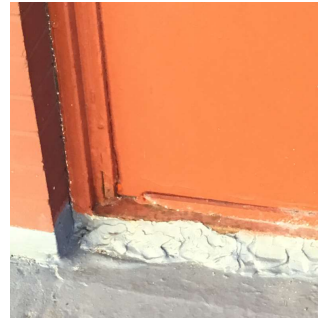
Facade G

3 - Fair

METAL: DENTED, MAJOR RUSTING

15
 S.F.
 REPLACE
 PRIORITY 4
 LEVEL 2

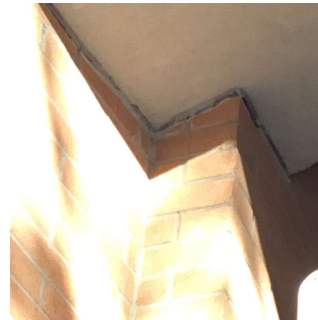
Facade A

3 - Fair

BRICK: MINOR CRACKS AND SPALLING

RESTITCH

PRIORITY 3

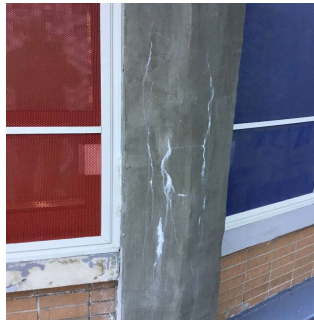
Facade D

CAST IN PLACE / PRE-CAST CONCRETE: MAJOR
 CRACKS/SPALLING

REPLACE

PRIORITY 4

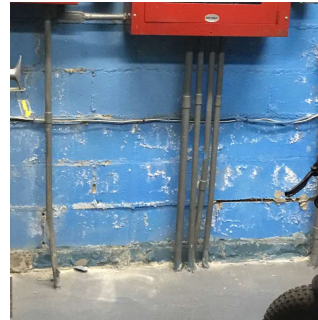
Facade E - Electrical Panel Room

CONCRETE MASONRY UNIT: MINOR CRACKS AND SPALLING

RESTITCH

PRIORITY 3
LEVEL 2

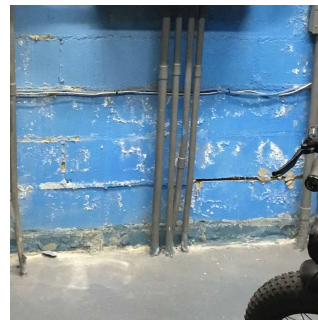
Facade E - Electrical Panel Room

CONCRETE MASONRY UNIT: DETERIORATED JOINTS

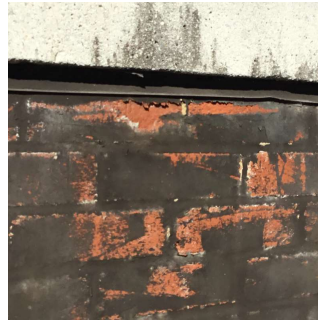
Roof 1

| Instance Condition | 5 - Poor |
| Deficiency | BRICK: MINOR CRACKS, SPALLING |

| Potential Action | REPAIR |

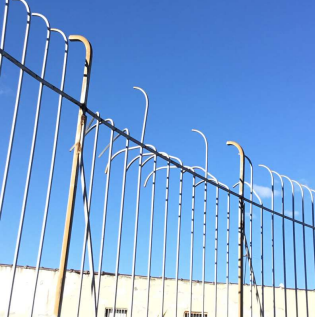
| Question | Response |
|---|--|
| | <p>Roof 1</p> |

| Question | Response |
|---|--|
| Deficiency | BEAR CLAW/METAL BAR: DETERIORATED, MAJOR RUSTING |

| Question | Response |
|---|--|
| Potential Action | REPLACE |
| Urgency of Action | PRIORITY 4 |

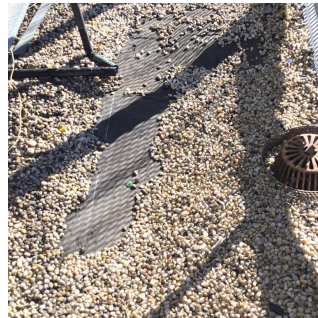
Roof 1

| Deficiency | BUILT-UP: ROOFING: LOSS OF GRAVEL |

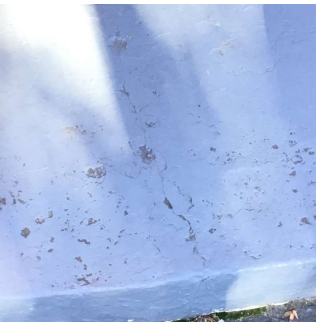
| Question | Response |
|---|--|
| Violations | Facade B No violations recorded. |

| Question | Response |
|---|--|
| Condition | 5 - Poor |
| Deficiency | CONCRETE: CRACKS/SPALLING - MINOR |

| Question | Response |
|---|--|
| Potential Action | REPAIR |
| Urgency of Action | PRIORITY 3 |

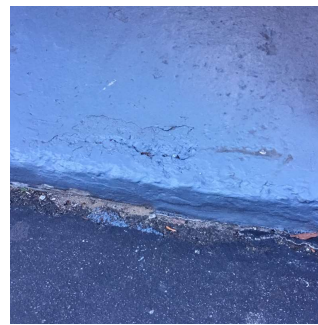
Facade D

| Question | Response |
|---|--|
| Deficiency | CONCRETE: CRACKS/SPALLING - MAJOR |

30
S.F.
REPLACE
PRIORITY 4
LEVEL 2

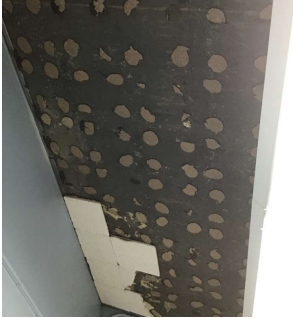
| Question | Response |
|--|--|
| | Room 103 |

| Question | Response |
|--|--|
| Deficiency | ACOUSTIC TILES ON PLASTER: DAMAGED/MISSING |
| Deficiency Location/Instance | Rooms 103, 105, 106, 108, |

| Question | Response |
|--|--|
| Potential Action | REPLACE |
| Urgency of Action | PRIORITY 3 |

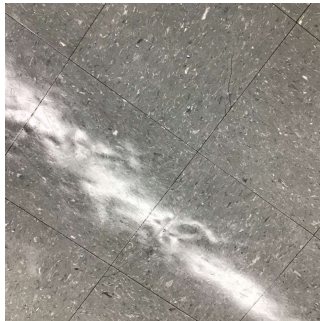
| Question | Response |
|--|--|
| | Room 103 |

| Question | Response |
|--|--|
| Deficiency | VINYL TILES: BROKEN/DETERIORATED/MISSING TILES |
| Deficiency Location/Instance | Room 103, 105, 106, 108 |

| Question | Response |
|--|--|
| Potential Action | REPLACE |

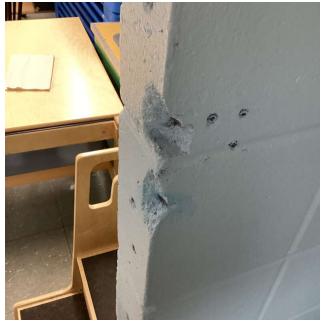
| Question | Response |
|--|--|
| | Room 108 |

| Question | Response |
|--|--|
| Deficiency | MASONRY: CRACKS/SPALLING |
| Deficiency Location/Instance | Rooms 103, 106, 108 |

| Question | Response |
|--|--|
| Potential Action | REPLACE |
| Urgency of Action | PRIORITY 3 |

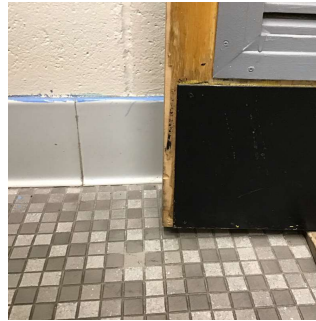
1st Floor - Men

| Question | Response |
|---|--|
| Condition | 5 - Poor |
| Deficiency | WOOD: DETERIORATED DOOR |
| Deficiency Location/Instance | 1st Floor - Men, Women |

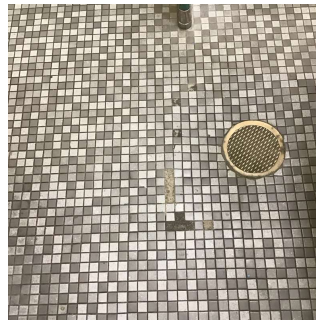
1st Floor - Men

CERAMIC TILE: BROKEN/MISSING TILES

REPLACE

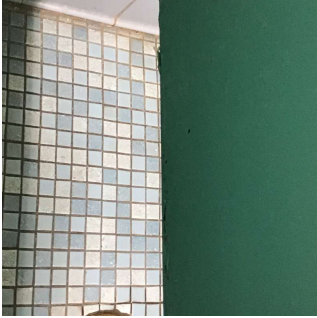
| Question | Response |
|---|--|
| | Room 103 |

| Question | Response |
|---|--|
| Condition | 5 - Poor |
| Deficiency | RUST - MAJOR |
| Deficiency Location/Instance | Rooms 103, 105, 106, 108 |

| Question | Response |
|---|--|
| Potential Action | REPLACE |
| Urgency of Action | PRIORITY 3 |

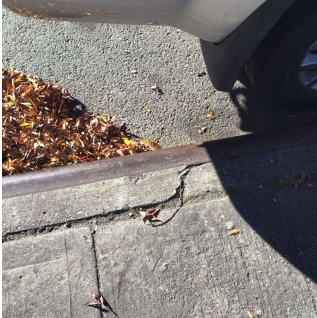
| Question | Response |
|---|--|
| Deficiency | DAMAGED CURBS |
| Deficiency Location/Instance | Along Pennsylvania Avenue |

| Question | Response |
|---|--|
| Potential Action | REPLACE |
| Urgency of Action | PRIORITY 4 |

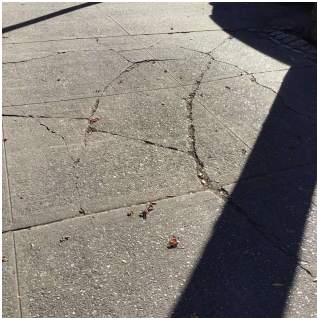
| Question | Response |
|---|--|
| Deficiency | DAMAGED/DETERIORATED/MISSING SECTIONS |
| Deficiency Location/Instance | Along Pennsylvania Avenue |

| Question | Response |
|---|--|
| Potential Action | REPLACE |
| Urgency of Action | PRIORITY 4 |
