NYC Department of Education
Building Condition Assessment Survey 2023 - 2024

Architectural Inspection

Asset: P.S. 134 - BROOKLYN, 4001 18 AVENUE, New York, 11218

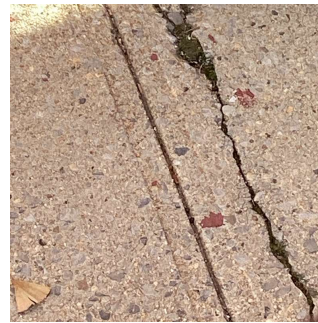
AW1

AREAWAY SLAB: CRACKS AND SPALLING

REPLACE

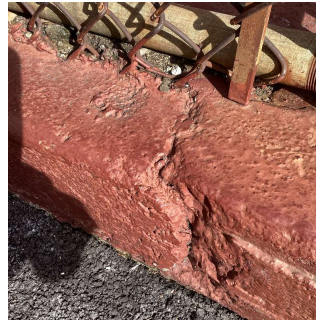
AW1

AREAWAY WALLS: CRACKS AND SPALLING

REPLACE

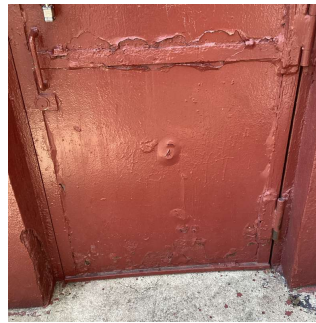
Facade C

METAL: DETERIORATED DOOR - MINOR DETERIORATION

1
EACH
MAINTENANCE
PRIORITY 3
LEVEL 2

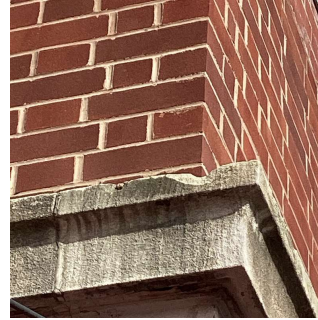
Facade C

TERRA COTTA: CHIPPED/SPALLED/BROKEN PIECES - MINOR

S.F.
REPAIR
PRIORITY 3
LEVEL 2

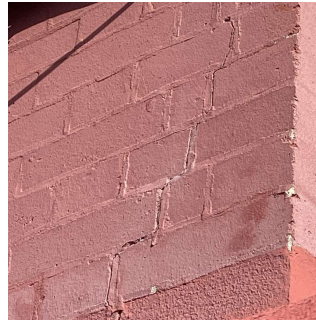
Facade D

BRICK: MINOR CRACKS AND SPALLING

10
S.F.
RESTITCH
PRIORITY 3
LEVEL 2

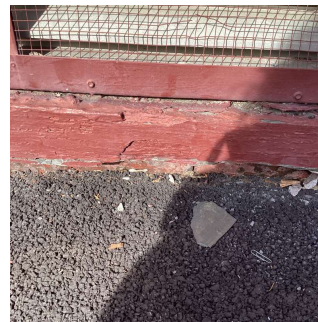
Facade C

BRICK: DETERIORATED MASONRY SILLS - MAJOR

REMOVE AND REPLACE

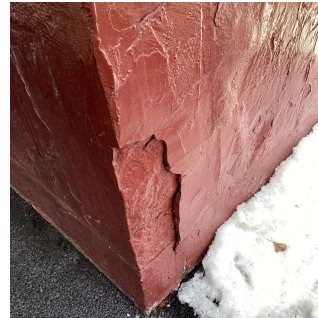
Facade C

STONE: CRACKS AT BUILDING CORNERS

REPLACE

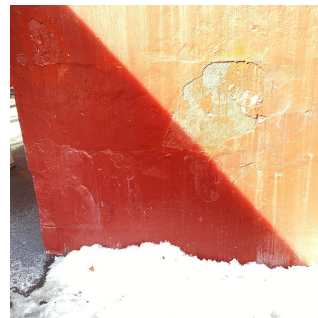
Facade C

STONE: CHIPPED/SPALLED/BROKEN PIECES - MAJOR

REPLACE

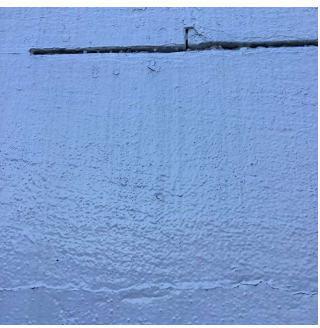
Question	Response
EXTERIOR	
EXTERIOR WALLS	
Violations	No violations recorded.
Deficiency	STONE: DETERIORATED JOINTS
Roof Plan reference	<p>K849</p>

Deficiency Quantity	40
Quantity Uom	L.F.
Potential Action	REPOINT
Urgency of Action	PRIORITY 4
Purpose of Action	LEVEL 2
Deficiency Photo1

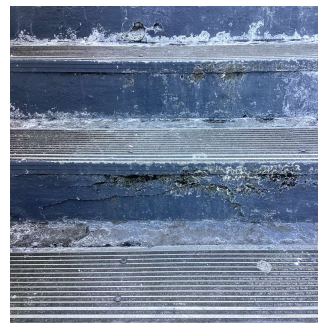
Facade A

CONCRETE: WORN-OUT TREAD/RISER/NOSING

20
S.F.
REPLACE
PRIORITY 4
LEVEL 2

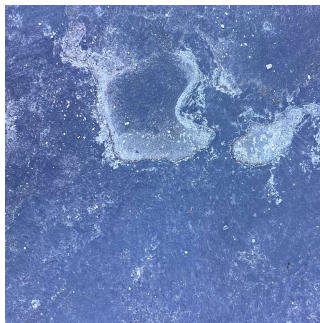
CONCRETE: CRACKS/SPALLING - MINOR

10
S.F.
REPAIR
PRIORITY 3
LEVEL 2

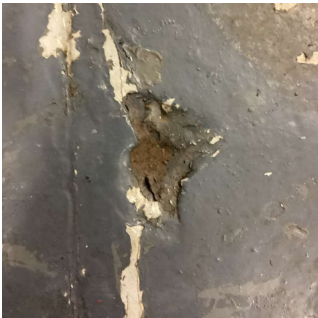
Basement - Boiler Room
Violations	No violations recorded.
FLOOR STRUCTURE	
	Inspected
Condition	4 - Between Fair and Poor
Deficiency	CONCRETE SLAB ON GRADE: THRU CRACKS
Deficiency Location/Instance	Basement - Boiler Room, Storage
Deficiency Quantity	120
Quantity Uom	S.F.
Potential Action	REPLACE
Urgency of Action	PRIORITY 4
Purpose of Action	LEVEL 5
Deficiency Photo1

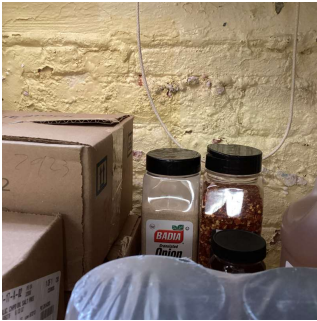
Basement - Boiler Room
Violations	No violations recorded.
FOUNDATION WALLS	
	Inspected
Material Type(s)	Concrete, Masonry
Condition	4 - Between Fair and Poor
Deficiency	BRICK: WATER INFILTRATION IN INSTRUCTIONAL SPACE
Deficiency Location/Instance	Basement - Kitchen
Deficiency Quantity	100
Quantity Uom	S.F.
Potential Action	INSTALL WATERPROOFING

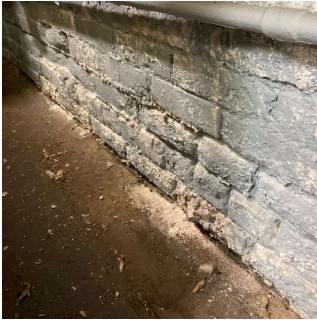
Violations	Basement - Kitchen No violations recorded.
Deficiency	CONCRETE: WATER INFILTRATION IN NON- INSTRUCTIONAL SPACE
Deficiency Location/Instance	Basement - Boiler Room
Deficiency Quantity	100
Quantity Uom	S.F.
Potential Action	INSTALL WATERPROOFING
Urgency of Action	PRIORITY 5
Purpose of Action	LEVEL 5
Deficiency Photo1

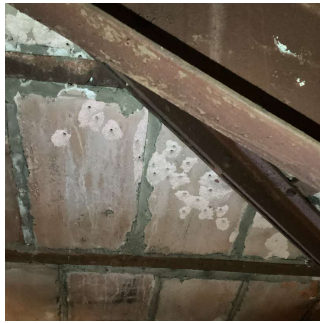
Violations	Basement - Boiler Room No violations recorded.
ROOF STRUCTURE	Inspected
Condition	3 - Fair
Deficiency	CLAY/CONCRETE TILES: MISSING/CRACKED/SPALLED
Deficiency Location/Instance	Attic
Deficiency Quantity	60
Quantity Uom	S.F.
Potential Action	REPLACE
Urgency of Action	PRIORITY 3
Purpose of Action	LEVEL 5

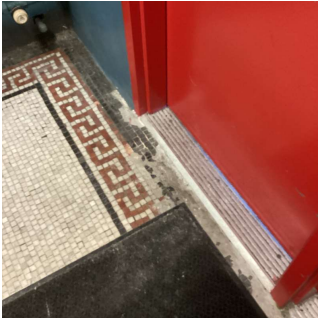
Violations	Exit 7 - Vestibule No violations recorded.
Floor Finish	Inspected
Condition	5 - Poor
Deficiency	CERAMIC TILE: BROKEN/MISSING TILES
Deficiency Location/Instance	Main Entrance - Vestibule
Deficiency Quantity	10
Quantity Uom	S.F.
Potential Action	REPLACE
Urgency of Action	PRIORITY 3
Purpose of Action	LEVEL 2
Deficiency Photo1

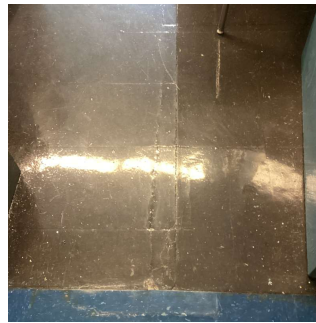
Room 255

Violations	Main Entrance - Vestibule No violations recorded.
Deficiency	VINYL TILES: DETERIORATED SUBSTRATE
Deficiency Location/Instance	Room 255, Corridor near Rooms 103, 105, 106, 153 and others
Deficiency Quantity	80
Quantity Uom	S.F.

Potential Action	REPLACE
Urgency of Action	PRIORITY 3
Purpose of Action	LEVEL 2

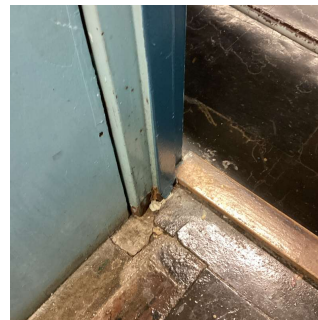
Instance on Basement	Inspected
Condition	3 - Fair
Deficiency	METAL: DETERIORATED DOOR AND FRAME
Deficiency Location/Instance	Kitchen Locker Room
Deficiency Quantity	1
Quantity Uom	EACH
Potential Action	MAINTENANCE
Urgency of Action	PRIORITY 3
Purpose of Action	LEVEL 2
Deficiency Photo1

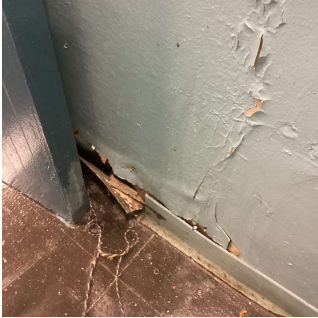
Violations	Office Room No violations recorded.
Deficiency	GYPSUM BOARD: DETERIORATED
Deficiency Location/Instance	In Kitchen Locker Room
Deficiency Quantity	10
Quantity Uom	S.F.
Potential Action	REPLACE
Urgency of Action	PRIORITY 3
Purpose of Action	LEVEL 2
Deficiency Photo1

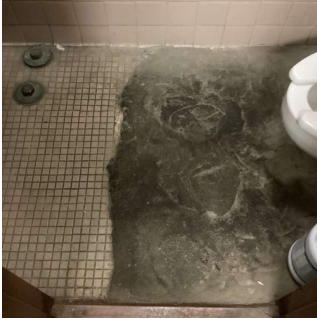
Violations	Room 310A No violations recorded.
Deficiency	CERAMIC TILE: BROKEN/MISSING TILES
Deficiency Location/Instance	In Kitchen Locker Room, Room 156A
Deficiency Quantity	30
Quantity Uom	S.F.
Potential Action	REPLACE
Urgency of Action	PRIORITY 3
Purpose of Action	LEVEL 2
Deficiency Photo1

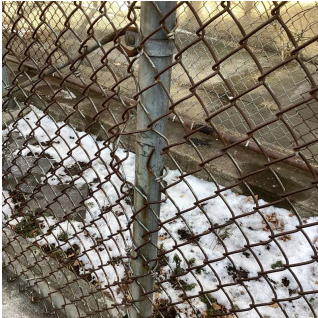
Yes	Protruding Elements	Damage chain link fence with protruding elements is a potential safety hazard.	SITE FENCES	Schoolyard	John Gattuso	Fireman

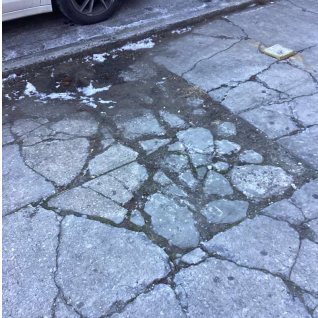
Question	Response
SITE	
PAVING	
DOT Sidewalk	
Concrete	
Violations	52221
Deficiency	DAMAGED/DETERIORATED/MISSING SECTIONS
Deficiency Location/Instance	18th Avenue, Webster Avenue
Deficiency Quantity	2,500
Quantity Uom	S.F.
Potential Action	REPLACE
Urgency of Action	PRIORITY 4
Purpose of Action	LEVEL 4
Deficiency Photo1

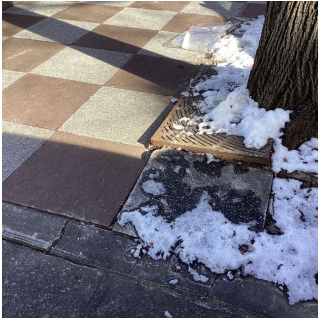
18th Avenue
Violations	52221
Pavers	Inspected
Condition	3 - Fair
Deficiency	HEAVING
Deficiency Location/Instance	Webster Avenue
Deficiency Quantity	50
Quantity Uom	S.F.
Potential Action	REPLACE
Urgency of Action	PRIORITY 5
Purpose of Action	LEVEL 6
Deficiency Photo1
