NYC Department of Education
Building Condition Assessment Survey 2023 - 2024

Architectural Inspection

Asset: P.S. 326 - BROOKLYN, 1800 UTICA AVENUE, New York, 11234

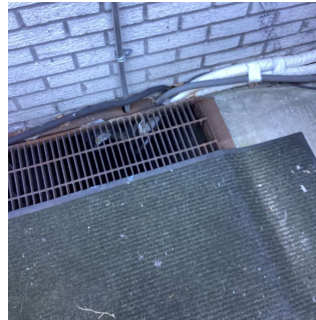
AW1
No violations recorded.

Deficiency	AREAWAY GRATINGS: MAJOR RUSTING / OR BROKEN
Roof Plan reference	K852

Deficiency Quantity	20
Quantity Uom	S.F.
Potential Action	REPLACE
Urgency of Action	PRIORITY 4
Purpose of Action	LEVEL 2
Deficiency Photo1

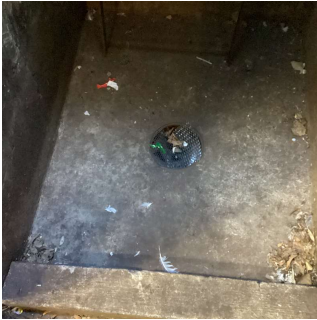
AW1
Violations	No violations recorded.
AWNINGS AND CANOPIES	
	Does not Exist
CHIMNEY	
Material Type(s)	Concrete
Condition	2 - Between Good and Fair
Deficiency	No deficiencies recorded
COPING	
Condition	3 - Fair
Deficiency	CAST STONE: DETERIORATED BED JOINT
Roof Plan reference	K852

Deficiency	AREAWAY DRAINS: DETERIORATED
Roof Plan reference	K852

Deficiency Quantity	1
Quantity Uom	EACH
Potential Action	REPLACE
Urgency of Action	PRIORITY 4
Purpose of Action	LEVEL 2

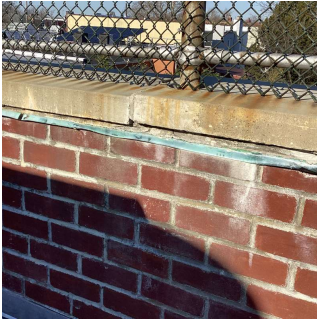
Roof 2
Violations	No violations recorded.
Deficiency	CAST STONE: DETERIORATED TRANSVERSE JOINTS

Deficiency Quantity	10
Quantity Uom	L.F.
Potential Action	REPOINT
Urgency of Action	PRIORITY 3
Purpose of Action	LEVEL 2
Deficiency Photo1

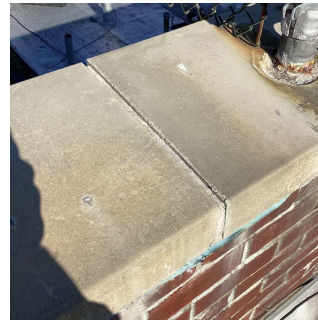
Roof 2
No violations recorded.

20
L.F.
MAINTENANCE
PRIORITY 3
LEVEL 2

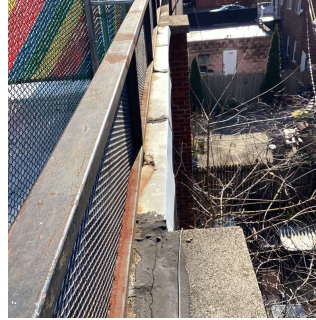
Roof 2
No violations recorded.

METAL: DETERIORATED
K852

20
L.F.
REPLACE-IN-KIND
PRIORITY 4
LEVEL 2

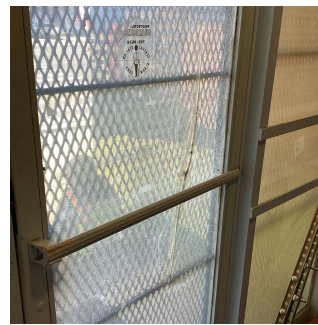
Facade A

METAL: DETERIORATED DOOR - MAJOR DETERIORATION

4
EACH
REPLACE
PRIORITY 4
LEVEL 2

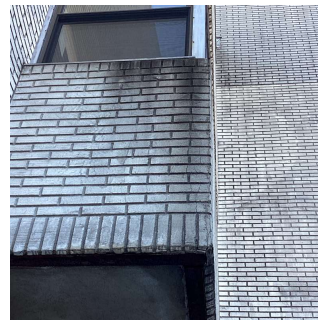
Facade D

Deficiency	BRICK: CRACKS/DISPLACED/SPALLED BRICK AT BUILDING CORNERS
------------	---

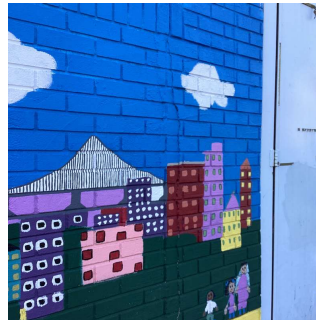
Facade A

BRICK: MAJOR / THRU CRACKS

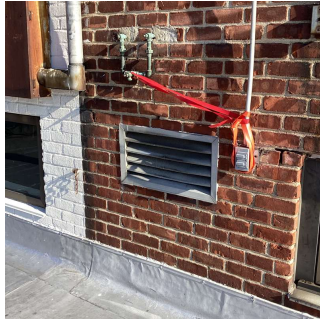
Inspected
3 - Fair
BROKEN/ DENTED BLADES
K852

10
S.F.
REPLACE
PRIORITY 4
LEVEL 2

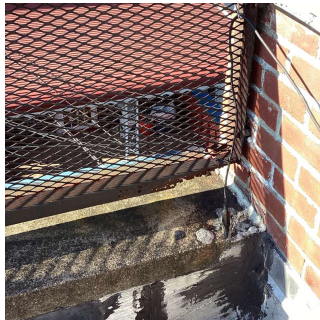
Violations	Facade C No violations recorded.
PARAPETS	Inspected
Material Type(s)	Masonry, Metal
Replacement Quantity	3,800
Replacement Uom	C.F.
Instance on All Facades	Inspected
Instance Condition	4 - Between Fair and Poor
Instance Quantity	3,800
Instance Quantity Uom	C.F.
Deficiency	METAL: RAILINGS: DETERIORATED
Roof Plan reference	K852

Deficiency Quantity	60
Quantity Uom	S.F.
Potential Action	REPLACE
Urgency of Action	PRIORITY 4
Purpose of Action	LEVEL 2
Deficiency Photo1

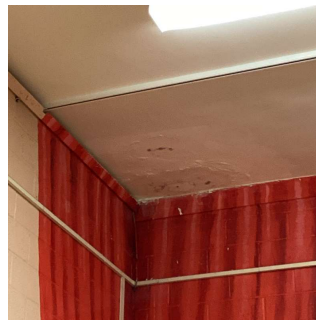
Roof 2 - Multipurpose Room (shown), Multipurpose Room Office
No violations recorded.

Deficiency MODIFIED BITUMEN: ROOFING: MAJOR ACTIVE ROOF LEAKS IN INSTRUCTIONAL SPACE

Deficiency Quantity	300
Quantity Uom	S.F.
Potential Action	REPLACE ROOFING WITHOUT MAJOR EQUIPMENT REMOVAL
Urgency of Action	PRIORITY 5
Purpose of Action	LEVEL 2
Deficiency Photo1

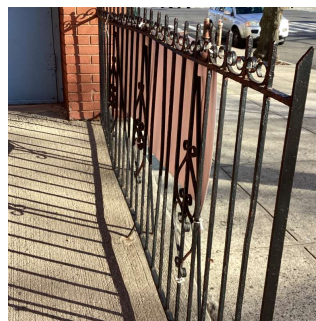
Facade B

DAMAGED

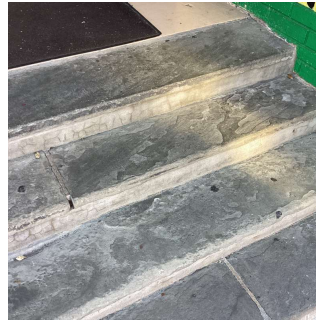
Facade A

STONE: CRACKS/SPALLING - MAJOR

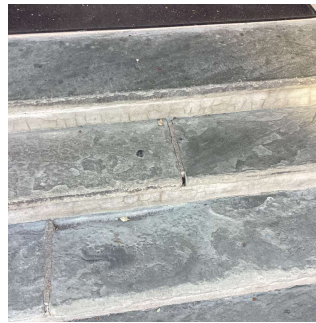
Facade A

STONE: DETERIORATED JOINTS

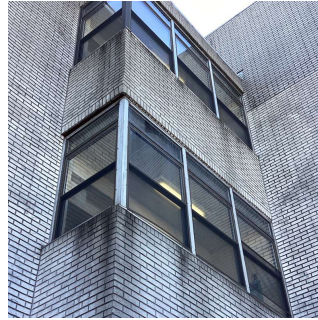
Facade D

ALUMINUM - DOUBLE HUNG: DETERIORATED

REPLACE WINDOW

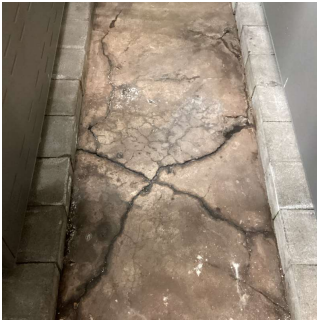
Question	Response
INTERIOR	
STRUCTURAL	
COLUMNS/BEAMS/BEARING WALLS	
Deficiency Photo1	 
Violations	Boiler Room No violations recorded.
FLOOR STRUCTURE	
Condition	Inspected
Deficiency	3 - Fair
Deficiency Location/Instance	CINDER CONCRETE FLAT SLAB: CRACKED/SPALLED/REINFORCEMENT EXPOSED
Deficiency Quantity	Basement - Electrical Panel Room
Quantity Uom	20
Potential Action	S.F.
Urgency of Action	REPAIR
Purpose of Action	PRIORITY 4
Deficiency Photo1	LEVEL 5  
Violations	Electrical Panel Room No violations recorded.
Deficiency	CONCRETE SLAB ON GRADE: THRU CRACKS
Deficiency Location/Instance	Basement - Boiler Room
Deficiency Quantity	20
Quantity Uom	S.F.
Potential Action	REPLACE
Urgency of Action	PRIORITY 4
Purpose of Action	LEVEL 5

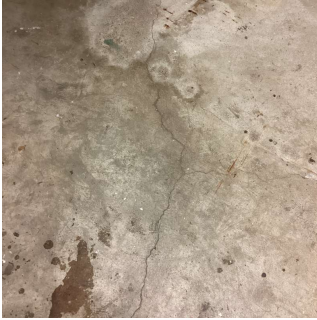
Boiler Room
Violations	No violations recorded.
Deficiency	CONCRETE SLAB ON GRADE: THRU CRACKS
Deficiency Location/Instance	Basement - Electrical Panel Room, Boiler Room
Deficiency Quantity	60
Quantity Uom	S.F.
Potential Action	REPAIR
Urgency of Action	PRIORITY 3
Purpose of Action	LEVEL 5
Deficiency Photo1

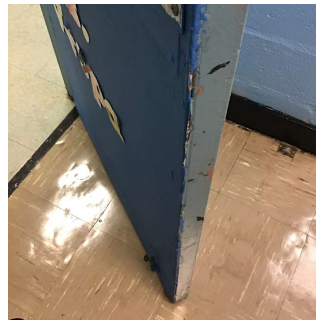
Room B5

METAL: DETERIORATED DOOR

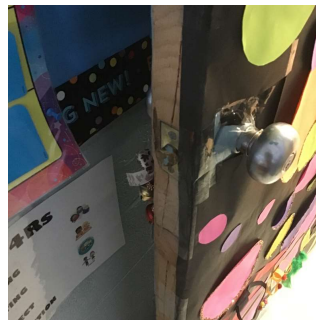
WOOD: DETERIORATED DOOR

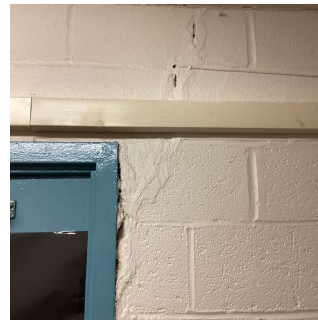
Corridor near Room 304

MASONRY: CRACKS/SPALLING

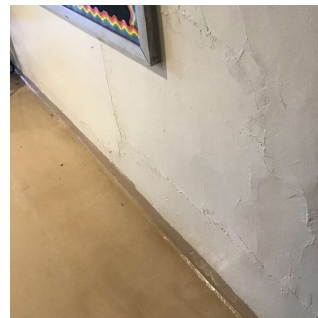
PLASTER: CRACKS/SPALLING

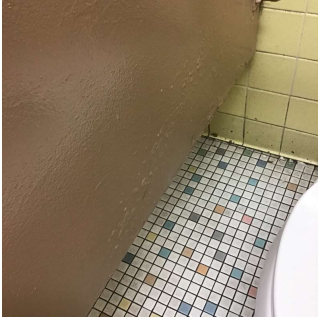
Violations	Room 103 No violations recorded.
Walls	Inspected
Condition	2 - Between Good and Fair
Deficiency	PLASTER: CRACKS/SPALLING
Deficiency Location/Instance	Room 200
Deficiency Quantity	15
Quantity Uom	S.F.

Violations	3rd Floor Girls No violations recorded.
Stalls	Inspected
Condition	3 - Fair
Deficiency	RUST - MAJOR
Deficiency Location/Instance	Room 103
Deficiency Quantity	2
Quantity Uom	EACH
Potential Action	REPLACE
Urgency of Action	PRIORITY 3
Purpose of Action	LEVEL 2
Deficiency Photo1
