NYC Department of Education
Building Condition Assessment Survey 2023 - 2024

Architectural Inspection

Asset: P.S. 178 AX (BED STUY ECC 1)-K, 1784 PARK PLACE, New York, 11212

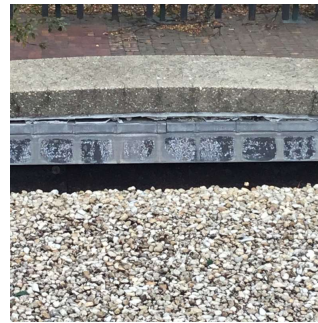
Roof 1

Deficiency CAST STONE: DETERIORATED BED JOINT

40

REPOINT

PRIORITY 3

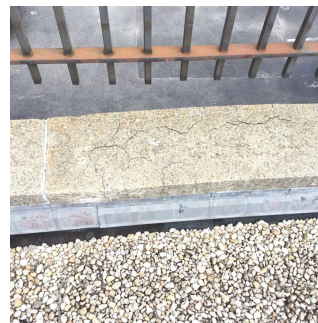
Roof 1

CAST STONE: DISINTEGRATING / FREEZE THAW

100

REPLACE-IN-KIND

PRIORITY 4

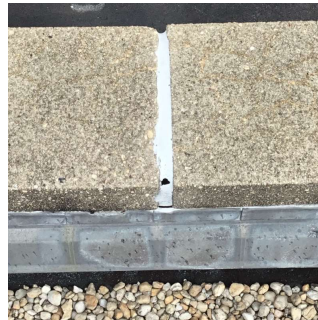
Roof 1
No violations recorded.

CAST STONE: DETERIORATED TRANSVERSE JOINTS

100
L.F.
MAINTENANCE
PRIORITY 3
LEVEL 2

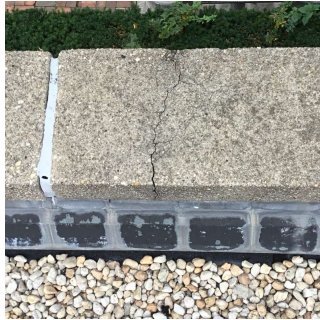
CAST STONE: CRACKED/BROKEN PIECES

50
L.F.
REPLACE-IN-KIND
PRIORITY 4
LEVEL 2

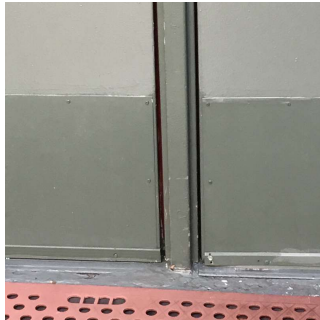
Violations	Roof 1 No violations recorded.
CORNICE	Does not Exist
DOORS	Inspected
DOORS AND FRAMES	Inspected
Condition	3 - Fair
Deficiency	METAL: DETERIORATED DOOR - MINOR DETERIORATION
Roof Plan reference	K854
Deficiency Quantity	2
Quantity Uom	EACH
Potential Action	MAINTENANCE
Urgency of Action	PRIORITY 3
Purpose of Action	LEVEL 2
Deficiency Photo1

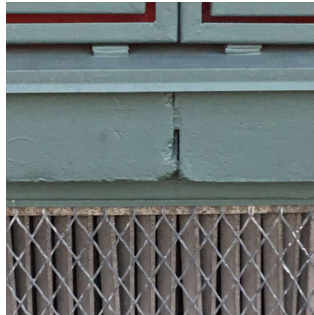
Facade A

Deficiency	CONCRETE MASONRY UNIT: MASONRY SILLS - DETERIORATED JOINTS
------------	--

10

REPOINT

PRIORITY 3

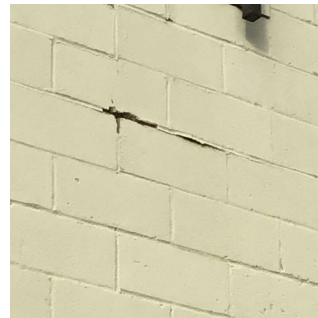
Facade E

CONCRETE MASONRY UNIT: DETERIORATED JOINTS

35

REPOINT

PRIORITY 4

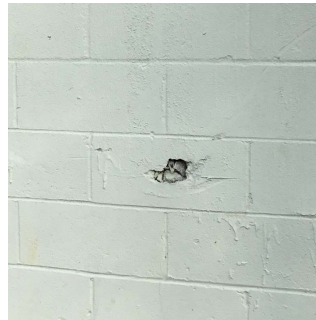
Facade F

CONCRETE MASONRY UNIT: MAJOR / THRU CRACKS

30

REMOVE AND REBUILD

PRIORITY 4

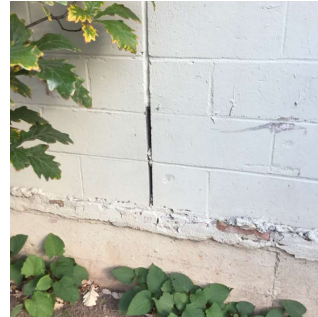
Facade F

CONCRETE MASONRY UNIT: DETERIORATED CONTROL/EXPANSION JOINTS

MAINTENANCE
PRIORITY 3
LEVEL 2

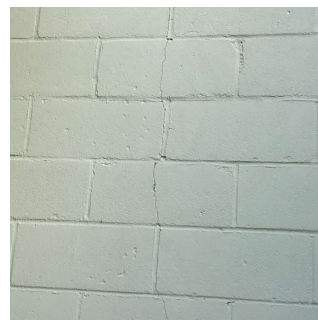
CONCRETE MASONRY UNIT: MINOR CRACKS AND SPALLING

50
S.F.
RESTITCH
PRIORITY 3
LEVEL 4

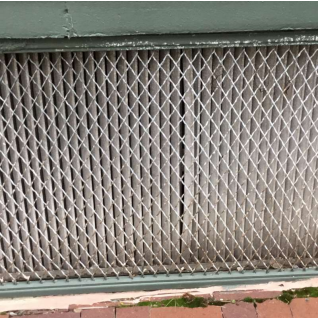
Question	Response
EXTERIOR	
EXTERIOR WALLS	Inspected
Violations	Facade F 35674658P
EXTERIOR SOFFITS	Does not Exist
LOADING DOCK	Does not Exist
LOUVER	Inspected
Condition	3 - Fair
Deficiency	BROKEN/ DENTED BLADES
Roof Plan reference	K854

Deficiency Quantity	60
Quantity Uom	S.F.
Potential Action	REPLACE
Urgency of Action	PRIORITY 4
Purpose of Action	LEVEL 2
Deficiency Photo1

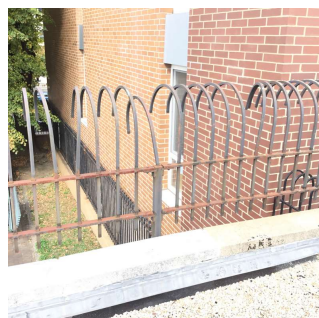
Question	Response
EXTERIOR	
PARAPETS	Inspected
Instance Quantity	500
Instance Quantity Uom	C.F.
Deficiency	No deficiencies recorded
PLAZA DECK	Does not Exist
ROOF	Inspected
Roofing	Inspected
Replacement Quantity	10,900
Replacement Uom	S.F.
ROOF HATCH/SMOKE HATCH	Does not Exist
LEADERS, GUTTERS, DOWNSPOUTS, SCUPPERS	Does not Exist
ROOF BARRIER/FENCE	Inspected
Condition	3 - Fair
Deficiency	BEAR CLAW/METAL BAR: DETERIORATED, MAJOR RUSTING
Roof Plan reference	<p>K854</p>

Deficiency Quantity	40
Quantity Uom	S.F.
Potential Action	REPLACE
Urgency of Action	PRIORITY 4
Purpose of Action	LEVEL 2
Deficiency Photo1

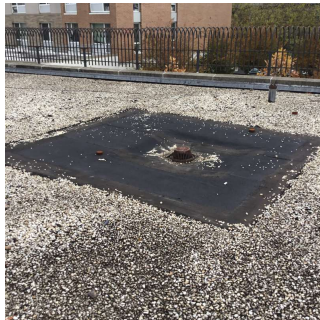
Roof 1
Instance Quantity	10,900
Instance Quantity Uom	S.F.
Does the roof have major mechanical equipment sitting on Dunnage Steel less than 18" above the Roofing?	No
Does this roof instance have a Sustainable Roof System?	No
Do solar panels exist on these roofs?	No
Is/Are the roof(s) suitable for Solar Panel installation?	Yes
Installation Year	1998
Source of Installation	Custodial Staff
Deficiency	BUILT-UP: ROOFING: LOSS OF GRAVEL
Roof Plan reference	K854

Deficiency Quantity	80
Quantity Uom	S.F.
Potential Action	INSTALL NEW GRAVEL
Urgency of Action	PRIORITY 3
Purpose of Action	LEVEL 2
Deficiency Photo1

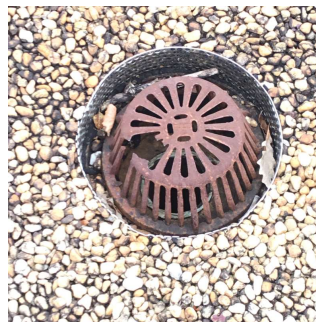
Roof 1
 No violations recorded.

Roof 1
Violations	No violations recorded.
ROOFING DRAINS	
Condition	Inspected
Deficiency	3 - Fair DETERIORATED

1
 EACH
 REPLACE
 PRIORITY 4
 LEVEL 2

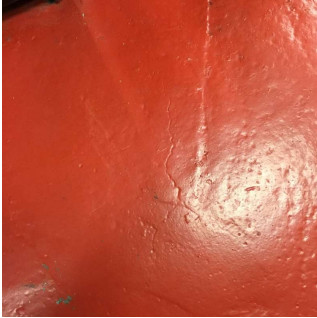
FLOOR STRUCTURE	
	Inspected
Condition	3 - Fair
Deficiency	CONCRETE SLAB ON GRADE: THRU CRACKS
Deficiency Location/Instance	1st Floor
Deficiency Quantity	15
Quantity Uom	S.F.

Question	Response
INTERIOR	
STRUCTURAL	
FLOOR STRUCTURE	
Potential Action	REPAIR
Urgency of Action	PRIORITY 3
Purpose of Action	LEVEL 5
Deficiency Photo1

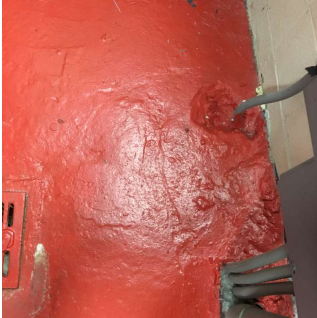
Room 7
Violations	No violations recorded.
Deficiency	CONCRETE SLAB ON GRADE: THRU CRACKS
Deficiency Location/Instance	1st Floor
Deficiency Quantity	10
Quantity Uom	S.F.
Potential Action	REPLACE
Urgency of Action	PRIORITY 4
Purpose of Action	LEVEL 5
Deficiency Photo1

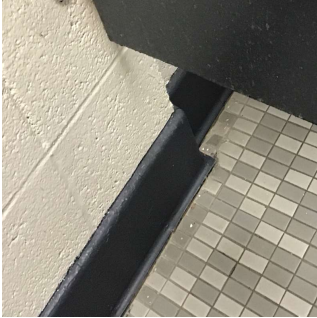
Question	Response
INTERIOR	
TOILET ROOMS - STAFF	Inspected
Ceiling	Does not Exist
Door(s)	Inspected
Condition	2 - Between Good and Fair
Deficiency	No deficiencies recorded
Floor Finish	Inspected
Condition	2 - Between Good and Fair
Deficiency	No deficiencies recorded
Stalls	Inspected
Condition	5 - Poor
Deficiency	RUST - MAJOR
Deficiency Location/Instance	Room 12, 10
Deficiency Quantity	2
Quantity Uom	EACH
Potential Action	REPLACE
Urgency of Action	PRIORITY 3
Purpose of Action	LEVEL 2
Deficiency Photo1

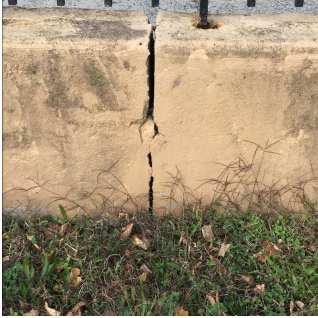
Question	Response
SITE	
RETAINING WALLS	
Deficiency	CAST IN PLACE CONCRETE: DETERIORATED CONTROL/EXPANSION JOINT
Deficiency Location/Instance	Along Park Place
Deficiency Quantity	10
Quantity Uom	L.F.
Potential Action	REPLACE
Urgency of Action	PRIORITY 3
Purpose of Action	LEVEL 2
Deficiency Photo1

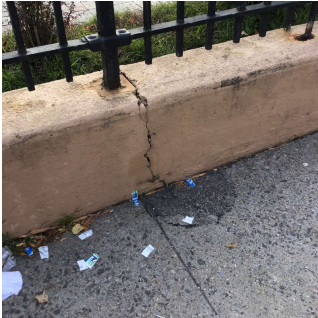
Violations	Along Park Place No violations recorded.
SEATING	Does not Exist
SITE WALLS (NOT RETAINING WALLS)	Inspected
Condition	2 - Between Good and Fair
Deficiency	CAST IN PLACE CONCRETE: CRACKS/SPALLING - MAJOR
Deficiency Location/Instance	Along Park Place
Deficiency Quantity	10
Quantity Uom	S.F.
Potential Action	REPLACE
Urgency of Action	PRIORITY 3
Purpose of Action	LEVEL 2
Deficiency Photo1
