**NYC Department of Education**  
**Building Condition Assessment Survey 2023 - 2024**

Architectural Inspection

**K855**

**Asset:** P.S. 135/P.S. 235 ANNEX - K, 5811 DITMAS AVENUE, New York, 11218

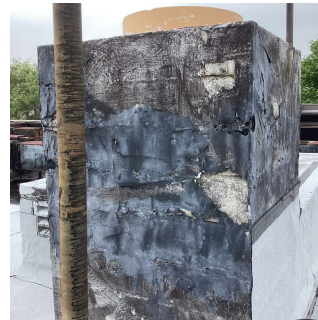
Roof 1  
No violations recorded.

30  
S.F.  
RESTITCH  
PRIORITY 3  
LEVEL 2

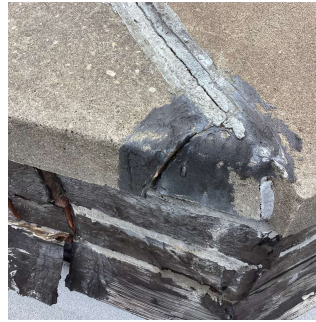
Roof 1

CAST STONE: CRACKED/BROKEN PIECES

10  
L.F.  
REPLACE-IN-KIND  
PRIORITY 4  
LEVEL 2

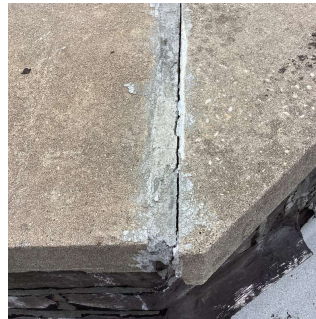
Roof 1

**CAST STONE: DETERIORATED TRANSVERSE JOINTS**

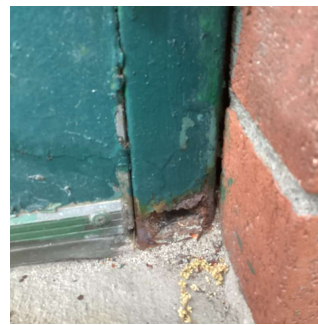
Facade C

**METAL: DETERIORATED DOOR AND FRAME - MAJOR DETERIORATION**

4  
EACH  
REPLACE  
PRIORITY 4  
LEVEL 2

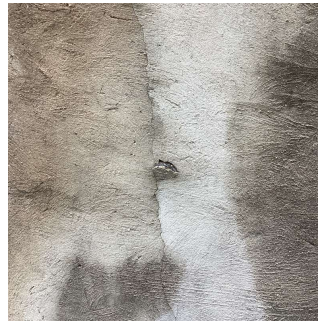
Facade D

Quantity Uom	S.F.
Potential Action	REPLACE
Urgency of Action	PRIORITY 4
Purpose of Action	LEVEL 2
Deficiency Photo1

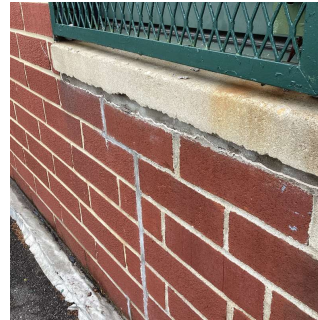
Facade E

Deficiency **BRICK: DETERIORATED MASONRY SILLS - MINOR**

Deficiency Quantity	10
Quantity Uom	L.F.
Potential Action	REPAIR
Urgency of Action	PRIORITY 3
Purpose of Action	LEVEL 2

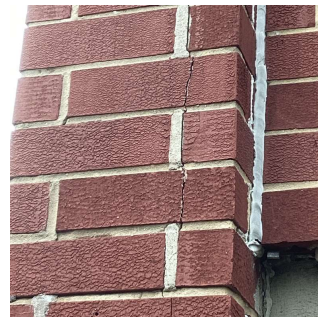
Facade A

**BRICK: MINOR CRACKS AND SPALLING**

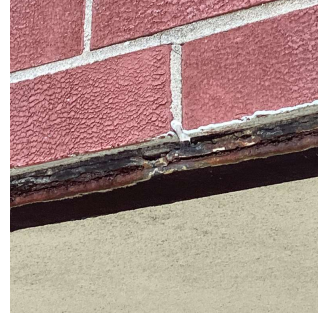
Facade H

**BRICK: RELIEVING ANGLES - MAJOR DETERIORATION**

REPLACE  
PRIORITY 4  
LEVEL 2

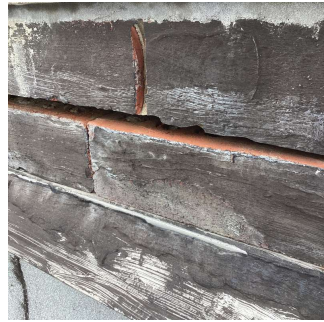
Deficiency Roof Plan reference	BRICK: DETERIORATED JOINTS K855
-----------------------------------	------------------------------------

Deficiency Quantity	100
Quantity Uom	S.F.
Potential Action	REPOINT
Urgency of Action	PRIORITY 4
Purpose of Action	LEVEL 4
Deficiency Photo1

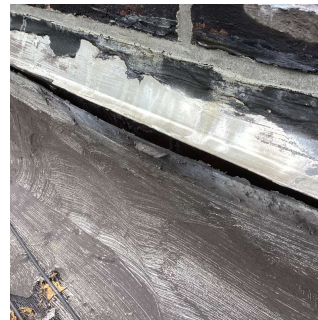
Roof 1

Does the roof have major mechanical equipment sitting on Dunnage Steel less than 18" above the Roofing?	No
Does this roof instance have a Sustainable Roof System?	Yes
Sustainable Roof Type	White Roof
Sustainable Roof Location (Roof Number)	Roofs 1-3
Do solar panels exist on these roofs?	No
Is/Are the roof(s) suitable for Solar Panel installation?	No
Installation Year	1996
Source of Installation	Custodial Staff
Deficiency	MODIFIED BITUMEN: FLASHING: BASE FLASHING DETERIORATED

10  
S.F.  
REPAIR  
PRIORITY 3  
LEVEL 2

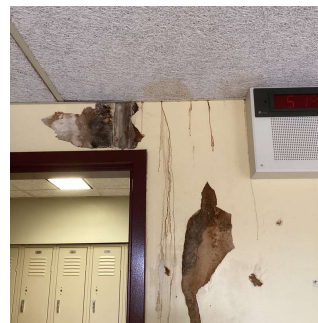
Roof 1 - Room 207

**MODIFIED BITUMEN: ROOFING: MAJOR ACTIVE ROOF  
LEAKS IN INSTRUCTIONAL SPACE**

**REPLACE ROOFING WITHOUT MAJOR EQUIPMENT  
REMOVAL**

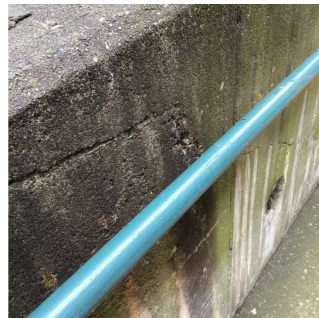
Question	Response
<b>EXTERIOR</b>	
<b>STAIRS/RAMPS: EXTERIOR</b>	Inspected
<b>BUILDING CHEEK/FLANK WALLS</b>	Inspected
Condition	3 - Fair
Deficiency	CAST IN PLACE CONCRETE: CRACKS/SPALLING - MINOR
Roof Plan reference

Deficiency Quantity	20
Quantity Uom	S.F.
Potential Action	REPAIR
Urgency of Action	PRIORITY 3
Purpose of Action	LEVEL 2
Deficiency Photo1

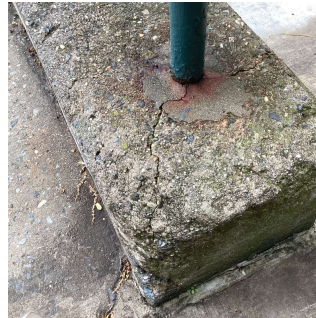
Violations	Facade D No violations recorded.
<b>RAILINGS</b>	Inspected
Condition	2 - Between Good and Fair
Deficiency	No deficiencies recorded
<b>STAIRS/RAMPS</b>	Inspected
Condition	3 - Fair
Deficiency	CONCRETE: CRACKS/SPALLING - MAJOR
Roof Plan reference

Deficiency Quantity	10
Quantity Uom	S.F.
Potential Action	REPLACE
Urgency of Action	PRIORITY 4

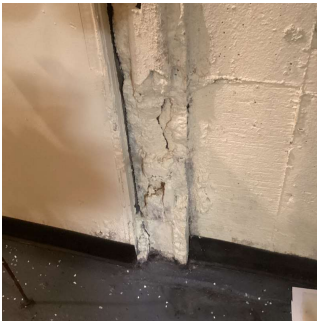
Deficiency	CONCRETE: CRACKED/SPALLED/REINFORCEMENT EXPOSED
Deficiency Location/Instance	Basement - Water and Gas Main Room
Deficiency Quantity	10
Quantity Uom	S.F.
Potential Action	REPAIR
Urgency of Action	PRIORITY 3
Purpose of Action	LEVEL 5

Basement - Water and Gas Main Room
Violations	No violations recorded.
<b>ROOF STRUCTURE</b>	
Condition	Inspected
	2 - Between Good and Fair
Deficiency	No deficiencies recorded
<b>VAULTS-BUNKERS</b>	
	Does not Exist
<b>AUDITORIUM</b>	
	Does not Exist
<b>CAFETERIA</b>	
	Inspected
Instance on Basement - Staff (600SF)	Inspected
Instance on Basement - Students	Inspected
<b>Ceiling</b>	
Instance on Basement - Staff (600SF)	Inspected
Condition	4 - Between Fair and Poor
Deficiency	TECTUM: DAMAGED/MISSING
Deficiency Location/Instance	Near Entrance, Serving Area
Deficiency Quantity	50
Quantity Uom	S.F.
Potential Action	REPLACE
Urgency of Action	PRIORITY 3
Purpose of Action	LEVEL 2
Deficiency Photo1

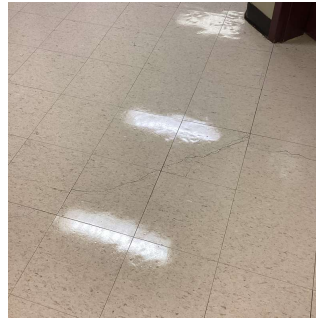
Corridor near Room 201

VINYL TILES: BROKEN/DETERIORATED/MISSING TILES

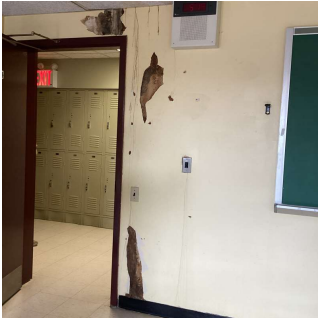
Question	Response
<b>INTERIOR</b>	
<b>CLASSROOMS/CORRIDORS/ADMIN SPACES</b>	
<b>Walls</b>	
Violations	Room 207 No violations recorded.
Deficiency	PLASTER: CRACKS/SPALLING - ACTIVE LEAK
Deficiency Location/Instance	Room 207
Deficiency Quantity	20
Quantity Uom	S.F.
Potential Action	REPLACE
Urgency of Action	PRIORITY 5
Purpose of Action	LEVEL 2
Deficiency Photo1

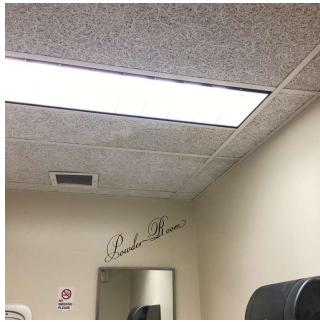
Violations	Stair B/1 No violations recorded.
<b>TOILET ROOMS - STAFF</b>	Inspected
<b>Ceiling</b>	Inspected
Condition	3 - Fair
Deficiency	TECTUM: DAMAGED/MISSING
Deficiency Location/Instance	Rooms 110, 210
Deficiency Quantity	20
Quantity Uom	S.F.
Potential Action	REPLACE
Urgency of Action	PRIORITY 3
Purpose of Action	LEVEL 2
Deficiency Photo1
