NYC Department of Education
Building Condition Assessment Survey 2023 - 2024

Architectural Inspection

Asset: P.S. 36 ANNEX - BROOKLYN, 2045 LINDEN BLVD, New York, 11207

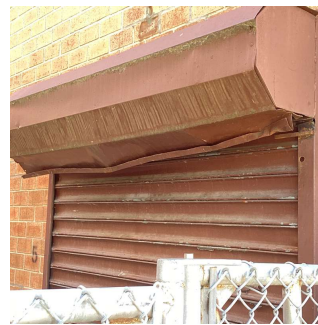
Facade C

Question	Response
Architectural	
EXTERIOR	Inspected
AREAWAY	Does not Exist
AWNINGS AND CANOPIES	Does not Exist
CHIMNEY	Does not Exist
COPING	Inspected
Condition	2 - Between Good and Fair
Deficiency	No deficiencies recorded
CORNICE	Does not Exist
DOORS	Inspected
DOORS AND FRAMES	Inspected
Condition	4 - Between Fair and Poor
Deficiency	ROLL-UP DOOR: DETERIORATED DOOR AND FRAME - MAJOR DETERIORATION

300
S.F.
REPLACE
PRIORITY 4
LEVEL 2

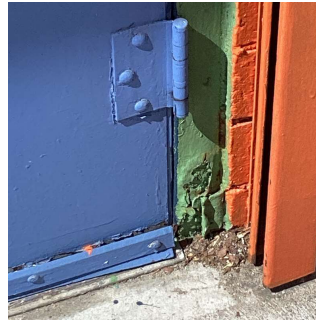
Facade D

METAL CLAD: DETERIORATED DOOR AND FRAME - MAJOR DETERIORATION

1
EACH
REPLACE
PRIORITY 4
LEVEL 2

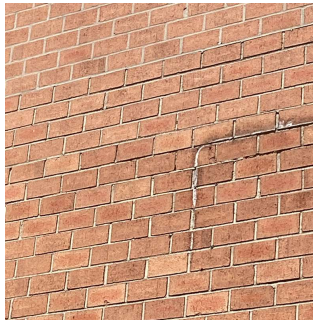
Facade A

BRICK: DETERIORATED JOINTS

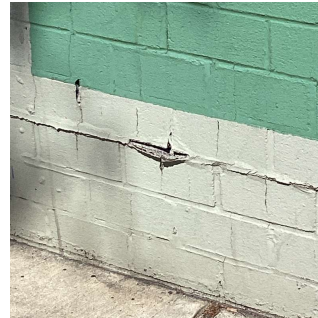
Facade A

BRICK: DETERIORATED JOINTS

PRIORITY 4
LEVEL 2

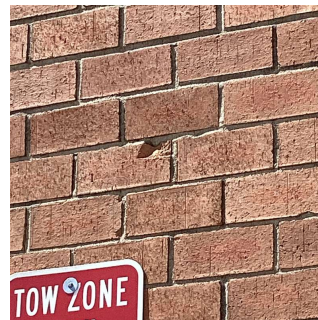
Facade D

BRICK: MINOR CRACKS AND SPALLING

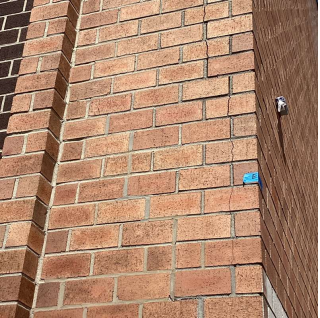
Question	Response
EXTERIOR	
EXTERIOR WALLS	
Violations	No violations recorded.
Deficiency	BRICK: CRACKS/DISPLACED/SPALLED BRICK AT BUILDING CORNERS
Roof Plan reference	<p align="center">K857</p>

Deficiency Quantity	80
Quantity Uom	S.F.
Potential Action	REMOVE AND REBUILD
Urgency of Action	PRIORITY 4
Purpose of Action	LEVEL 2
Deficiency Photo1

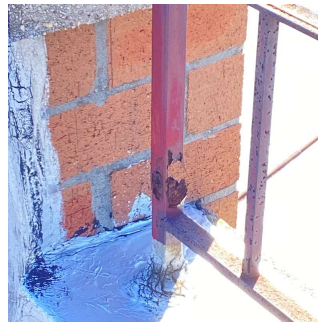
Roof 1
No violations recorded.

Instance Condition	2 - Between Good and Fair
Instance Quantity	4,000
Instance Quantity Uom	C.F.
Deficiency	METAL: RAILINGS: RUSTED
Roof Plan reference

Deficiency Quantity	25
Quantity Uom	S.F.
Potential Action	REPAIR AND REPAINT
Urgency of Action	PRIORITY 3
Purpose of Action	LEVEL 2
Deficiency Photo1

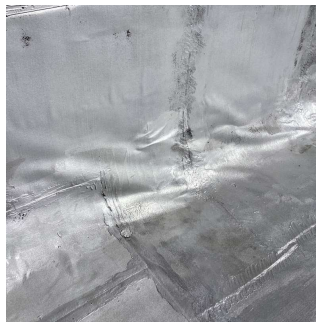
Roof 1	No violations recorded.
--------	-------------------------

Deficiency	MODIFIED BITUMEN: FLASHING: BASE FLASHING DETERIORATED
------------	--

Deficiency Quantity	70
Quantity Uom	S.F.
Potential Action	REPAIR
Urgency of Action	PRIORITY 3
Purpose of Action	LEVEL 2
Deficiency Photo1

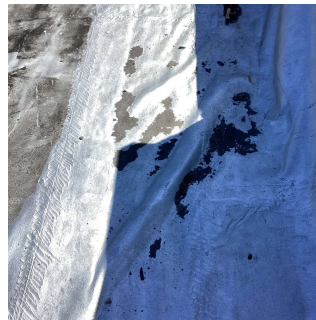
Roof 1
No violations recorded.

Violations	
Deficiency	MODIFIED BITUMEN: ROOFING: DELAMINATION

200
S.F.
REPLACE ROOFING WITH MAJOR EQUIPMENT REMOVAL
PRIORITY 4
LEVEL 2

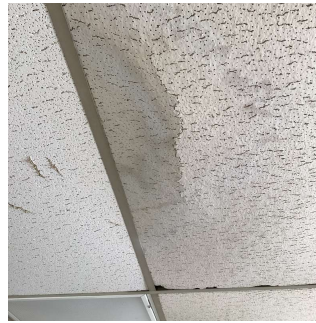
BH

3 - Fair
BULKHEAD/PENTHOUSE CEILING: ACOUSTIC TILES DAMAGED/MISSING

20
S.F.
REPLACE

PRIORITY 4
LEVEL 2

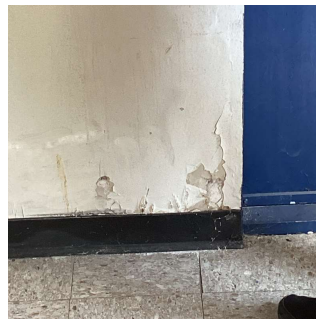
BH

BULKHEAD/PENTHOUSE WALLS/INTERIOR: GYPSUM BOARD DAMAGED/DETERIORATED

30
S.F.
REPLACE
PRIORITY 4
LEVEL 2

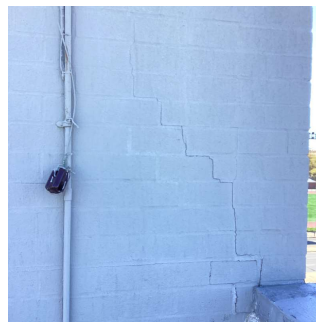
BULKHEAD/PENTHOUSE WALLS/EXTERIOR: CRACKS/SPALLING - MAJOR

35
 S.F.
 REPLACE
 PRIORITY 4
 LEVEL 2

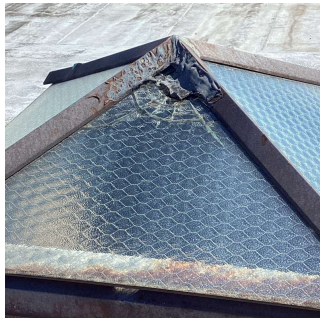
Violations	Roof 1 No violations recorded.
SKYLIGHT/ROOF VENT	Inspected
Material Type(s)	Glass
Condition	3 - Fair
Deficiency	BROKEN GLASS
Roof Plan reference

Deficiency Quantity	20
Quantity Uom	S.F.
Potential Action	MAINTENANCE
Urgency of Action	PRIORITY 3
Purpose of Action	LEVEL 2
Deficiency Photo1

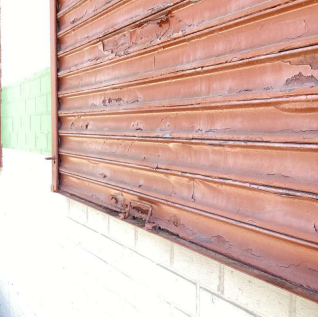
Question	Response
EXTERIOR	
WINDOWS	
EXTERIOR GUARDS	
Condition	Inspected 4 - Between Fair and Poor
Deficiency	DETERIORATED/TORN-OUT/MISSING
Roof Plan reference

Deficiency Quantity	300
Quantity Uom	S.F.
Potential Action	REPLACE
Urgency of Action	PRIORITY 4
Purpose of Action	LEVEL 2
Deficiency Photo1

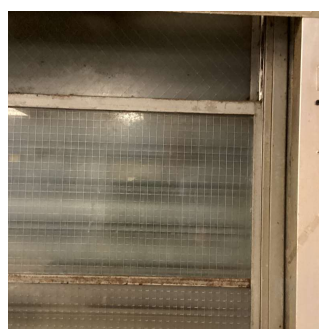
Deficiency Quantity	60
Quantity Uom	EACH
Potential Action	MAINTENANCE
Urgency of Action	PRIORITY 3
Purpose of Action	LEVEL 2
Deficiency Photo1	No photo recorded
Violations	No violations recorded.
Instance on Steel: Facade C	Inspected
Instance Condition	3 - Fair
Instance Quantity	600
Instance Quantity Uom	S.F.
Are these windows insulated	No
Installation Year	1973
Source of Installation	Custodial Staff
Deficiency	STEEL: DETERIORATED

Deficiency Quantity	100
Quantity Uom	S.F.
Potential Action	REPLACE WINDOW
Urgency of Action	PRIORITY 4
Purpose of Action	LEVEL 2
Deficiency Photo1

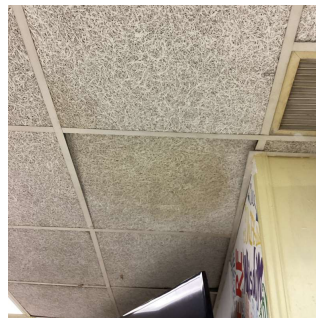
Main Entrance Lobby

TECTUM: DAMAGED/MISSING

REPLACE

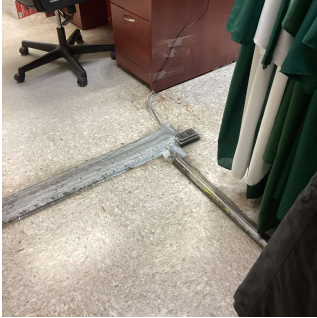
Violations	Room 307 No violations recorded.
Floor Finish	
Condition	Inspected 2 - Between Good and Fair
Deficiency	VINYL TILES: TRIPPING HAZARD - ELECTRICAL OUTLET
Deficiency Location/Instance	Room 101
Deficiency Quantity	10

Quantity Uom	S.F.
Potential Action	REMOVE

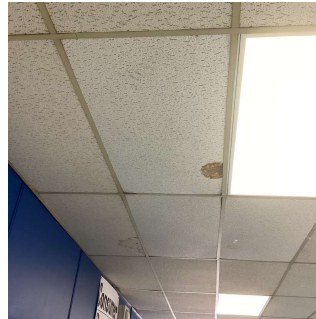
Left Side

Deficiency	ACOUSTIC TILES: DAMAGED/MISSING
------------	---------------------------------

Deficiency Location/Instance	Center and Left Side, near Windows
------------------------------	------------------------------------

Potential Action	REPLACE
------------------	---------

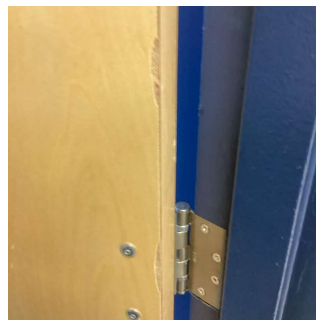
Deficiency	WOOD: DETERIORATED DOOR
------------	-------------------------

Deficiency Location/Instance	Main Entrance
------------------------------	---------------

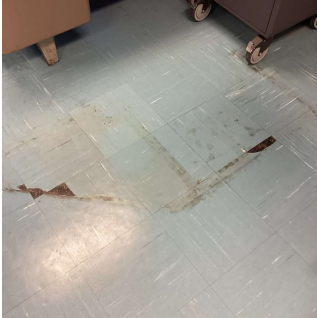
Deficiency	VINYL TILES: BROKEN/DETERIORATED/MISSING TILES
------------	--

Question	Response
INTERIOR	
LIBRARY	
Floor Finish	
Deficiency Location/Instance	Near Windows
Deficiency Quantity	10
Quantity Uom	S.F.
Potential Action	REPLACE
Urgency of Action	PRIORITY 3
Purpose of Action	LEVEL 2
Deficiency Photo1

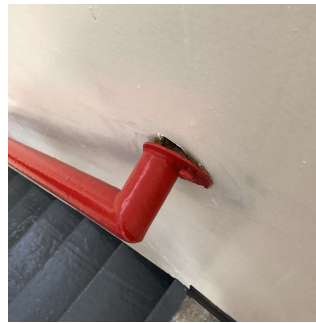
Stair A/3

Violations	Exit 2 - Vestibule No violations recorded.
Door(s)	Inspected
Condition	2 - Between Good and Fair
Deficiency	No deficiencies recorded
Partition	Does not Exist
Railings	Inspected
Condition	3 - Fair
Deficiency	METAL: BROKEN BRACKET
Deficiency Location/Instance	Stairs A/3

Deficiency Quantity	3
Quantity Uom	EACH
Potential Action	REPLACE
Urgency of Action	PRIORITY 3
Purpose of Action	LEVEL 2

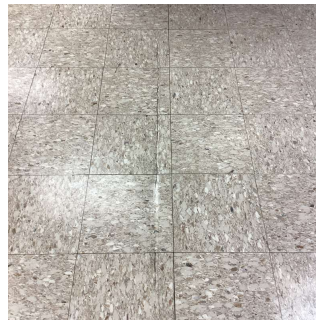
Stair B/1

VINYL TILES: DETERIORATED SUBSTRATE

REPLACE

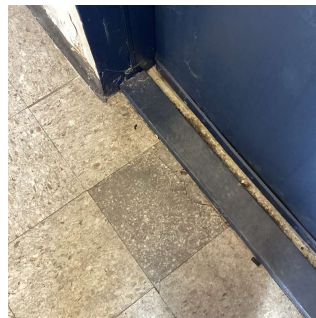
VINYL TILES: BROKEN/DETERIORATED/MISSING TILES

REPLACE
