**NYC Department of Education
Building Condition Assessment Survey 2023 - 2024**

Architectural Inspection

Asset: P.S. 361 (OLD 89) - BROOKLYN, 3109 NEWKIRK AVENUE, New York, 11226

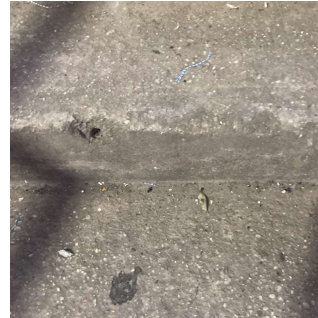
AW1

Deficiency: AREAWAY STAIRS: DETERIORATED TREADS/RISERS/NOSINGS

10
 S.F.
 REPLACE
 PRIORITY 4
 LEVEL 2

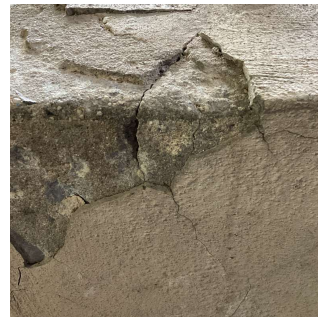
AW1

AREAWAY WALLS: CRACKS AND SPALLING

10
 S.F.
 REPLACE
 PRIORITY 4
 LEVEL 2

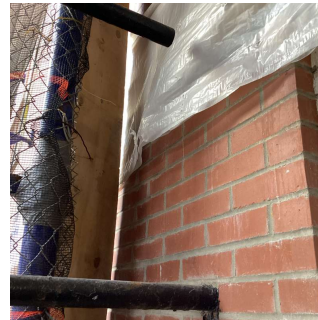
AW1

AREAWAY STAIRS: DETERIORATED RAILINGS

REPLACE

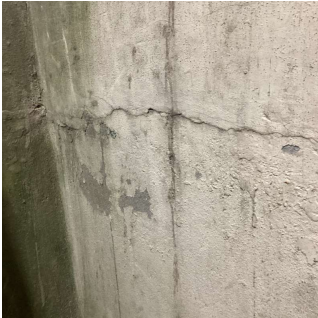
AREAWAY WALLS: CRACKS AND SPALLING

REPAIR

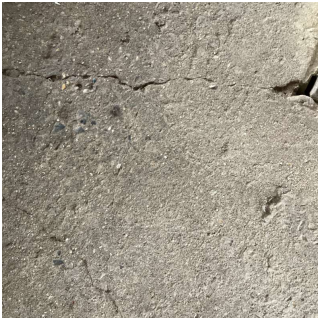
Violations	AW1 No violations recorded.
Deficiency	AREAWAY SLAB: CRACKS AND SPALLING
Roof Plan reference

Deficiency Quantity	10
Quantity Uom	S.F.
Potential Action	REPLACE
Urgency of Action	PRIORITY 4
Purpose of Action	LEVEL 2
Deficiency Photo1

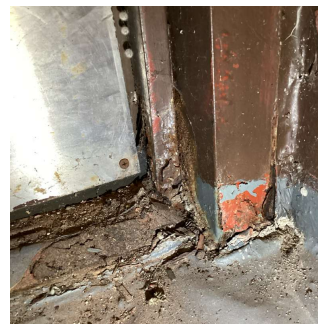
Facade B

Violations	AW1 No violations recorded.
AWNINGS AND CANOPIES	Does not Exist
CHIMNEY	Under Construction
COPING	Under Construction
CORNICE	Under Construction
DOORS	Inspected
DOORS AND FRAMES	Inspected
Condition	5 - Poor
Deficiency	METAL: DETERIORATED DOOR AND FRAME - MAJOR DETERIORATION

4
 EACH
 REPLACE
 PRIORITY 4
 LEVEL 2

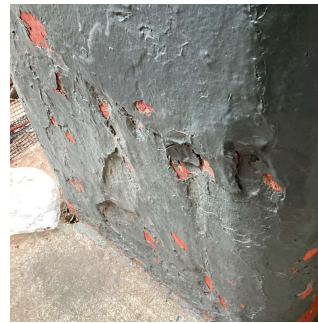
Facade A

Roof 8
Instance Quantity	9,000
Instance Quantity Uom	S.F.
ROOFING DRAINS	Under Construction
Specialties	Inspected
BULKHEAD/PENTHOUSE	Does not Exist
CUPOLA/ SPIRES/ TOWERS	Does not Exist
DORMER	Does not Exist
DUNNAGE STEEL	Inaccessible
SKYLIGHT/ROOF VENT	Inaccessible
ROOF/GRAVITY TANK	Does not Exist
STAIRS/RAMPS: EXTERIOR	Inspected
BUILDING CHEEK/FLANK WALLS	Inspected
Condition	4 - Between Fair and Poor
Deficiency	CAST IN PLACE CONCRETE: CRACKS/SPALLING - MAJOR

20
 S.F.
 REPLACE
 PRIORITY 4
 LEVEL 2

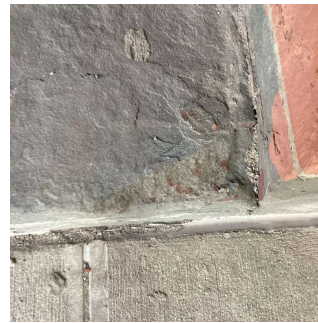
Facade B

STONE: CRACKS/SPALLING - MAJOR

20
 S.F.
 REPLACE
 PRIORITY 4
 LEVEL 2

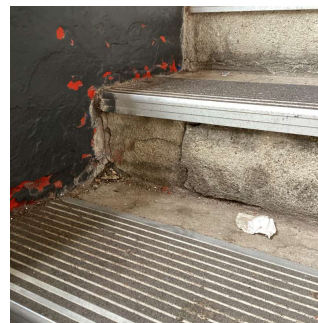
Facade A

CONCRETE: CRACKS/SPALLING - MAJOR

REPLACE

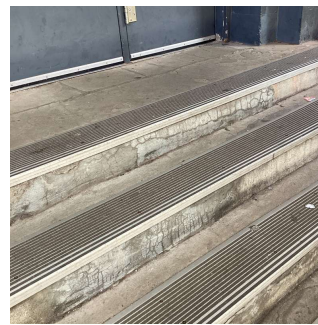
CONCRETE: CRACKS/SPALLING - MINOR

Facade A
 No violations recorded.

10
 S.F.
 REPAIR
 PRIORITY 3
 LEVEL 2

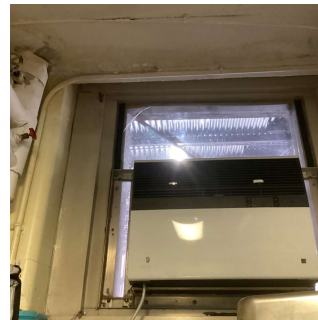
ALUMINUM - DOUBLE HUNG: BROKEN PANE

Facade B - Kitchen
 No violations recorded.

30
 S.F.
 MAINTENANCE
 PRIORITY 3
 LEVEL 2

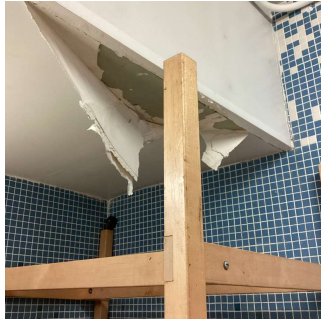
Basement - Pool
No violations recorded.

Instance on Basement	Inspected
Condition	3 - Fair
Deficiency	PLASTER/CONCRETE: CRACKS, SPALLING
Deficiency Location/Instance	Basement - Pool
Deficiency Quantity	20
Quantity Uom	S.F.
Potential Action	REPAIR
Urgency of Action	PRIORITY 4
Purpose of Action	LEVEL 2
Deficiency Photo1

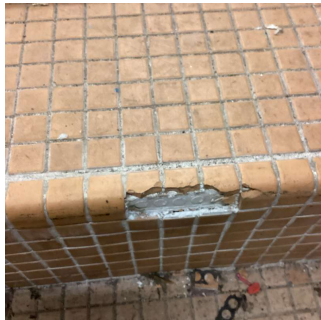
Basement - Pool
No violations recorded.

Instance on Basement	Inspected
Condition	3 - Fair
Deficiency	CERAMIC TILES: BROKEN/MISSING/WORN TILES
Deficiency Location/Instance	Basement - Pool
Deficiency Quantity	20
Quantity Uom	S.F.
Potential Action	REPLACE
Urgency of Action	PRIORITY 4
Purpose of Action	LEVEL 2
Deficiency Photo1

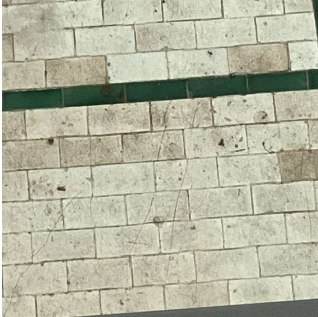
Instance on Basement	Inspected
Condition	3 - Fair
Deficiency	TILE: BROKEN/MISSING/WORN TILES

Deficiency Location/Instance	Basement - Pool
Deficiency Quantity	10
Quantity Uom	S.F.
Potential Action	REPLACE
Urgency of Action	PRIORITY 4
Purpose of Action	LEVEL 2
Deficiency Photo1

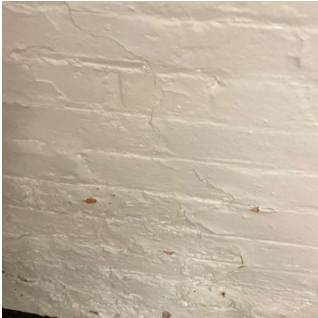
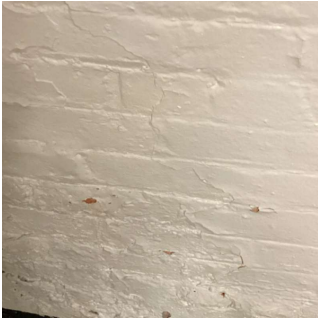
Basement - Multipurpose Room

Condition	Inspected
Deficiency	3 - Fair
Deficiency	MASONRY BEARING WALL: CRACKED/SPALLED
Deficiency Location/Instance	Basement - Multipurpose Room, Corridor
Deficiency Quantity	40
Quantity Uom	S.F.
Potential Action	RESTITCH
Urgency of Action	PRIORITY 3
Purpose of Action	LEVEL 5
Deficiency Photo1

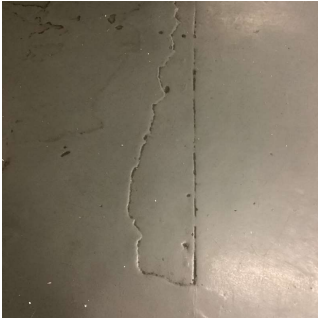
Question	Response
INTERIOR	
STRUCTURAL	
COLUMNS/BEAMS/BEARING WALLS	Inspected
Violations	No violations recorded.
FLOOR STRUCTURE	
Condition	Inspected
Deficiency	3 - Fair
Deficiency Location/Instance	CONCRETE SLAB ON GRADE: THRU CRACKS
Deficiency Quantity	Basement - Multipurpose Room, Corridor
Quantity Uom	90
Potential Action	S.F.
Urgency of Action	REPLACE
Purpose of Action	PRIORITY 4
Deficiency Photo1	LEVEL 5

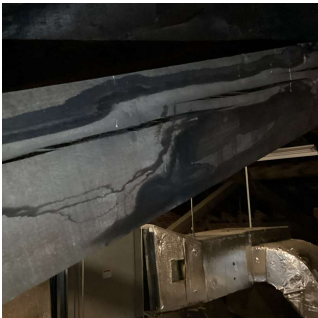
Violations	Basement - Multipurpose Room, Corridor
	No violations recorded.
FOUNDATION WALLS	
	Under Construction
ROOF STRUCTURE	
Condition	Inspected
Deficiency	3 - Fair
Deficiency Location/Instance	WOOD COLUMNS AND BEAMS: DETERIORATED
Deficiency Quantity	Roof 1 - Attic, Roof 2 - Attic
Quantity Uom	60
Potential Action	S.F.
Urgency of Action	REPLACE
Purpose of Action	PRIORITY 4
Deficiency Photo1	LEVEL 5

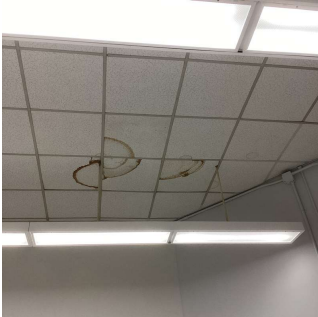
Question	Response
INTERIOR	
CLASSROOMS/CORRIDORS/ADMIN SPACES	
Ceiling	Inspected
Condition	2 - Between Good and Fair
Deficiency	METAL PAN: DAMAGED/MISSING
Deficiency Location/Instance	Corridor near Rooms 109, 101, 111
Deficiency Quantity	40
Quantity Uom	S.F.
Potential Action	REPLACE
Urgency of Action	PRIORITY 3
Purpose of Action	LEVEL 2
Deficiency Photo1	 
	Corridor near Room 109
Violations	No violations recorded.
Deficiency	ACOUSTIC TILES: DAMAGED/MISSING
Deficiency Location/Instance	Rooms 309, 111
Deficiency Quantity	30
Quantity Uom	S.F.
Potential Action	REPLACE
Urgency of Action	PRIORITY 3
Purpose of Action	LEVEL 2
Deficiency Photo1

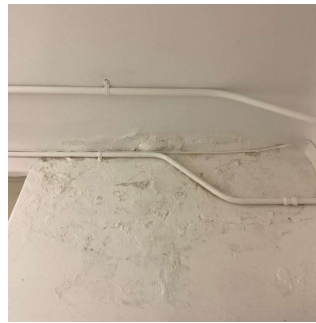
Corridor near Room 309

Room 309
Violations	No violations recorded.
Deficiency	PLASTER: CRACKS/SPALLING
Deficiency Location/Instance	Room 309, Corridor near Rooms 109A, 111, 309, by Multipurpose Room - 3rd and others
Deficiency Quantity	70
Quantity Uom	S.F.
Potential Action	REPLACE
Urgency of Action	PRIORITY 3

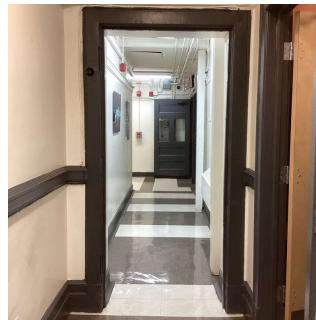
Corridor near Room 104

WOOD: MISSING DOOR

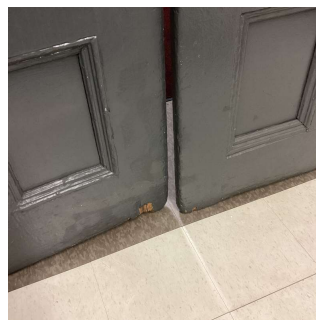
WOOD: DETERIORATED DOOR

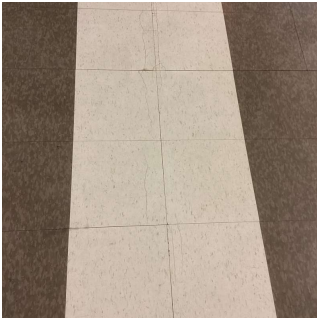
Violations	Corridor near Multipurpose Room - 3rd Floor No violations recorded.
Deficiency	VINYL TILES: DETERIORATED SUBSTRATE
Deficiency Location/Instance	Main Entrance - Lobby, Room 109A, Corridor near Rooms 109A, 106, by Boys Toilet Room - 2nd Floor and others
Deficiency Quantity	100
Quantity Uom	S.F.
Potential Action	REPLACE
Urgency of Action	PRIORITY 3
Purpose of Action	LEVEL 2
Deficiency Photo1

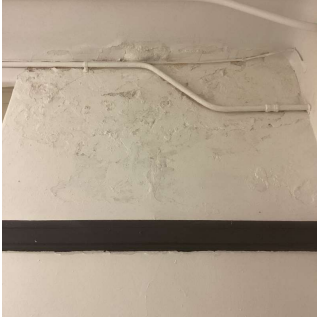
Violations	Corridor near Room 109A No violations recorded.
Walls	Inspected
Condition	2 - Between Good and Fair
Deficiency	PLASTER: CRACKS/SPALLING
Deficiency Location/Instance	Rooms 109A, 309, Corridor near Rooms 109A, 309, by Stair F/2 and others
Deficiency Quantity	90

Question	Response
INTERIOR	
CLASSROOMS/CORRIDORS/ADMIN SPACES	
Walls	
Quantity Uom	S.F.
Potential Action	REPLACE
Urgency of Action	PRIORITY 3
Purpose of Action	LEVEL 2
Deficiency Photo1

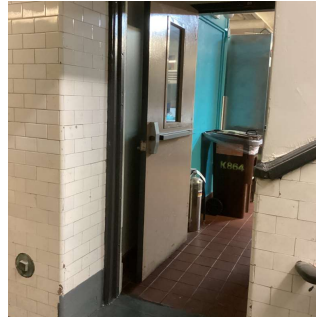
Instance on Basement	Inspected
Condition	5 - Poor
Deficiency	WOOD: MISSING DOOR
Deficiency Location/Instance	Near Room B8
Deficiency Quantity	1
Quantity Uom	EACH
Potential Action	MAINTENANCE
Urgency of Action	PRIORITY 3
Purpose of Action	LEVEL 2
Deficiency Photo1

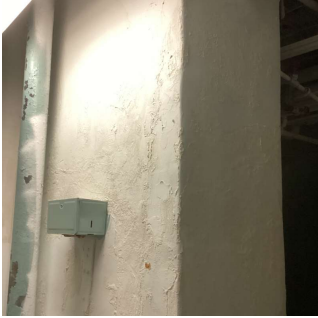
Question	Response
INTERIOR	
LOCKER ROOM	
Locker Room Lockers	
Instance on Basement Swimming Pool - Room 08 (400 SF, 28 Lockers)	Inspected
Condition	2 - Between Good and Fair
Deficiency	No deficiencies recorded
Walls	
Instance on Basement Swimming Pool - Room 08 (400 SF, 28 Lockers)	Inspected
Condition	5 - Poor
Deficiency	PLASTER: CRACKS/SPALLING
Deficiency Location/Instance	Room 08
Deficiency Quantity	100
Quantity Uom	S.F.
Potential Action	REPLACE
Urgency of Action	PRIORITY 3
Purpose of Action	LEVEL 2
Deficiency Photo1

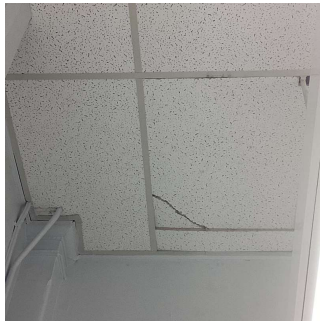
Violations	Room 08 No violations recorded.
MULTI-PURPOSE ROOM	
Instance on 3rd Floor	Inspected
Instance on Basement	Inspected
Instance on 1st Floor - Room 111	Inspected
Ceiling	
Instance on 1st Floor - Room 111	Inspected
Condition	2 - Between Good and Fair
Deficiency	ACOUSTIC TILES: DAMAGED/MISSING
Deficiency Location/Instance	Near Right Side Windows, by Rear Wall
Deficiency Quantity	20
Quantity Uom	S.F.

Question	Response
INTERIOR	
MULTI-PURPOSE ROOM	
Ceiling	
Deficiency Photo1

Potential Action	REPLACE
Urgency of Action	PRIORITY 3
Purpose of Action	LEVEL 2

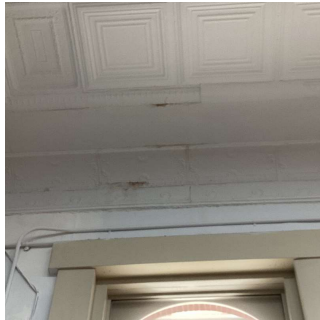
Near Right Side Windows
Violations	No violations recorded.
Instance on 3rd Floor	Inspected
Condition	2 - Between Good and Fair
Deficiency	METAL PAN: DAMAGED/MISSING
Deficiency Location/Instance	Near Windows
Deficiency Quantity	10
Quantity Uom	S.F.
Potential Action	REPLACE
Urgency of Action	PRIORITY 3
Purpose of Action	LEVEL 2
Deficiency Photo1

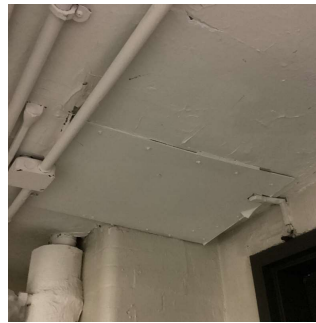
Right Side

Near Windows
Violations	No violations recorded.
Instance on Basement	Inspected
Condition	2 - Between Good and Fair
Deficiency	PLASTER: CRACKS/SPALLING
Deficiency Location/Instance	Right and Left Side
Deficiency Quantity	40
Quantity Uom	S.F.
Potential Action	REPLACE
Urgency of Action	PRIORITY 3
Purpose of Action	LEVEL 2

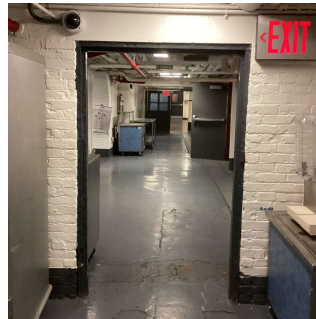
Instance on Basement	Inspected
Condition	3 - Fair
Deficiency	METAL: MISSING DOOR
Deficiency Location/Instance	Between Right and Left Side of Multipurpose Room
Deficiency Quantity	1
Quantity Uom	EACH
Potential Action	MAINTENANCE
Urgency of Action	PRIORITY 3
Purpose of Action	LEVEL 2
Deficiency Photo1

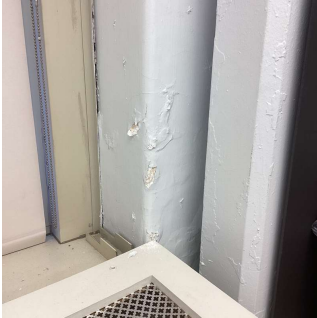
Question	Response
INTERIOR	
MULTI-PURPOSE ROOM	
Walls	
Condition	2 - Between Good and Fair
Deficiency	PLASTER: CRACKS/SPALLING
Deficiency Location/Instance	Near Right and Left Side Windows, Rear Wall
Deficiency Quantity	30
Quantity Uom	S.F.
Potential Action	REPLACE
Urgency of Action	PRIORITY 3
Purpose of Action	LEVEL 2
Deficiency Photo1

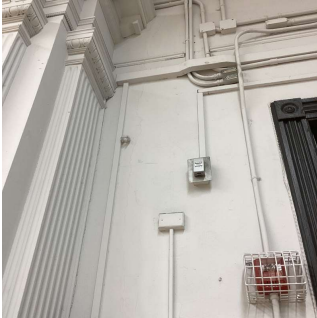
Near Right Side Windows
Violations	No violations recorded.
Instance on 3rd Floor	Inspected
Condition	2 - Between Good and Fair
Deficiency	PLASTER: CRACKS/SPALLING
Deficiency Location/Instance	Near Right Side Main Entrance
Deficiency Quantity	10
Quantity Uom	S.F.
Potential Action	REPLACE
Urgency of Action	PRIORITY 3
Purpose of Action	LEVEL 2
Deficiency Photo1

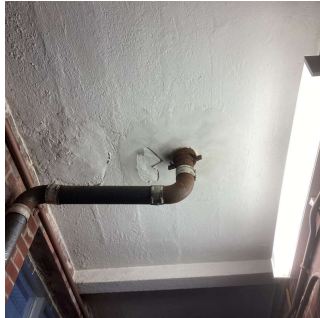
Question	Response
INTERIOR	
SHOWER ROOM	Inspected
Walls	
Instance on Basement Swimming Pool	Not Required
STAIRS/RAMPS: INTERIOR	Inspected
Do Letter Stair Signs Exist?	Partially
Ceiling	
Condition	2 - Between Good and Fair
Deficiency	PLASTER: CRACKS/SPALLING
Deficiency Location/Instance	Stairs AC/Exit - Vestibule, BD/Exit - Vestibule, F/3
Deficiency Quantity	40
Quantity Uom	S.F.
Potential Action	REPLACE
Urgency of Action	PRIORITY 3
Purpose of Action	LEVEL 2
Deficiency Photo1

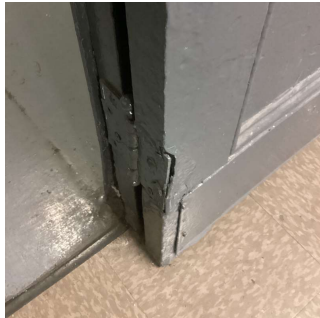
Stair AC/Exit - Vestibule
Violations	No violations recorded.
Door(s)	
Condition	3 - Fair
Deficiency	METAL CLAD WOOD: DETERIORATED DOOR
Deficiency Location/Instance	Stairs AC/Basement, BD/Basement
Deficiency Quantity	2
Quantity Uom	EACH
Potential Action	MAINTENANCE
Urgency of Action	PRIORITY 3
Purpose of Action	LEVEL 2
Deficiency Photo1

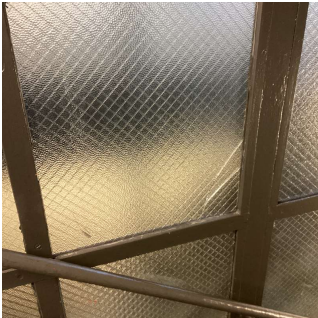
Stair AC/Basement
Violations	No violations recorded.
Partition	
Condition	3 - Fair
Deficiency	GLASS PANEL: DAMAGED/DETERIORATED

Deficiency Location/Instance	Stairs AC/1, 2, 3, 4, BD/1 and others

Question	Response
INTERIOR	
STAIRS/RAMPS: INTERIOR	Inspected
Partition	
Deficiency Quantity	90
Quantity Uom	S.F.
Potential Action	REPLACE
Urgency of Action	PRIORITY 3
Purpose of Action	LEVEL 2
Deficiency Photo1

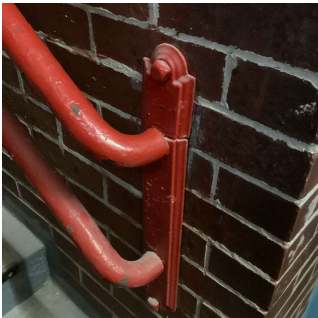
Violations	Stair BD/1 No violations recorded.
Railings	Inspected
Condition	5 - Poor
Deficiency	METAL: BROKEN BRACKET
Deficiency Location/Instance	Stairs AC/ Exit - Vestibule, BD/Exit - Vestibule
Deficiency Quantity	3
Quantity Uom	EACH
Potential Action	REPLACE
Urgency of Action	PRIORITY 3
Purpose of Action	LEVEL 2
Deficiency Photo1

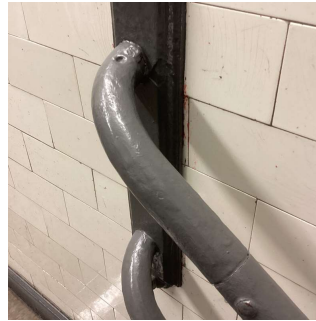
Violations	Stair BD/Exit - Vestibule No violations recorded.
Deficiency	METAL: DAMAGED
Deficiency Location/Instance	Stair AC/1
Deficiency Quantity	10
Quantity Uom	L.F.
Potential Action	REPLACE
Urgency of Action	PRIORITY 3
Purpose of Action	LEVEL 2

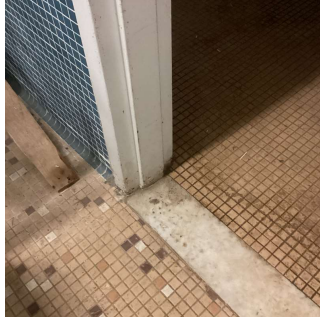
Boys Toilet Room - 1st Floor
Violations	No violations recorded.
Door(s)	Inspected
Condition	5 - Poor
Deficiency	METAL: DETERIORATED DOOR AND FRAME
Deficiency Location/Instance	Room 04
Deficiency Quantity	1
Quantity Uom	EACH
Potential Action	MAINTENANCE
Urgency of Action	PRIORITY 3
Purpose of Action	LEVEL 2
Deficiency Photo1

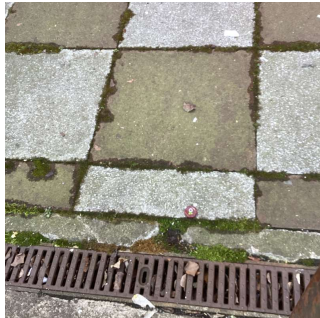
Violations	East 32nd Street No violations recorded.
Pavers	Inspected
Condition	2 - Between Good and Fair
Deficiency	DAMAGED/MISSING
Deficiency Location/Instance	Avenue D, East 32nd Street
Deficiency Quantity	20
Quantity Uom	S.F.
Potential Action	REPLACE
Urgency of Action	PRIORITY 3
Purpose of Action	LEVEL 2
Deficiency Photo1

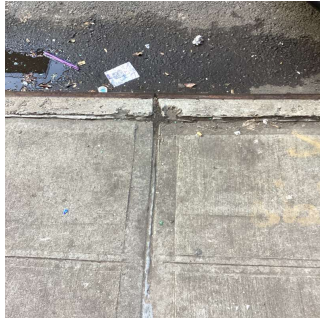
Violations	Newkirk Avenue No violations recorded.
Deficiency	DAMAGED CURBS
Deficiency Location/Instance	Newkirk Avenue, East 32nd Street
Deficiency Quantity	30
Quantity Uom	L.F.
Potential Action	REPLACE
Urgency of Action	PRIORITY 3
Purpose of Action	LEVEL 2
Deficiency Photo1
