NYC Department of Education
Building Condition Assessment Survey 2023 - 2024

Architectural Inspection

Asset: **I.S. 364 AX (POOL&GYM)-BROOKLYN, 1540 VAN SICLEN AVE, New York, 11239**

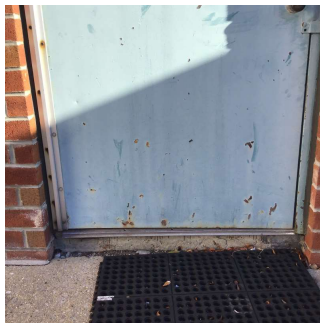
Question	Response
Architectural	
EXTERIOR	Inspected
AREAWAY	Not Required
AWNINGS AND CANOPIES	Not Required
CHIMNEY	Not Required
COPING	Inspected
Condition	2 - Between Good and Fair
Deficiency	No deficiencies recorded
CORNICE	Does not Exist
DOORS	Inspected
DOORS AND FRAMES	Inspected
Condition	3 - Fair
Deficiency	METAL: DETERIORATED DOOR - MINOR DETERIORATION
Roof Plan reference	K866

Question	Response
EXTERIOR	
DOORS	
DOORS AND FRAMES	
Deficiency Photo1

Deficiency Quantity	2
Quantity Uom	EACH
Potential Action	MAINTENANCE
Urgency of Action	PRIORITY 3
Purpose of Action	LEVEL 2

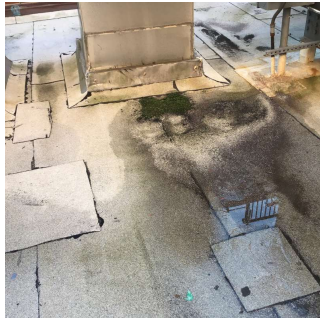
Roof 4
Violations	No violations recorded.

Roof 4
Instance Quantity	500
Instance Quantity Uom	S.F.
Does the roof have major mechanical equipment sitting on Dunnage Steel less than 18" above the Roofing?	No
Does this roof instance have a Sustainable Roof System?	Yes
Sustainable Roof Type	White Roof
Sustainable Roof Location (Roof Number)	Roof 4
Do solar panels exist on these roofs?	No
Is/Are the roof(s) suitable for Solar Panel installation?	No
Installation Year	1978
Source of Installation	Inspector Estimate
Deficiency	MODIFIED BITUMEN: ROOFING: DELAMINATION
Roof Plan reference	K866

Deficiency Quantity	100
Quantity Uom	S.F.
Potential Action	REPLACE ROOFING WITHOUT MAJOR EQUIPMENT REMOVAL
Urgency of Action	PRIORITY 4
Purpose of Action	LEVEL 2
Deficiency Photo1

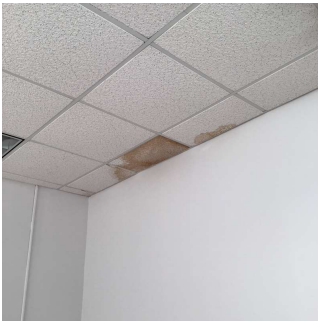
CAFETERIA	Does not Exist
CLASSROOMS/CORRIDORS/ADMIN SPACES	Inspected
Ceiling	Inspected
Condition	2 - Between Good and Fair
Deficiency	ACOUSTIC TILES: DAMAGED/MISSING
Deficiency Location/Instance	Near Entrance, center, 1st Floor - Boys, girls
Deficiency Quantity	30
Quantity Uom	S.F.
Potential Action	REPLACE
Urgency of Action	PRIORITY 3
Purpose of Action	LEVEL 2

Question	Response
INTERIOR	
CLASSROOMS/CORRIDORS/ADMIN SPACES	
Ceiling	
Deficiency Photo1

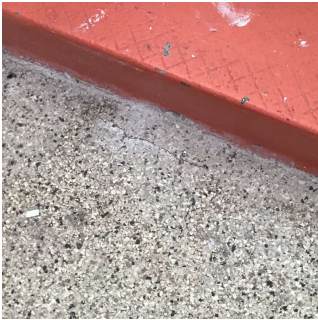
Violations	Near Entrance No violations recorded.
Door(s)	Does not Exist
Floor Finish	Inspected
Condition	2 - Between Good and Fair
Deficiency	TERRAZZO: CRACKS
Deficiency Location/Instance	Near Entrance, Gymnasium
Deficiency Quantity	20
Quantity Uom	S.F.
Potential Action	REPLACE
Urgency of Action	PRIORITY 3
Purpose of Action	LEVEL 2
Deficiency Photo1

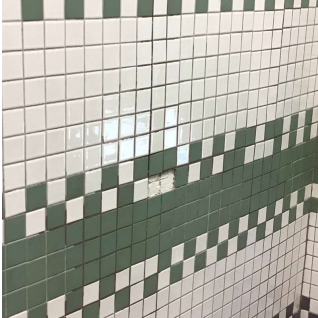
Question	Response
INTERIOR	
TOILET ROOMS - STUDENTS	
Floor Finish	Inspected
Violations	No violations recorded.
Stalls	Inspected
Condition	2 - Between Good and Fair
Deficiency	No deficiencies recorded
Walls	Inspected
Condition	2 - Between Good and Fair
Deficiency	CERAMIC TILE: BROKEN/ MISSING
Deficiency Location/Instance	1st Floor - Boys
Deficiency Quantity	10
Quantity Uom	S.F.
Potential Action	REPLACE
Urgency of Action	PRIORITY 3
Purpose of Action	LEVEL 2
Deficiency Photo1
