NYC Department of Education
Building Condition Assessment Survey 2023 - 2024

Architectural Inspection

Asset: P.S. 138 AX (CROWN HGTS ECC 1)-K, 960 PROSPECT PLACE, New York, 11216

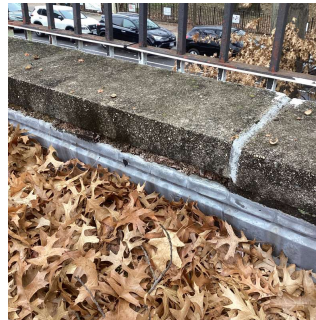
Roof 1

4 - Between Fair and Poor

CAST STONE: DETERIORATED BED JOINT

REPOINT

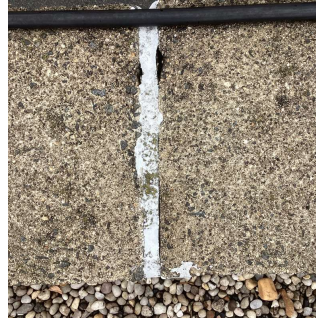
Roof 1

CAST STONE: DETERIORATED TRANSVERSE JOINTS

MAINTENANCE

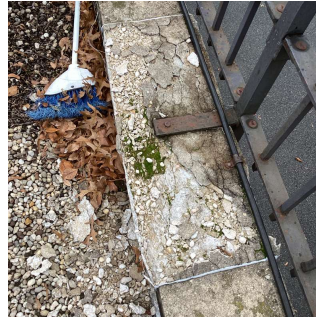
Roof 1

Yes	Potential Falling Debris	Cracked cast stone coping is a potential falling debris hazard.	EXTERIOR COPING	Roof above DOE parking lot	Nabil Alsoora	Custodian

CAST STONE: CRACKED/BROKEN PIECES

REPLACE-IN-KIND

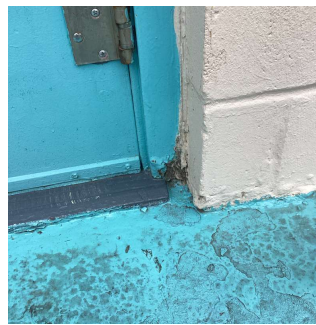
Facade B

4 - Between Fair and Poor

METAL CLAD: DETERIORATED DOOR AND FRAME - MAJOR DETERIORATION

2
EACH
REPLACE
PRIORITY 4
LEVEL 2

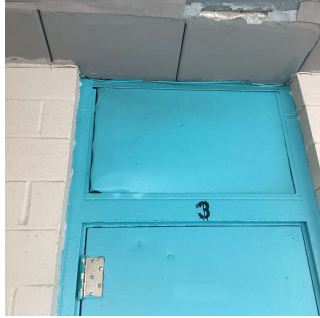
METAL: DENTED, MAJOR RUSTING

10
S.F.
REPLACE

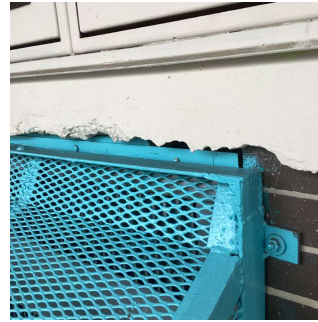
Violations	Facade A No violations recorded.
EXTERIOR WALLS	
Material Type(s)	Inspected Concrete, Masonry
Replacement Quantity	9,000
Replacement Uom	S.F.
Instance on All Facades	Inspected
Instance Condition	4 - Between Fair and Poor
Instance Quantity	9,000
Instance Quantity Uom	S.F.
Deficiency	BRICK: DETERIORATED MASONRY SILLS - MAJOR
Roof Plan reference	K867

Deficiency Quantity	20
Quantity Uom	L.F.
Potential Action	REMOVE AND REPLACE
Urgency of Action	PRIORITY 4
Purpose of Action	LEVEL 2

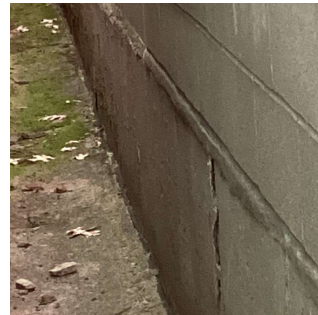
Facade E

CAST IN PLACE / PRE-CAST CONCRETE: MAJOR CRACKS/SPALLING

REPLACE

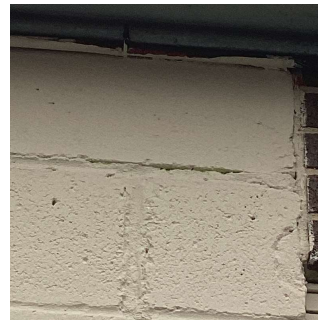
Facade H

CONCRETE MASONRY UNIT: DETERIORATED JOINTS

REPOINT

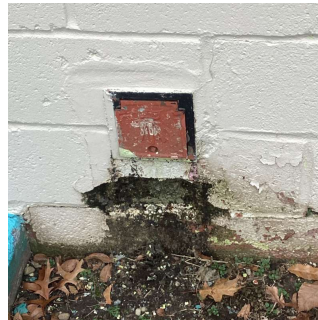
Facade H

CONCRETE MASONRY UNIT: MAJOR / THRU CRACKS

REMOVE AND REBUILD

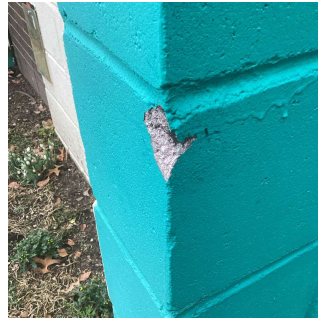
Facade H

STONE: CRACKS AT BUILDING CORNERS

REPLACE

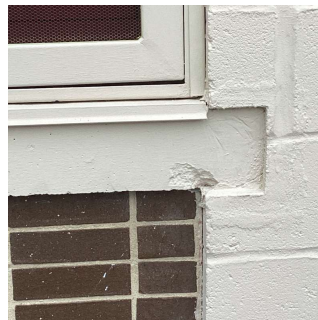
Facade B

BRICK: DETERIORATED MASONRY SILLS - MINOR

REPAIR

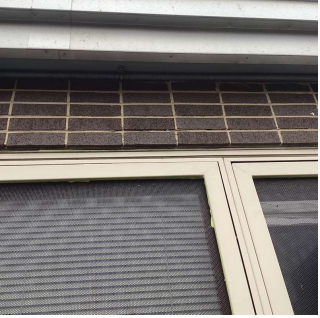
Question	Response
EXTERIOR	
EXTERIOR WALLS	
Violations	No violations recorded.
Deficiency	BRICK: DETERIORATED JOINTS
Roof Plan reference	K867

Deficiency Quantity	50
Quantity Uom	S.F.
Potential Action	REPOINT
Urgency of Action	PRIORITY 3
Purpose of Action	LEVEL 2
Deficiency Photo1

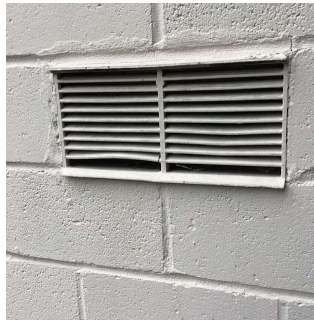
Violations	Facade B No violations recorded.
EXTERIOR SOFFITS	Does not Exist
LOADING DOCK	Does not Exist
LOUVER	Inspected
Condition	3 - Fair
Deficiency	BROKEN/ DENTED BLADES

REPLACE

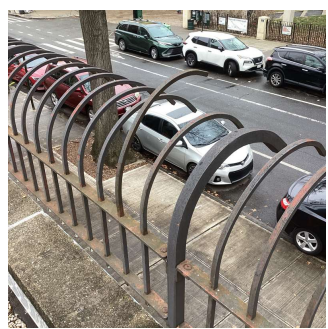
Question	Response
EXTERIOR	
ROOF	
Roofing	
Replacement Uom	S.F.
ROOF HATCH/SMOKE HATCH	Does not Exist
LEADERS, GUTTERS, DOWNSPOUTS, SCUPPERS	Does not Exist
ROOF BARRIER/FENCE	Inspected
Condition	3 - Fair
Deficiency	BEAR CLAW/METAL BAR: DETERIORATED, MAJOR RUSTING
Roof Plan reference	K867

Deficiency Quantity	10
Quantity Uom	S.F.
Potential Action	REPLACE
Urgency of Action	PRIORITY 4
Purpose of Action	LEVEL 2
Deficiency Photo1

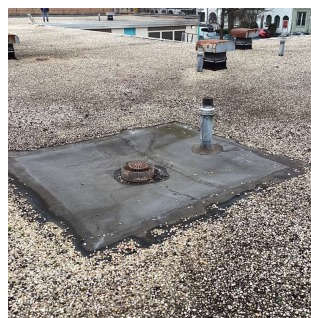
Question	Response
EXTERIOR	
ROOF	
Roofing	
ROOFING	
Does the roof have major mechanical equipment sitting on Dunnage Steel less than 18" above the Roofing?	No
Does this roof instance have a Sustainable Roof System?	No
Do solar panels exist on these roofs?	No
Is/Are the roof(s) suitable for Solar Panel installation?	Yes
Installation Year	2000
Source of Installation	Custodial Staff
Deficiency	BUILT-UP: ROOFING: LOSS OF GRAVEL
Roof Plan reference	<p>K867</p>

<p>Brooklyn Avenue</p> <p>Prospect Pl.</p>
Deficiency Quantity	40
Quantity Uom	S.F.
Potential Action	INSTALL NEW GRAVEL
Urgency of Action	PRIORITY 3
Purpose of Action	LEVEL 2
Deficiency Photo1

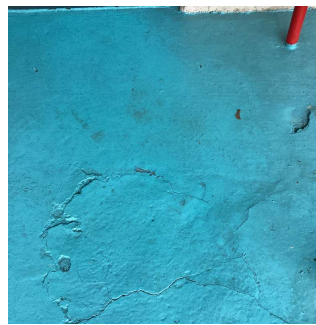
Facade A

Condition	Inspected
Deficiency	2 - Between Good and Fair
Deficiency	No deficiencies recorded
STAIRS/RAMPS	
Condition	Inspected
Deficiency	4 - Between Fair and Poor
Deficiency	CONCRETE: CRACKS/SPALLING - MAJOR

20
 S.F.
 REPLACE
 PRIORITY 4
 LEVEL 2

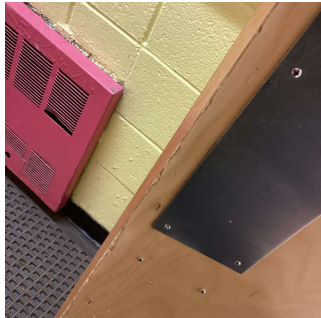
Question	Response
INTERIOR	
CLASSROOMS/CORRIDORS/ADMIN SPACES	
Ceiling	Does not Exist
Door(s)	Inspected
Condition	5 - Poor
Deficiency	WOOD: DETERIORATED DOOR
Deficiency Location/Instance	Exits 1, 3 - Vestibules, Rooms 102, 107, 108 and others
Deficiency Quantity	7
Quantity Uom	EACH
Potential Action	MAINTENANCE
Urgency of Action	PRIORITY 3
Purpose of Action	LEVEL 2
Deficiency Photo1

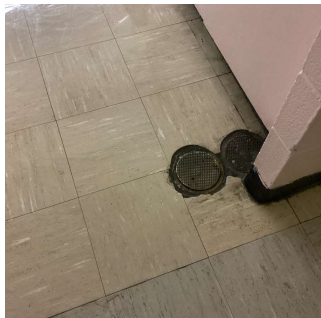
Exit 3 - Vestibule
Violations	No violations recorded.
Floor Finish	Inspected
Condition	2 - Between Good and Fair
Deficiency	VINYL TILES: BROKEN/DETERIORATED/MISSING TILES
Deficiency Location/Instance	Rooms 102, 108, 109, 112, Corridor near Room 103 and others
Deficiency Quantity	70
Quantity Uom	S.F.
Potential Action	REPLACE
Urgency of Action	PRIORITY 3
Purpose of Action	LEVEL 2
Deficiency Photo1

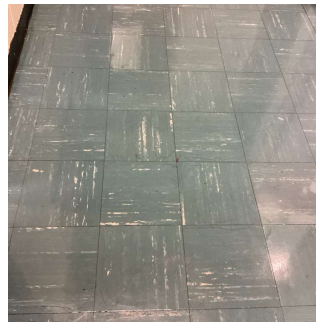
Room 108
Violations	No violations recorded.
Deficiency	VINYL TILES: DETERIORATED SUBSTRATE
Deficiency Location/Instance	Rooms 102, 119, Corridor near Room 116

Deficiency Quantity	50
Quantity Uom	S.F.
Potential Action	REPLACE
Urgency of Action	PRIORITY 3
Purpose of Action	LEVEL 2

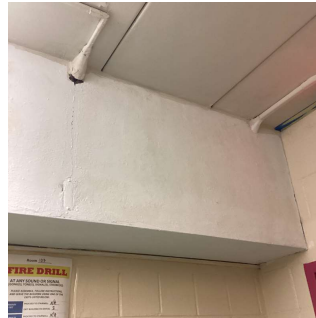
Room 107

PLASTER: CRACKS/SPALLING

REPLACE

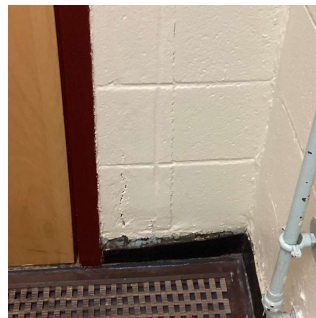
MASONRY: CRACKS/SPALLING

REPLACE

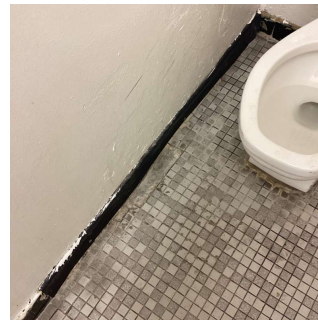
Room 103

CERAMIC TILE: BROKEN/MISSING TILES

REPLACE

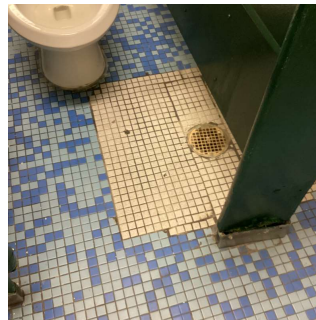
In Multipurpose Room

CERAMIC TILE: BROKEN/MISSING TILES

REPLACE

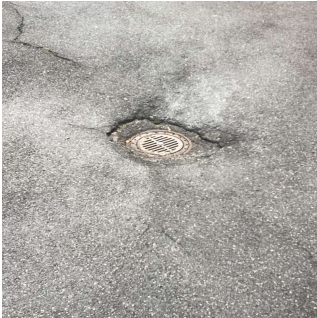
Yes	Tripping Hazard	Localized sink area is a potential tripping hazard.	SITE PAVING Student Non-Use Asphalt	Prospect Place	James Baker	Cleaner

Question	Response
SITE	
Drainage System for Soil	Inspected
Culverts - Soil Covering	Does not Exist
DRINKING FOUNTAINS	Does not Exist
FENCES	Inspected
Condition	3 - Fair
Deficiency	WROUGHT IRON: DAMAGED/DETERIORATED
Deficiency Location/Instance	Prospect Place
Deficiency Quantity	240
Quantity Uom	S.F.
Potential Action	REPLACE
Urgency of Action	PRIORITY 3
Purpose of Action	LEVEL 2
Deficiency Photo1	 
Violations	Prospect Place No violations recorded.
Deficiency	CONCRETE CURB: DAMAGED/DETERIORATED
Deficiency Location/Instance	Prospect Place
Deficiency Quantity	50
Quantity Uom	S.F.
Potential Action	REPLACE
Urgency of Action	PRIORITY 3
Purpose of Action	LEVEL 2
Deficiency Photo1	 
Violations	Prospect Place No violations recorded.
IRRIGATION SYSTEM	Does not Exist
PAVING	Inspected
Student Non-Use	Inspected
Gravel Exists?	No
Asphalt	Inspected
Condition	3 - Fair
Deficiency	POTHOLE

Question	Response
SITE	
PAVING	
Student Non-Use	
Asphalt	
Deficiency Location/Instance	Prospect Place
Deficiency Quantity	20
Quantity Uom	S.F.
Potential Action	REPAIR
Urgency of Action	PRIORITY 5
Purpose of Action	LEVEL 6
Deficiency Photo1

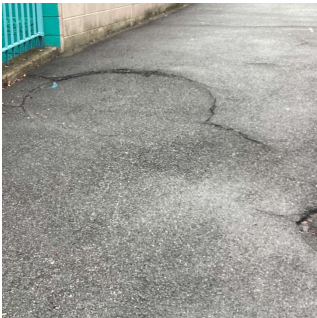
Violations	Prospect Place No violations recorded.
Cracks - Major	
Deficiency	CRACKS - MAJOR
Deficiency Location/Instance	Prospect Place
Deficiency Quantity	200
Quantity Uom	S.F.
Potential Action	REPLACE
Urgency of Action	PRIORITY 3
Purpose of Action	LEVEL 2
Deficiency Photo1

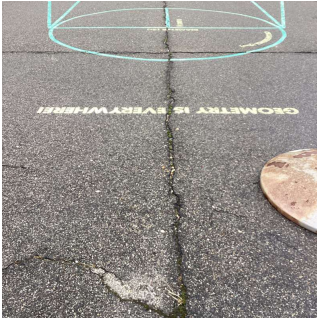
Violations	Prospect Place No violations recorded.
Concrete	
Condition	Inspected
Deficiency	2 - Between Good and Fair
Pavers	
Condition	Does not Exist
Student Use	
Gravel Exists?	Inspected No
Asphalt	
Condition	Inspected
Deficiency	4 - Between Fair and Poor
Deficiency Location/Instance	CRACKS - MAJOR Schoolyard
Deficiency Quantity	500

Question	Response
SITE	
PAVING	
Student Use	
Asphalt	
Quantity Uom	S.F.
Potential Action	REPLACE
Urgency of Action	PRIORITY 3
Purpose of Action	LEVEL 2
Deficiency Photo1
