**NYC Department of Education**  
**Building Condition Assessment Survey 2023 - 2024**

Architectural Inspection

**Asset: P.S. 361 MINISCHOOL - BROOKLYN, 3109 NEWKIRK AVENUE, New York, 11210**

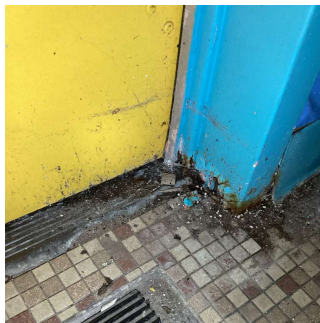
Question	Response
<b>Architectural</b>	
<b>EXTERIOR</b>	Inspected
<b>AREAWAY</b>	Does not Exist
<b>AWNINGS AND CANOPIES</b>	Does not Exist
<b>CHIMNEY</b>	Does not Exist
<b>COPING</b>	Does not Exist
<b>CORNICE</b>	Does not Exist
<b>DOORS</b>	Inspected
<b>DOORS AND FRAMES</b>	Inspected
Condition	5 - Poor

Deficiency METAL: DETERIORATED DOOR AND FRAME - MAJOR DETERIORATION

Violations	Facade D No violations recorded.
<b>DOOR HARDWARE</b>	Inspected
Condition	3 - Fair
Deficiency	No deficiencies recorded
<b>LINTELS</b>	Does not Exist
<b>TRANSOM/SIDE LIGHT</b>	Does not Exist
<b>EXTERIOR WALLS</b>	Inspected
Material Type(s)	Masonry, Steel
Replacement Quantity	6,000
Replacement Uom	S.F.
Instance on All Facades	Inspected
Instance Condition	5 - Poor
Instance Quantity	6,000
Instance Quantity Uom	S.F.
Deficiency	METAL PANEL: SEVERE DENTS
Roof Plan reference

Potential Action

REPLACE

PRIORITY 4

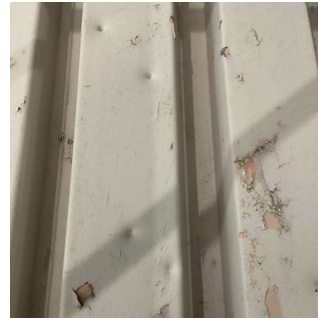
Facade A

Deficiency Quantity	80
Quantity Uom	S.F.
Potential Action	REPLACE

PRIORITY 4  
LEVEL 2

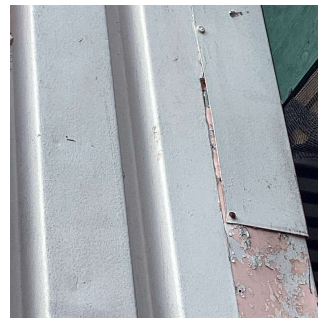
Facade B

METAL PANEL: DAMAGED TRIM

30

REPLACE

PRIORITY 4

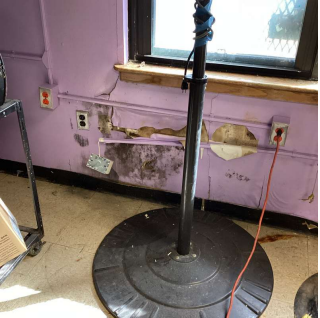
Question	Response
<b>EXTERIOR</b>	
<b>EXTERIOR WALLS</b>	
Violations	No violations recorded.
Deficiency	METAL PANEL: WATER INFILTRATION IN INSTRUCTIONAL SPACE
Roof Plan reference

Deficiency Quantity	800
Quantity Uom	S.F.
Potential Action	REPAIR
Urgency of Action	PRIORITY 5
Purpose of Action	LEVEL 2
Deficiency Photo1

Violations	Facade B - Rooms 2 (Shown), 4, 6, 13, Facade D - Rooms 7, 11, Office, Staff No violations recorded.
<b>EXTERIOR SOFFITS</b>	
Condition	Inspected
Deficiency	2 - Between Good and Fair
Deficiency	No deficiencies recorded
<b>LOADING DOCK</b>	
Deficiency	Does not Exist
<b>LOUVER</b>	
Condition	Inspected
Deficiency	2 - Between Good and Fair
Deficiency	No deficiencies recorded
<b>PARAPETS</b>	
Deficiency	Does not Exist
<b>PLAZA DECK</b>	
Deficiency	Does not Exist

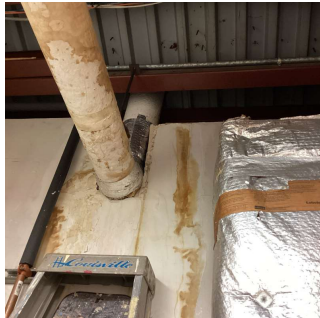
Roof 1
Instance Quantity	10,000
Instance Quantity Uom	S.F.
Does the roof have major mechanical equipment sitting on Dunnage Steel less than 18" above the Roofing?	No
Does this roof instance have a Sustainable Roof System?	No
Do solar panels exist on these roofs?	No
Is/Are the roof(s) suitable for Solar Panel installation?	No
Installation Year	1989
Source of Installation	Custodial Staff
Deficiency	METAL: ROOFING: MAJOR ACTIVE ROOF LEAKS IN NON-INSTRUCTIONAL SPACE

Deficiency Quantity	100
Quantity Uom	S.F.
Potential Action	REPLACE
Urgency of Action	PRIORITY 5
Purpose of Action	LEVEL 2

Violations	Roof 1 - Mechanical Room 5 No violations recorded.
Deficiency	<b>METAL: ROOFING: MAJOR ACTIVE ROOF LEAKS IN INSTRUCTIONAL SPACE</b>
Roof Plan reference

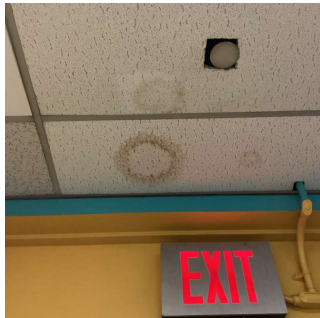
<p>K869</p> <p>Main Entrance</p> <p>HC Ramp</p> <p>K864 (P.S. 361 Parent Asset)</p> <p>E.32nd Street</p> <p>Avenue D</p> <p>A, B, C, D</p>
Deficiency Quantity	1,800
Quantity Uom	S.F.
Potential Action	REPLACE
Urgency of Action	PRIORITY 5
Purpose of Action	LEVEL 2
Deficiency Photo1

Violations	Roof 1 - Rooms 1, 2, 3, 4, 6, 7, 10, 11, 13, Office, Staff, Exits A, B (Shown), C - Vestibules, In Rooms 1/3, 2/4, 7/13, 10/12 No violations recorded.
<b>ROOFING DRAINS</b>	Does not Exist
<b>Specialties</b>	Does not Exist
<b>STAIRS/RAMPS: EXTERIOR</b>	Inspected
<b>BUILDING CHEEK/FLANK WALLS</b>	Inspected
Condition	4 - Between Fair and Poor
Deficiency	CAST IN PLACE CONCRETE: CRACKS/SPALLING - MAJOR

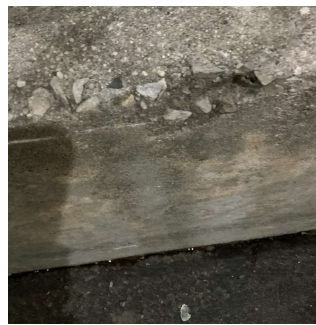
Facade A

20  
S.F.  
REPLACE  
PRIORITY 4  
LEVEL 2

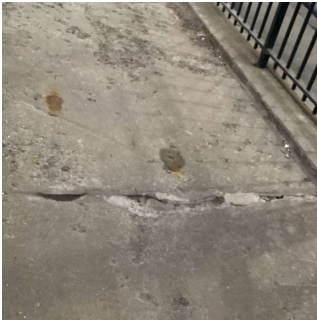
CONCRETE: CRACKS/SPALLING - MAJOR

30  
S.F.  
REPLACE  
PRIORITY 4  
LEVEL 2

Violations	Facade A No violations recorded.
Deficiency	<b>CONCRETE: CRACKS/SPALLING - MINOR</b>
Roof Plan reference	<p>K869</p>

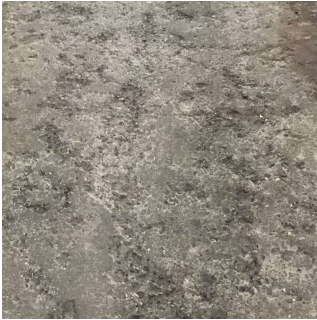
<p>E.32nd Street</p>
Deficiency Quantity	20
Quantity Uom	S.F.
Potential Action	REPAIR
Urgency of Action	PRIORITY 3
Purpose of Action	LEVEL 2
Deficiency Photo1

Violations	Facade A No violations recorded.
<b>WINDOWS</b>	Inspected
Replacement Quantity	720
Replacement Uom	S.F.
<b>EXTERIOR GUARDS</b>	Inspected
Condition	3 - Fair
Deficiency	RUST - MAJOR

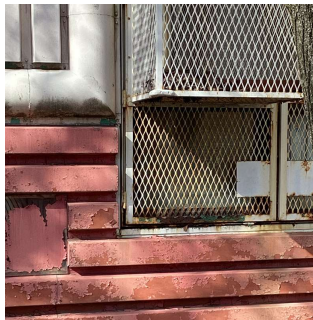
120  
S.F.  
REPLACE  
PRIORITY 4  
LEVEL 2

Facade B  
No violations recorded.

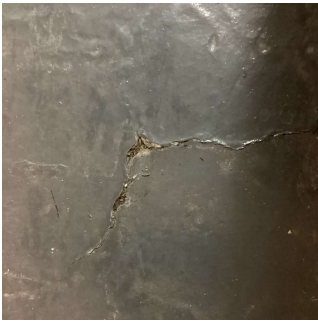
Question	Response
<b>INTERIOR</b>	
<b>POOLS</b>	Does not Exist
<b>STRUCTURAL</b>	Inspected
<b>COLUMNS/BEAMS/BEARING WALLS</b>	Inspected
Condition	2 - Between Good and Fair
Deficiency	No deficiencies recorded
<b>FLOOR STRUCTURE</b>	Inspected
Condition	3 - Fair
Deficiency	CONCRETE SLAB ON GRADE: THRU CRACKS
Deficiency Location/Instance	1st Floor - Mechanical Room
Deficiency Quantity	40
Quantity Uom	S.F.
Potential Action	REPLACE
Urgency of Action	PRIORITY 4
Purpose of Action	LEVEL 5
Deficiency Photo1

1st Floor - Mechanical Room
Violations	No violations recorded.
<b>FOUNDATION WALLS</b>	Inspected
Material Type(s)	Concrete
Condition	3 - Fair
Deficiency	CONCRETE: CRACKED/SPALLED/REINFORCEMENT EXPOSED
Deficiency Location/Instance	All Facades
Deficiency Quantity	50
Quantity Uom	S.F.
Potential Action	REPAIR
Urgency of Action	PRIORITY 3
Purpose of Action	LEVEL 5
Deficiency Photo1

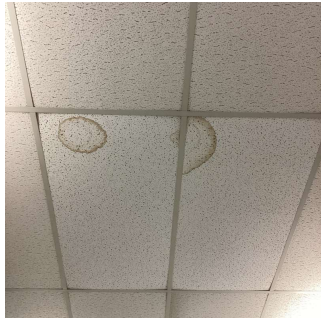
<b>Question</b>	<b>Response</b>
<b>INTERIOR</b>	
<b>STRUCTURAL</b>	Inspected
<b>ROOF STRUCTURE</b>	Inspected
Deficiency	No deficiencies recorded
<b>VAULTS-BUNKERS</b>	Does not Exist
<b>AUDITORIUM</b>	Does not Exist
<b>CAFETERIA</b>	Does not Exist
<b>CLASSROOMS/CORRIDORS/ADMIN SPACES</b>	Inspected
<b>Ceiling</b>	Inspected
Condition	5 - Poor
Deficiency	ACOUSTIC TILES: DAMAGED/MISSING
Deficiency Location/Instance	Corridor near Room 3, by Men Toilet Room, by Exit A
Deficiency Quantity	70
Quantity Uom	S.F.
Potential Action	REPLACE
Urgency of Action	PRIORITY 3
Purpose of Action	LEVEL 2
Deficiency Photo1

Violations	Corridor near Room 3 No violations recorded.
Deficiency	ACOUSTIC TILES: DAMAGED/MISSING - ACTIVE LEAK
Deficiency Location/Instance	Exits A, B, C - Vestibules, Rooms 1, 2, 3, 4, 6, 7, 10, 11, 13, Office, Staff
Deficiency Quantity	2,970
Quantity Uom	S.F.
Potential Action	REPLACE
Urgency of Action	PRIORITY 5

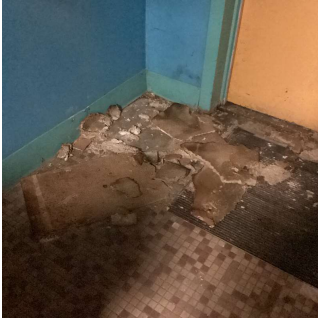
Question	Response
<b>INTERIOR</b>	
<b>CLASSROOMS/CORRIDORS/ADMIN SPACES</b>	
<b>Floor Finish</b>	Inspected
Condition	3 - Fair
Deficiency	CERAMIC TILE: BROKEN/MISSING TILES
Deficiency Location/Instance	Exits A, B, C - Vestibules
Deficiency Quantity	80
Quantity Uom	S.F.
Potential Action	REPLACE
Urgency of Action	PRIORITY 3
Purpose of Action	LEVEL 2
Deficiency Photo1

Violations	Exit A - Vestibule No violations recorded.
Deficiency	VINYL TILES: BROKEN/DETERIORATED/MISSING TILES
Deficiency Location/Instance	Corridor near Rooms 4, 7, 12, Rooms 1, 2 and others
Deficiency Quantity	180
Quantity Uom	S.F.
Potential Action	REPLACE
Urgency of Action	PRIORITY 3
Purpose of Action	LEVEL 2
Deficiency Photo1

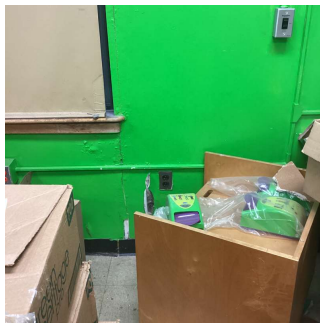
Violations	Corridor near Room 12 No violations recorded.
<b>Walls</b>	Inspected
Condition	4 - Between Fair and Poor
Deficiency	GYPSUM BOARD: DETERIORATED
Deficiency Location/Instance	Rooms 1, 3, 4, 7, Corridor near Room 5 and others

Deficiency Quantity	200
Quantity Uom	S.F.
Potential Action	REPLACE
Urgency of Action	PRIORITY 3
Purpose of Action	LEVEL 2

Room 1
Violations	No violations recorded.
Deficiency	GYPSUM BOARD: DETERIORATED - ACTIVE LEAK
Deficiency Location/Instance	Rooms 2, 4, 6, 7, 11, 13, Office, Staff
Deficiency Quantity	380
Quantity Uom	S.F.
Potential Action	REPLACE
Urgency of Action	PRIORITY 5
Purpose of Action	LEVEL 2
Deficiency Photo1

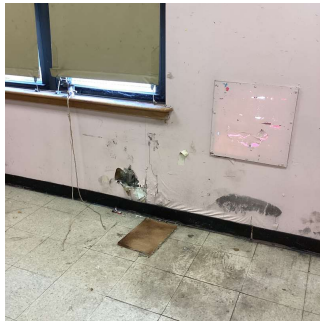
Room 4
Violations	No violations recorded.
<b>Specialties</b>	Does not Exist
<b>GYMNASIUM</b>	Does not Exist
<b>INTERIOR DOOR HARDWARE</b>	Inspected
Condition	3 - Fair
Deficiency	No deficiencies recorded
<b>INTERIOR GUARDS</b>	Does not Exist
<b>KITCHEN</b>	Does not Exist
<b>LIBRARY</b>	Does not Exist
<b>LOCKER ROOM</b>	Does not Exist
<b>MULTI-PURPOSE ROOM</b>	Does not Exist
<b>SCIENCE DEMO ROOM</b>	Does not Exist
<b>SCIENCE LAB</b>	Does not Exist
<b>SCIENCE PREP ROOM</b>	Does not Exist
<b>SHOWER ROOM</b>	Does not Exist

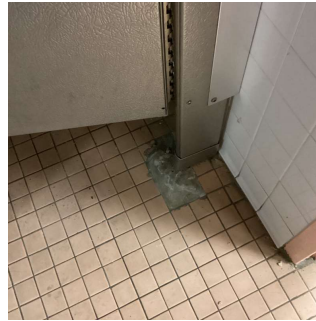
<b>Door(s)</b>	Inspected
Condition	2 - Between Good and Fair
Deficiency	No deficiencies recorded
<b>Floor Finish</b>	Inspected
Condition	2 - Between Good and Fair
Deficiency	CERAMIC TILE: BROKEN/MISSING TILES
Deficiency Location/Instance	In Room 2/4
Deficiency Quantity	10
Quantity Uom	S.F.
Potential Action	REPLACE
Urgency of Action	PRIORITY 3
Purpose of Action	LEVEL 2

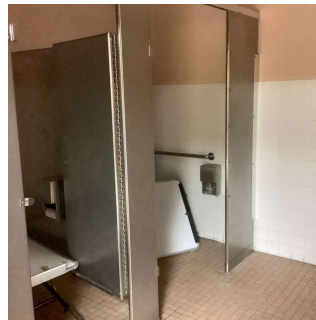
BROKEN/MISSING

In Room 1/3

1

REPLACE

PRIORITY 3
