**NYC Department of Education**  
**Building Condition Assessment Survey 2023 - 2024**

Architectural Inspection

**K871**

**Asset: COMM SCHL COMP ED (PRG GIRLS) - K, 67-69 SCHERMERHORN STREET, New York, 11201**

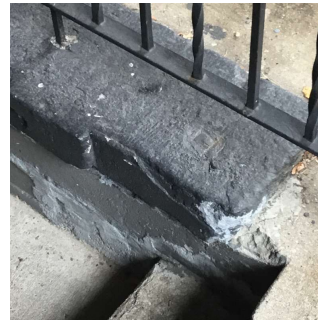
AW3  
No violations recorded.

| Question | Response |
|---|---|
| Deficiency | AREAWAY WALLS: DETERIORATED COPING STONE |

15  
S.F.  
REPLACE  
PRIORITY 4  
LEVEL 2

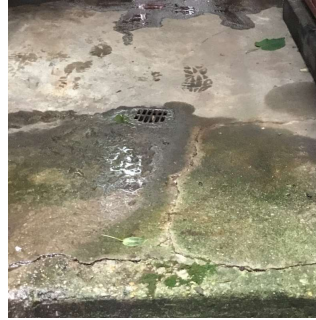
AW2

**AREAWAY SLAB: CRACKS AND SPALLING**

25  
S.F.  
REPLACE  
PRIORITY 4  
LEVEL 2

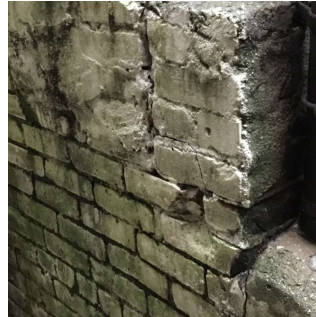
AW2

AREAWAY WALLS: CRACKS AND SPALLING

REPLACE

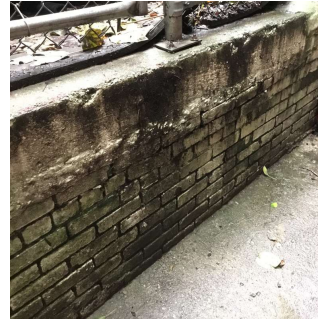
AW2

AREAWAY WALLS: DETERIORATED JOINTS

REPAIR

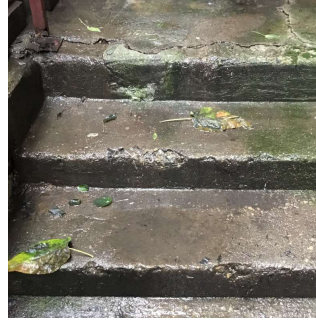
AW2  
No violations recorded.

**AREAWAY STAIRS: DETERIORATED TREADS/RISERS/NOSINGS**

REPLACE

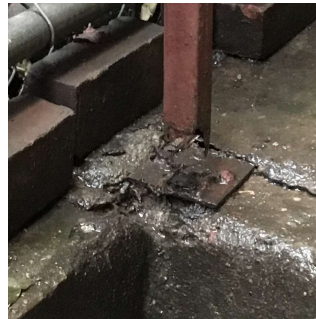
AW2  
No violations recorded.

**AREAWAY STAIRS: DETERIORATED RAILINGS**

10  
L.F.  
REPLACE  
PRIORITY 4  
LEVEL 2

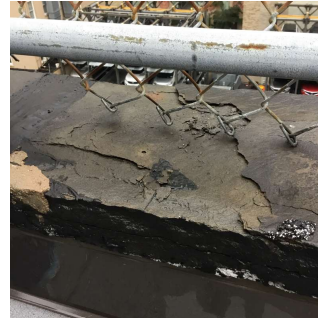
Roof 1

STONE: CRACKED/BROKEN PIECES

REPLACE-IN-KIND

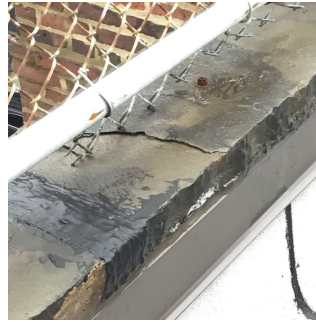
Roof 1  
No violations recorded.

**CAST STONE: CRACKED/BROKEN PIECES**

REPLACE-IN-KIND

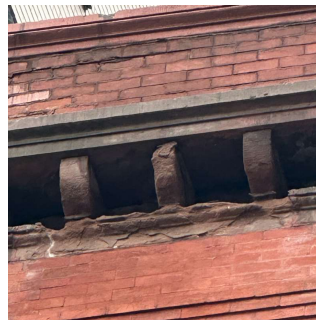
Facade A  
No violations recorded.

STONE: MAJOR CRACKS, SPALLING

REPLACE

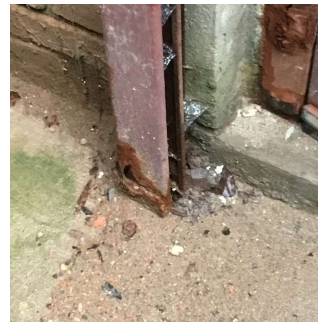
Facade D  
No violations recorded.

ROLL-UP DOOR: DETERIORATED DOOR AND FRAME - MAJOR DETERIORATION

600  
S.F.  
REPLACE  
PRIORITY 4  
LEVEL 2

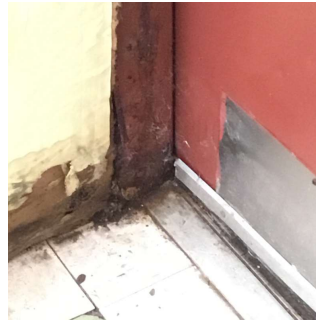
Facade C

Deficiency METAL: DETERIORATED DOOR AND FRAME - MAJOR DETERIORATION

4  
EACH  
REPLACE  
PRIORITY 4  
LEVEL 2

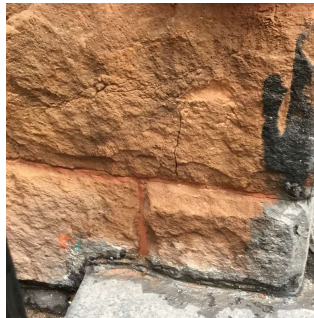
Facade A

STONE: CHIPPED/SPALLED/BROKEN PIECES - MINOR

REPAIR

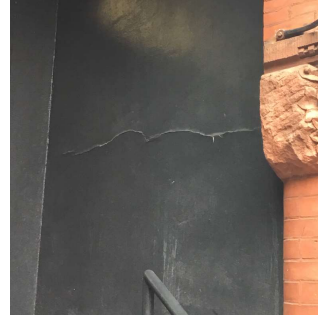
Facade A

STUCCO CEMENT SURFACE: CRACKS, SPALLING

REPLACE

PRIORITY 4  
LEVEL 2

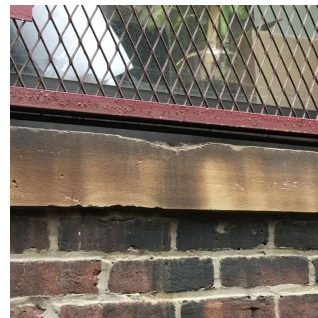
Facade D

**BRICK: DETERIORATED MASONRY SILLS - MAJOR**

REMOVE AND REPLACE

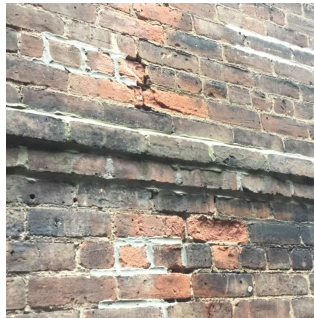
Facade D

BRICK: MAJOR / THRU CRACKS

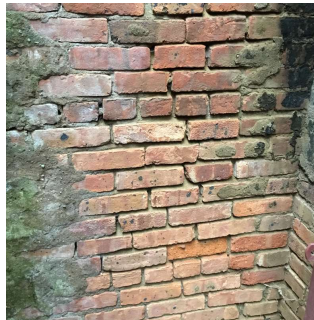
Facade D

BRICK: DETERIORATED JOINTS

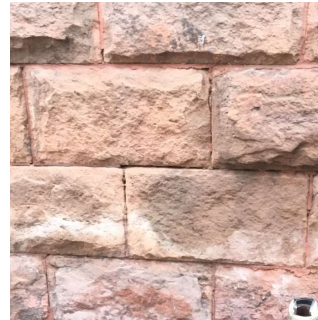
Facade A

STONE: DETERIORATED JOINTS

PRIORITY 4  
LEVEL 2

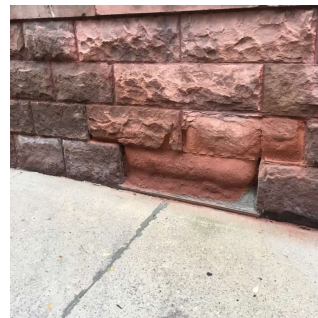
Facade A

STONE: CHIPPED/SPALLED/BROKEN PIECES - MAJOR

REPLACE

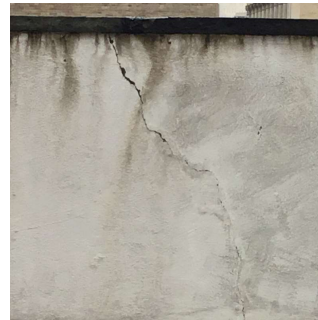
Roof 1  
No violations recorded.

| Question | Response |
|---|---|
| Deficiency | CONCRETE: MINOR CRACKS, SPALLING |

50  
S.F.  
REPAIR  
PRIORITY 3  
LEVEL 2

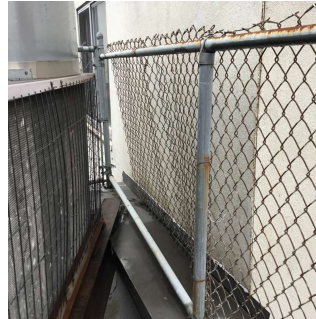
Roof 1

CHAIN LINK: DETERIORATED, MAJOR RUSTING

| Potential Action | REPLACE |

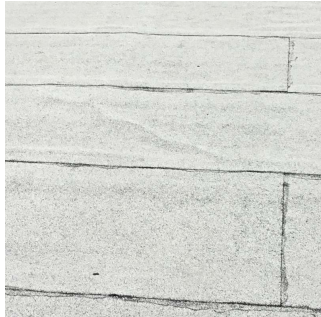
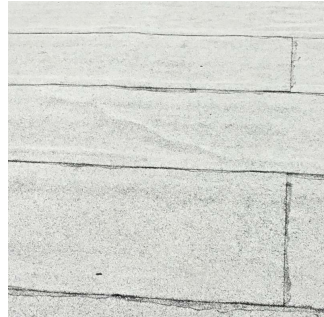
Roof 1

| Deficiency | MODIFIED BITUMEN: ROOFING: DELAMINATION |

| Potential Action | REPLACE ROOFING WITHOUT MAJOR EQUIPMENT REMOVAL |

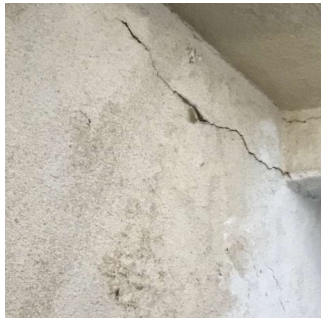
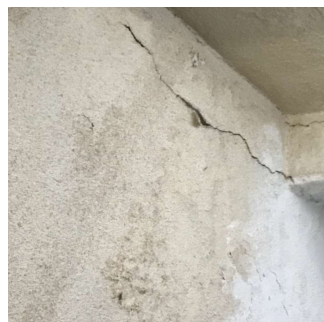
BULKHEAD/PENTHOUSE WALLS/INTERIOR: PLASTER CRACKS/SPALLING

| Potential Action | REPLACE |

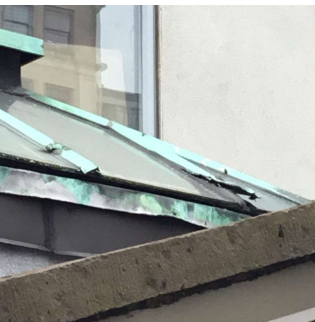
| Question | Response |
|---|---|
| Deficiency | DAMAGED FLASHING |

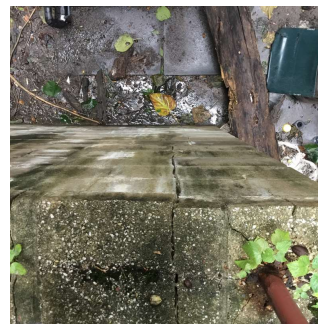
Facade C

| Question | Response |
|---|---|
| Deficiency | MASONRY UNIT: CRACKS/SPALLING - MAJOR |

20  
 S.F.  
 REPLACE  
 PRIORITY 4  
 LEVEL 2

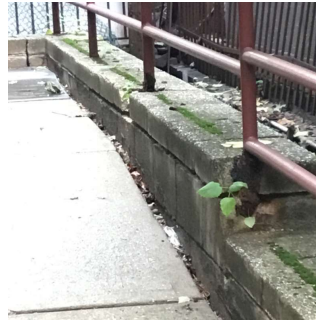
Facade C

MASONRY UNIT: DETERIORATED JOINTS AT COPING STONES

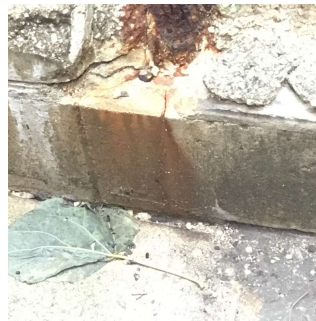
Facade C

**MASONRY UNIT: CRACKS/SPALLING - MINOR**

REPAIR

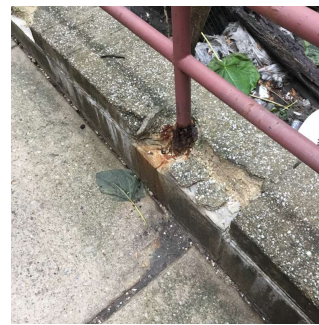
Facade C  
No violations recorded.

**MASONRY UNIT: DETERIORATED COPING STONE**

K871  
35  
S.F.  
REPLACE  
PRIORITY 4  
LEVEL 2

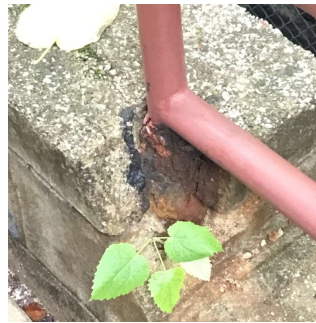
Facade C

RUST - MAJOR

K871  
35  
L.F.  
REPLACE  
PRIORITY 4  
LEVEL 2

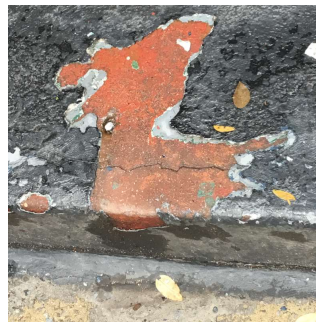
Facade A

STONE: CRACKS/SPALLING - MINOR

REPAIR

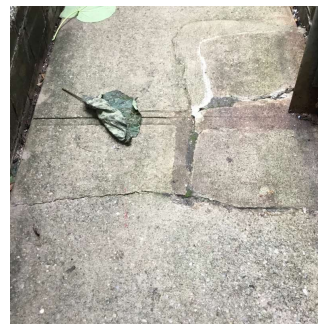
Facade C

CONCRETE: CRACKS/SPALLING - MAJOR

20  
S.F.  
REPLACE  
PRIORITY 4  
LEVEL 2

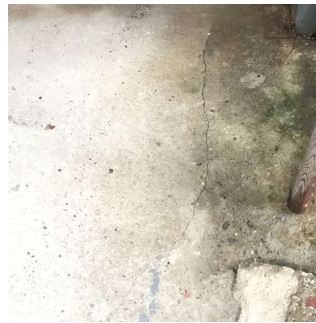
Facade C

CONCRETE: CRACKS/SPALLING - MINOR

30  
S.F.  
REPAIR  
PRIORITY 3  
LEVEL 2

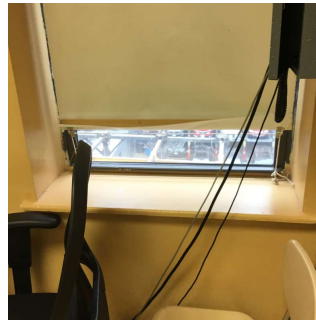
Facade D - Room 403  
No violations recorded.

ALUMINUM - DOUBLE HUNG: DETERIORATED

30  
S.F.  
REPLACE WINDOW  
PRIORITY 4  
LEVEL 2

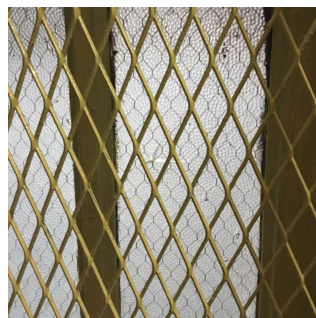
Facade B - Stairwell A/3 and A/1

| Deficiency | STEEL: BROKEN PANE |

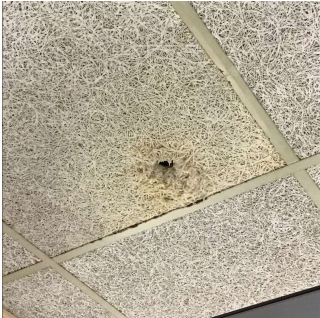
| Question | Response |
|---|---|
| Violations | Near Exit<br>No violations recorded. |

| Question | Response |
|---|---|
| Deficiency | TECTUM: DAMAGED/MISSING |

| Question | Response |
|---|---|
| Potential Action | REPLACE |

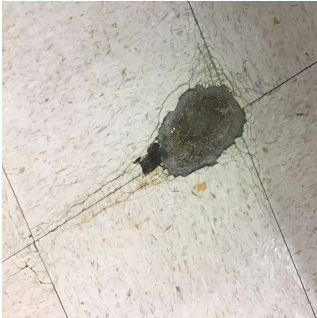
| <b>Question</b> | <b>Response</b> |
|---|---|
| | Near center |

| <b>Question</b> | <b>Response</b> |
|---|---|
| Deficiency | VINYL TILES: BROKEN/DETERIORATED/MISSING TILES |

| <b>Question</b> | <b>Response</b> |
|---|---|
| Potential Action | REPLACE |

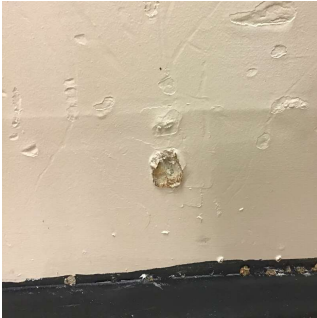
| <b>Question</b> | <b>Response</b> |
|---|---|
| | Near Right Side |

| <b>Question</b> | <b>Response</b> |
|---|---|
| Deficiency | GYPSUM BOARD: DETERIORATED |

| <b>Question</b> | <b>Response</b> |
|---|---|
| Potential Action | REPLACE |

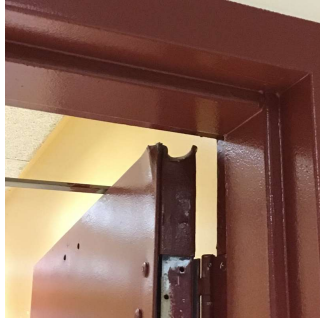
| <b>Question</b> | <b>Response</b> |
|---|---|
| Violations | Room 403<br>No violations recorded. |

| <b>Question</b> | <b>Response</b> |
|---|---|
| Deficiency | METAL: DETERIORATED DOOR |

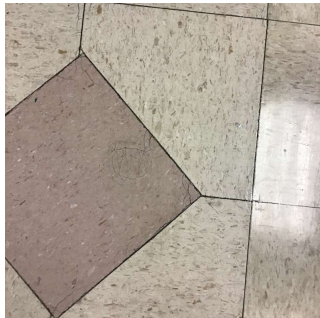
| <b>Question</b> | <b>Response</b> |
|---|---|
| Violations | Corridor near Room 105<br>No violations recorded. |

| <b>Question</b> | <b>Response</b> |
|---|---|
| Deficiency | VINYL TILES: BROKEN/DETERIORATED/MISSING TILES |

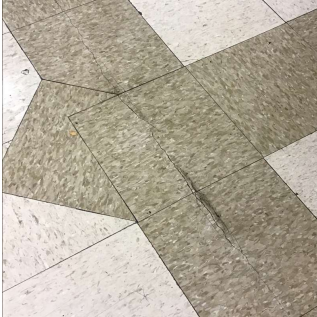
| <b>Question</b> | <b>Response</b> |
|---|---|
| | Lobby |

| <b>Question</b> | <b>Response</b> |
|---|---|
| Deficiency | VINYL TILES: DETERIORATED SUBSTRATE |
