NYC Department of Education
Building Condition Assessment Survey 2023 - 2024

Architectural Inspection

Asset: I.S. 364 ANNEX - BROOKLYN, 1461 GENEVA LOOP, New York, 11239

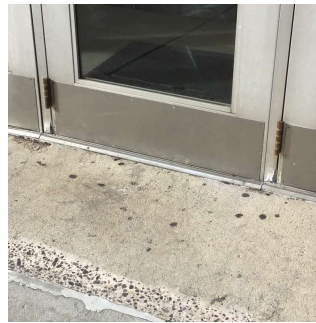
Facade A

Deficiency METAL: DETERIORATED DOOR AND FRAME - MAJOR DETERIORATION

REPLACE

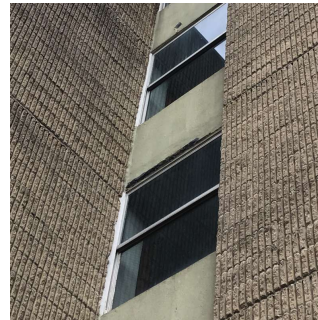
Facade A

CAST IN PLACE / PRE-CAST CONCRETE: MAJOR CRACKS/SPALLING

REPLACE

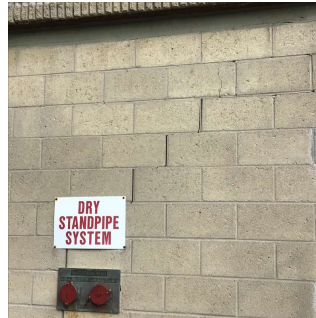
Facade A

CONCRETE MASONRY UNIT: MAJOR / THRU CRACKS

REMOVE AND REBUILD

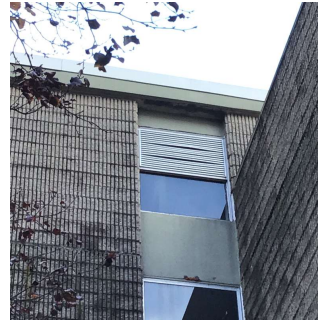
Facade A

BROKEN/ DENTED BLADES

40
S.F.
REPLACE
PRIORITY 4
LEVEL 2

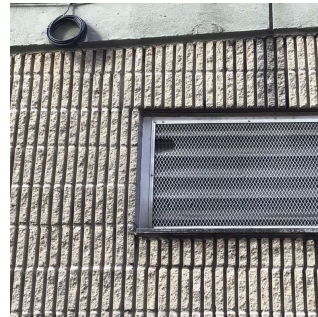
Facade A

MISSING/DAMAGED SCREEN

REPLACE

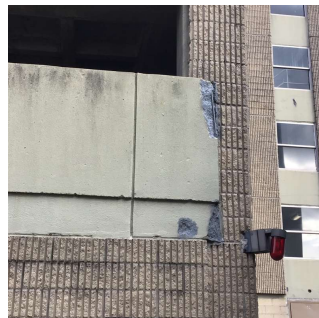
Question	Response
EXTERIOR	
PARAPETS	
Material Type(s)	Concrete
Replacement Quantity	4,200
Replacement Uom	C.F.
Instance on All Facades	Inspected
Instance Condition	3 - Fair
Instance Quantity	4,200
Instance Quantity Uom	C.F.
Deficiency	CONCRETE: MAJOR DETERIORATION/CRACKS
Roof Plan reference	<p>K872</p>

Deficiency Quantity	20
Quantity Uom	S.F.
Potential Action	REMOVE AND REBUILD
Urgency of Action	PRIORITY 4
Purpose of Action	LEVEL 2
Deficiency Photo1

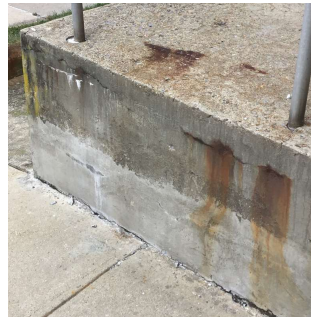
Question	Response
EXTERIOR	
ROOF	
Roofing	Inspected
ROOFING DRAINS	Inspected
Condition	2 - Between Good and Fair
Deficiency	No deficiencies recorded
Specialties	Inspected
BULKHEAD/PENTHOUSE	Not Required
CUPOLA/ SPIRES/ TOWERS	Does not Exist
DORMER	Does not Exist
DUNNAGE STEEL	Does not Exist
SKYLIGHT/ROOF VENT	Does not Exist
ROOF/GRAVITY TANK	Does not Exist
STAIRS/RAMPS: EXTERIOR	Inspected
BUILDING CHEEK/FLANK WALLS	Inspected
Condition	4 - Between Fair and Poor
Deficiency	CAST IN PLACE CONCRETE: CRACKS/SPALLING - MAJOR
Roof Plan reference

Deficiency Quantity	20
Quantity Uom	S.F.
Potential Action	REPLACE
Urgency of Action	PRIORITY 4
Purpose of Action	LEVEL 2
Deficiency Photo1

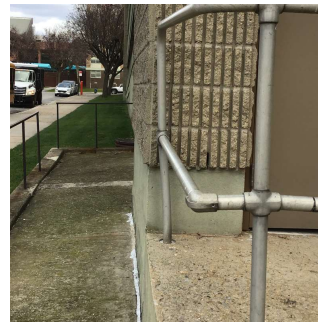
Facade C

Violations	<p>Facade C</p> <p>No violations recorded.</p>
RAILINGS	Inspected
Condition	3 - Fair
Deficiency	DAMAGED

10
L.F.
REPLACE
PRIORITY 4
LEVEL 2

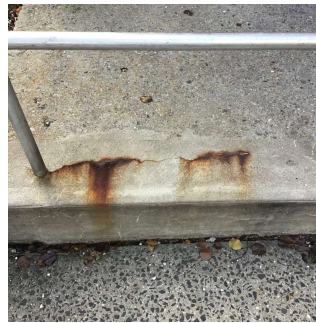
Facade A

CONCRETE: CRACKS/SPALLING - MAJOR

70
S.F.
REPLACE
PRIORITY 4
LEVEL 2

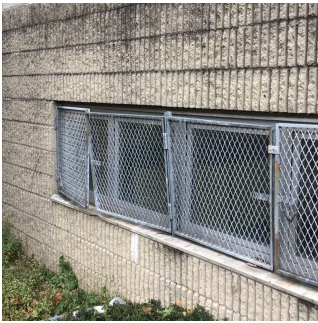
DETERIORATED/TORN-OUT/MISSING

REPLACE

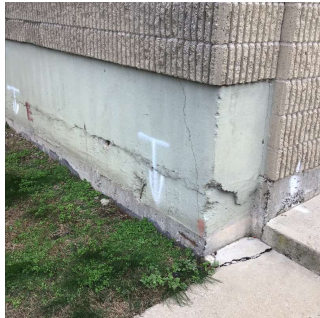
FLOOR STRUCTURE	Inspected
Condition	2 - Between Good and Fair
Deficiency	No deficiencies recorded
FOUNDATION WALLS	Inspected
Material Type(s)	Concrete
Condition	3 - Fair
Deficiency	CONCRETE: CRACKED/SPALLED/REINFORCEMENT EXPOSED
Deficiency Location/Instance	Facade C

Question	Response
INTERIOR	
STRUCTURAL	
FOUNDATION WALLS	
Deficiency Quantity	30
Quantity Uom	S.F.
Potential Action	REPAIR
Urgency of Action	PRIORITY 3
Purpose of Action	LEVEL 5
Deficiency Photo1

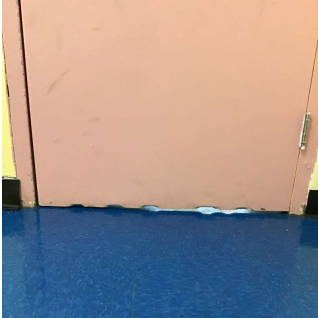
Question	Response
INTERIOR	
CLASSROOMS/CORRIDORS/ADMIN SPACES	
Door(s)	Inspected
Condition	5 - Poor
Deficiency	METAL: DETERIORATED DOOR
Deficiency Location/Instance	Room 215
Deficiency Quantity	1
Quantity Uom	EACH
Potential Action	MAINTENANCE
Urgency of Action	PRIORITY 3
Purpose of Action	LEVEL 2
Deficiency Photo1

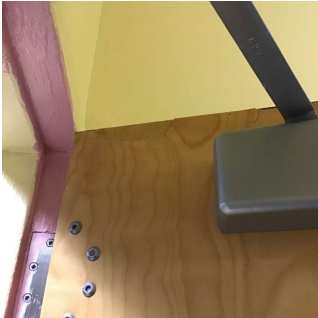
Violations	Room 215 No violations recorded.
Deficiency	WOOD: DETERIORATED DOOR
Deficiency Location/Instance	Room 207
Deficiency Quantity	1
Quantity Uom	EACH
Potential Action	MAINTENANCE
Urgency of Action	PRIORITY 3
Purpose of Action	LEVEL 2
Deficiency Photo1

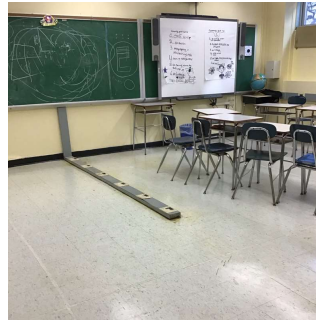
Violations	Room 207 No violations recorded.
Floor Finish	Inspected
Condition	2 - Between Good and Fair
Deficiency	VINYL TILES: TRIPPING HAZARD - ELECTRICAL OUTLET
Deficiency Location/Instance	Room 214
Deficiency Quantity	10
Quantity Uom	S.F.
Potential Action	REMOVE
Urgency of Action	PRIORITY 5
Purpose of Action	LEVEL 6

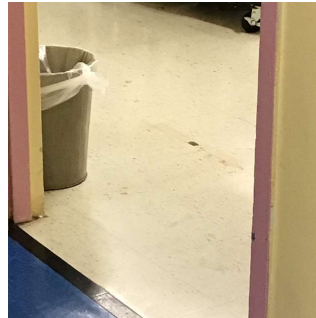
Room 200

VINYL TILES: BROKEN/DETERIORATED/MISSING TILES

REPLACE

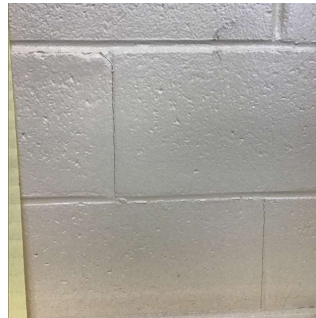
MASONRY: CRACKS/SPALLING

Room 206, exit 2, exit 3

REPLACE
