NYC Department of Education
Building Condition Assessment Survey 2023 - 2024

Architectural Inspection

Asset: P.S. 274 MINISCHOOL - BROOKLYN, 800 BUSHWICK AVENUE, New York, 11221

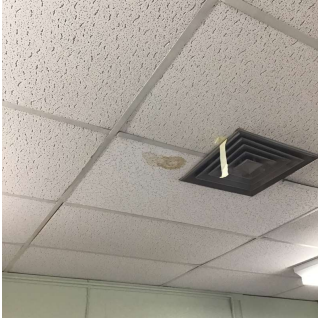
Question	Response
INTERIOR	
CLASSROOMS/CORRIDORS/ADMIN SPACES	
Ceiling	
Condition	2 - Between Good and Fair
Deficiency	ACOUSTIC TILES: DAMAGED/MISSING
Deficiency Location/Instance	Rooms 1-2, M12, Corridor near Rooms 1-2, 4, Exit Vestibule 3, and others
Deficiency Quantity	80
Quantity Uom	S.F.
Potential Action	REPLACE
Urgency of Action	PRIORITY 3
Purpose of Action	LEVEL 2
Deficiency Photo1

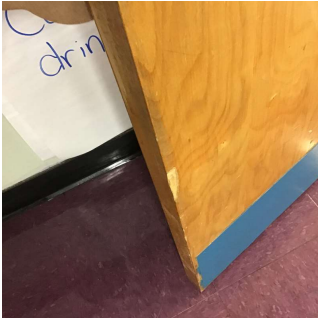
Violations	Room M12 No violations recorded.
Door(s)	
Condition	Inspected
Condition	5 - Poor
Deficiency	WOOD: DETERIORATED DOOR
Deficiency Location/Instance	Rooms 1-2, 3, 4, 9, 10
Deficiency Quantity	5
Quantity Uom	EACH
Potential Action	MAINTENANCE
Urgency of Action	PRIORITY 3
Purpose of Action	LEVEL 2
Deficiency Photo1

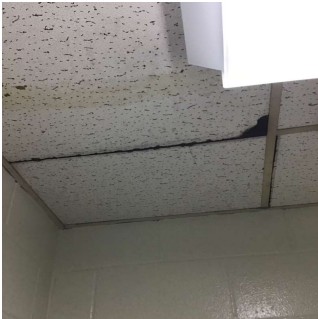
Question	Response
INTERIOR	
SHOWER ROOM	Does not Exist
STAIRS/RAMPS: INTERIOR	Does not Exist
TOILET ROOMS - STAFF	Inspected
Ceiling	Inspected
Condition	4 - Between Fair and Poor
Deficiency	ACOUSTIC TILES: DAMAGED/MISSING
Deficiency Location/Instance	Men
Deficiency Quantity	10
Quantity Uom	S.F.
Potential Action	REPLACE
Urgency of Action	PRIORITY 3
Purpose of Action	LEVEL 2
Deficiency Photo1

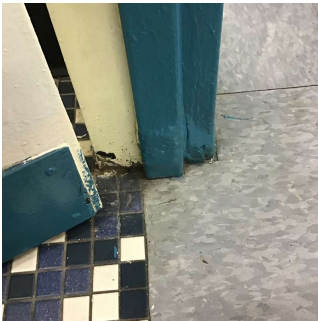
Violations	Men No violations recorded.
Door(s)	Inspected
Condition	5 - Poor
Deficiency	METAL: DETERIORATED DOOR AND FRAME
Deficiency Location/Instance	Women
Deficiency Quantity	1
Quantity Uom	EACH
Potential Action	MAINTENANCE
Urgency of Action	PRIORITY 3
Purpose of Action	LEVEL 2
Deficiency Photo1

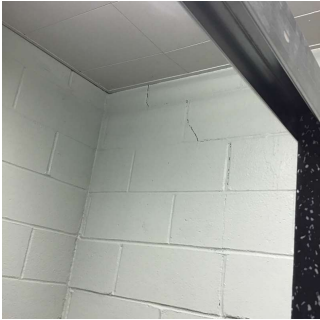
Question	Response
INTERIOR	
TOILET ROOMS - STUDENTS	
Stalls	Inspected
Condition	2 - Between Good and Fair
Deficiency	No deficiencies recorded
Walls	Inspected
Condition	2 - Between Good and Fair
Deficiency	MASONRY: CRACKS/SPALLING
Deficiency Location/Instance	Boys
Deficiency Quantity	10
Quantity Uom	S.F.
Potential Action	REPLACE
Urgency of Action	PRIORITY 3
Purpose of Action	LEVEL 2
Deficiency Photo1
