**NYC Department of Education**  
**Building Condition Assessment Survey 2023 - 2024**

Architectural Inspection

**K877**

**Asset:** P.S. 369 AX-(OL 396X/FLTB TN HL)-K, 35 SNYDER AVENUE, New York, 11226

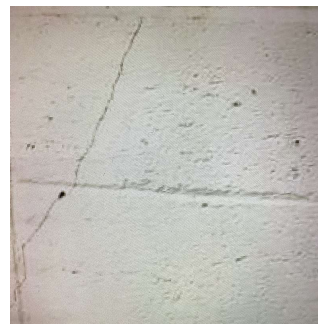
Facade D

Deficiency	No deficiencies recorded
<b>ROOFING DRAINS</b>	Does not Exist
<b>Specialties</b>	Inspected
<b>BULKHEAD/PENTHOUSE</b>	Does not Exist
<b>CUPOLA/ SPIRES/ TOWERS</b>	Inspected
Condition	2 - Between Good and Fair
Deficiency	No deficiencies recorded
<b>DORMER</b>	Inspected
Condition	2 - Between Good and Fair
Deficiency	No deficiencies recorded
<b>DUNNAGE STEEL</b>	Does not Exist
<b>SKYLIGHT/ROOF VENT</b>	Does not Exist
<b>ROOF/GRAVITY TANK</b>	Does not Exist
<b>STAIRS/RAMPS: EXTERIOR</b>	Inspected
<b>BUILDING CHEEK/FLANK WALLS</b>	Inspected
Condition	3 - Fair
Deficiency	MASONRY UNIT: CRACKS/SPALLING - MAJOR

10  
S.F.  
REPLACE  
PRIORITY 4  
LEVEL 2

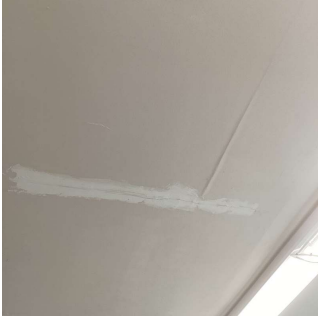
<b>VAULTS-BUNKERS</b>	Does not Exist
<b>AUDITORIUM</b>	Does not Exist
<b>CAFETERIA</b>	Does not Exist
<b>CLASSROOMS/CORRIDORS/ADMIN SPACES</b>	Inspected
<b>Ceiling</b>	Inspected
Condition	2 - Between Good and Fair
Deficiency	GYPSUM BOARD: DAMAGED/DETERIORATED
Deficiency Location/Instance	Room 7, Room in the Attic, Corridor near Room 4, by Stair CD/2, Main Entrance Lobby and others
Deficiency Quantity	80
Quantity Uom	S.F.

Question	Response
<b>INTERIOR</b>	
<b>CLASSROOMS/CORRIDORS/ADMIN SPACES</b>	
<b>Ceiling</b>	
Potential Action	REPLACE
Urgency of Action	PRIORITY 3
Purpose of Action	LEVEL 2
Deficiency Photo1

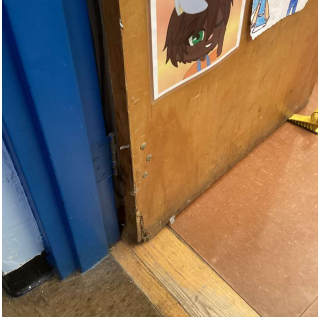
Violations	Room in the Attic No violations recorded.
<b>Door(s)</b>	Inspected
Condition	5 - Poor
Deficiency	WOOD: DETERIORATED DOOR
Deficiency Location/Instance	Rooms 3, 4, 6, 8, Main Entrance - Vestibule
Deficiency Quantity	6
Quantity Uom	EACH
Potential Action	MAINTENANCE
Urgency of Action	PRIORITY 3
Purpose of Action	LEVEL 2
Deficiency Photo1

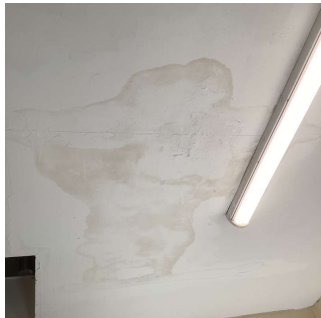
Condition	2 - Between Good and Fair
Deficiency	GYPSUM BOARD: DAMAGED/DETERIORATED
Deficiency Location/Instance	Stair D/3
Deficiency Quantity	50
Quantity Uom	S.F.
Potential Action	REPLACE
Urgency of Action	PRIORITY 3
Purpose of Action	LEVEL 2
Deficiency Photo1

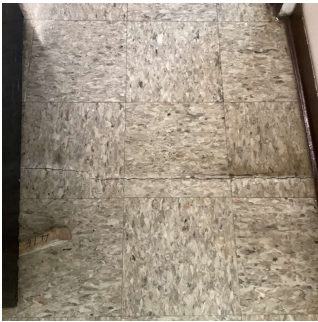
Question	Response
<b>INTERIOR</b>	
<b>STAIRS/RAMPS: INTERIOR</b>	
<b>Ceiling</b>	Inspected
Violations	No violations recorded.
<b>Door(s)</b>	Inspected
Condition	2 - Between Good and Fair
Deficiency	No deficiencies recorded
<b>Partition</b>	Does not Exist
<b>Railings</b>	Inspected
Condition	2 - Between Good and Fair
Deficiency	No deficiencies recorded
<b>Stairs and Landings</b>	Inspected
Condition	2 - Between Good and Fair
Deficiency	VINYL TILES: DETERIORATED SUBSTRATE
Deficiency Location/Instance	Stairs A/2, CD/3, 2
Deficiency Quantity	30
Quantity Uom	S.F.
Potential Action	REPLACE
Urgency of Action	PRIORITY 3
Purpose of Action	LEVEL 2
Deficiency Photo1

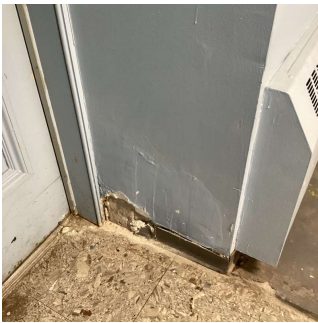
Violations	Stair D/3 No violations recorded.
<b>Walls</b>	Inspected
Condition	3 - Fair
Deficiency	PLASTER: CRACKS/SPALLING
Deficiency Location/Instance	Near Exit F
Deficiency Quantity	20
Quantity Uom	S.F.
Potential Action	REPLACE
Urgency of Action	PRIORITY 3
Purpose of Action	LEVEL 2

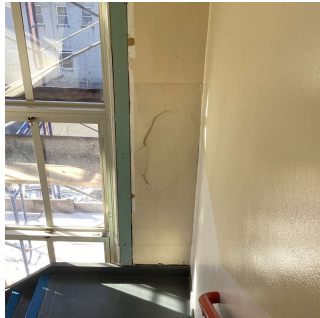
Question	Response
<b>INTERIOR</b>	
<b>STAIRS/RAMPS: INTERIOR</b>	
<b>Walls</b>	
Violations	No violations recorded.
Deficiency	GYPSUM BOARD: DETERIORATED
Deficiency Location/Instance	Stairs A/2,1, CD/3, 2, 1 and others
Deficiency Quantity	250
Quantity Uom	S.F.
Potential Action	REPLACE
Urgency of Action	PRIORITY 3
Purpose of Action	LEVEL 2
Deficiency Photo1

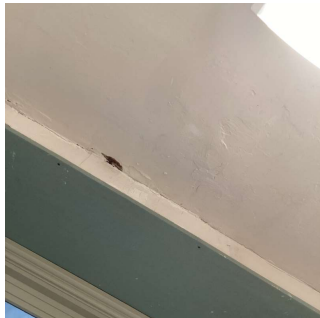
Violations	Stair CD/3 No violations recorded.
<b>TOILET ROOMS - STAFF</b>	
Violations	Inspected
<b>Ceiling</b>	
Violations	Inspected
Condition	5 - Poor
Deficiency	PLASTER: CRACKS/SPALLING
Deficiency Location/Instance	Men Toilet Room - Basement
Deficiency Quantity	10
Quantity Uom	S.F.
Potential Action	REPLACE
Urgency of Action	PRIORITY 3
Purpose of Action	LEVEL 2
Deficiency Photo1

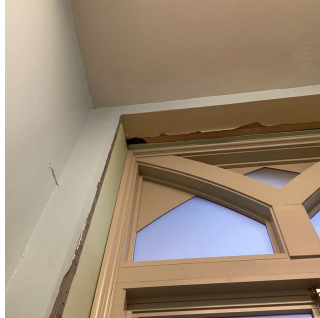
Violations	Men Toilet Room - Basement No violations recorded.
Deficiency	GYPSUM BOARD: DAMAGED/DETERIORATED
Deficiency Location/Instance	Women Toilet Room - 1st Floor, Men Toilet Room - Basement, Women Toilet Room - Basement

Deficiency Quantity	30
Quantity Uom	S.F.
Potential Action	REPLACE
Urgency of Action	PRIORITY 3

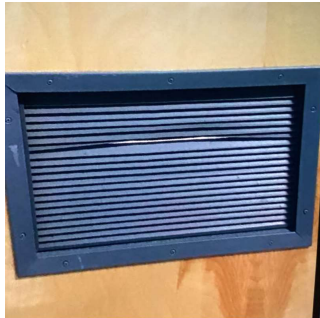
Women Toilet Room - 1st Floor
Violations	No violations recorded.
<b>Door(s)</b>	
Condition	Inspected
Deficiency	5 - Poor
Deficiency Location/Instance	WOOD: DAMAGED LOUVER
Deficiency Quantity	Men Toilet Room - 1st Floor
Quantity Uom	1
Potential Action	EACH
Urgency of Action	MAINTENANCE
Purpose of Action	PRIORITY 3
Deficiency Photo1	LEVEL 2

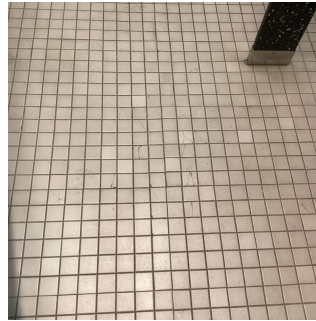
Women Toilet Room - 1st Floor
Violations	No violations recorded.
<b>Floor Finish</b>	
Condition	Inspected
Deficiency	4 - Between Fair and Poor
Deficiency Location/Instance	CERAMIC TILE: BROKEN/MISSING TILES
Deficiency Quantity	Women Toilet Room - 1st Floor, Men Toilet Room - 1st Floor
Quantity Uom	20
Potential Action	S.F.
Urgency of Action	REPLACE
Purpose of Action	PRIORITY 3
	LEVEL 2

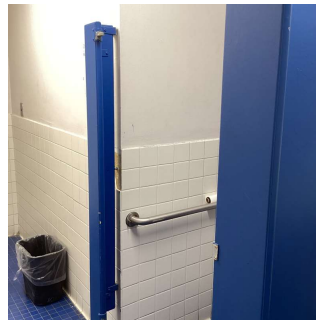
BROKEN/MISSING

Men Toilet Room - Basement

REPLACE

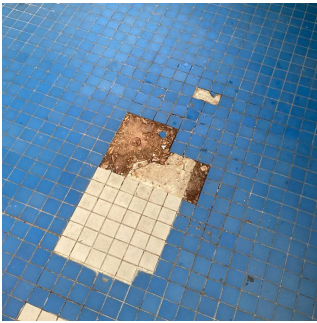
Question	Response
<b>INTERIOR</b>	
<b>TOILET ROOMS - STAFF</b>	
<b>Walls</b>	
Deficiency Photo1	 
	Women Toilet Room - 1st Floor
Violations	No violations recorded.
Deficiency	CERAMIC TILE: BROKEN/ MISSING
Deficiency Location/Instance	Men Toilet Room - Basement, Women Toilet Room - Basement
Deficiency Quantity	20
Quantity Uom	S.F.
Potential Action	REPLACE
Urgency of Action	PRIORITY 3
Purpose of Action	LEVEL 2
Deficiency Photo1	 
	Men Toilet Room - Basement
Violations	No violations recorded.
<b>TOILET ROOMS - STUDENTS</b>	
	Inspected
<b>Ceiling</b>	Inspected
Condition	2 - Between Good and Fair
Deficiency	No deficiencies recorded
<b>Door(s)</b>	Inspected
Condition	2 - Between Good and Fair
Deficiency	No deficiencies recorded
<b>Floor Finish</b>	Inspected
Condition	2 - Between Good and Fair
Deficiency	CERAMIC TILE: BROKEN/MISSING TILES
Deficiency Location/Instance	Boys Toilet Room - 2nd Floor
Deficiency Quantity	10
Quantity Uom	S.F.

Potential Action	REPLACE
Urgency of Action	PRIORITY 3
Purpose of Action	LEVEL 2

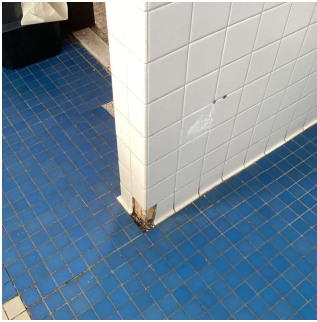
Boys Toilet Room - 2nd Floor
Violations	No violations recorded.
<b>Stalls</b>	Inspected
Condition	2 - Between Good and Fair
Deficiency	No deficiencies recorded
<b>Walls</b>	Inspected
Condition	2 - Between Good and Fair
Deficiency	CERAMIC TILE: BROKEN/ MISSING
Deficiency Location/Instance	Boys Toilet Room - 2nd Floor
Deficiency Quantity	10
Quantity Uom	S.F.
Potential Action	REPLACE
Urgency of Action	PRIORITY 3
Purpose of Action	LEVEL 2
Deficiency Photo1

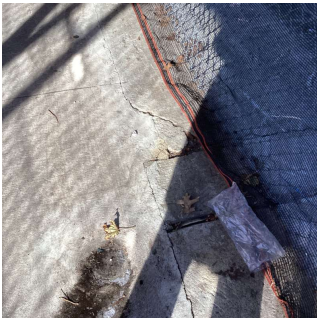
Question	Response
<b>SITE</b>	
<b>Drainage System for Concrete</b>	Inspected
<b>Catch Basins/Manhole - Surrounded by concrete</b>	Inspected
Condition	1 - Good
Deficiency	No deficiencies recorded
<b>Culverts - Concrete Covering</b>	Does not Exist
<b>Drainage System for Soil</b>	Does not Exist
<b>DRINKING FOUNTAINS</b>	Does not Exist
<b>FENCES</b>	Inaccessible
<b>IRRIGATION SYSTEM</b>	Does not Exist
<b>PAVING</b>	Inspected
<b>Student Non-Use</b>	Inspected
Gravel Exists?	No
<b>Asphalt</b>	Does not Exist
<b>Concrete</b>	Inspected
Condition	2 - Between Good and Fair
Deficiency	No deficiencies recorded
<b>Pavers</b>	Does not Exist
<b>Student Use</b>	Inspected
Gravel Exists?	No
<b>Asphalt</b>	Inaccessible
<b>Concrete</b>	Does not Exist
<b>Pavers</b>	Does not Exist
<b>Site Sidewalks &amp; Walkways</b>	Inspected
<b>Asphalt</b>	Does not Exist
<b>Concrete</b>	Inspected
Condition	3 - Fair
Deficiency	DAMAGED/DETERIORATED/MISSING SECTIONS

Deficiency Location/Instance	Snyder Avenue
Deficiency Quantity	175
Quantity Uom	S.F.
Potential Action	REPLACE
Urgency of Action	PRIORITY 3
Purpose of Action	LEVEL 2
Deficiency Photo1

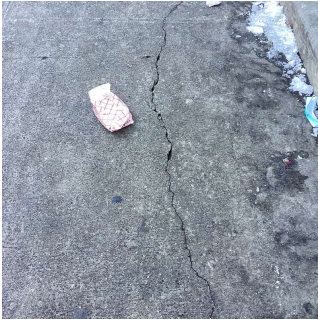
Question	Response
<b>SITE</b>	
<b>PAVING</b>	
<b>DOT Sidewalk</b>	
<b>Concrete</b>	
Condition	3 - Fair
Deficiency	DAMAGED/DETERIORATED/MISSING SECTIONS
Deficiency Location/Instance	Snyder Avenue
Deficiency Quantity	100
Quantity Uom	S.F.
Potential Action	REPLACE
Urgency of Action	PRIORITY 4
Purpose of Action	LEVEL 4
Deficiency Photo1
