NYC Department of Education
Building Condition Assessment Survey 2023 - 2024

Architectural Inspection

Asset: MIDDLE COLLEGE HS - BROOKLYN, 1150 CARROLL STREET, New York, 11225

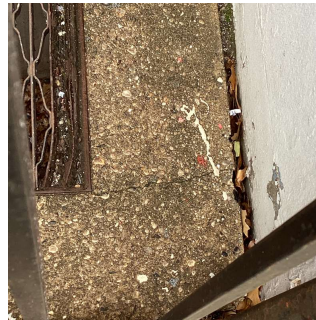
AW1
No violations recorded.

Question	Response
Architectural	
EXTERIOR	Inspected
AREAWAY	Inspected
Instance on AW1-AW2	Inspected
Instance Condition	2 - Between Good and Fair
Instance Quantity	2
Instance Quantity Uom	EACH
Deficiency	AREAWAY WALLS: CRACKS AND SPALLING

20
S.F.
REPAIR
PRIORITY 3
LEVEL 2

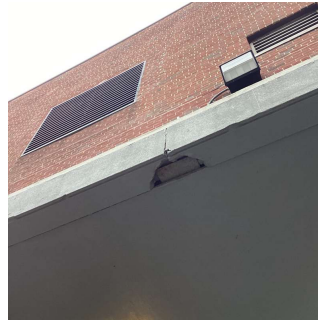
Facade A - Main Entrance
No violations recorded.

CONCRETE: MAJOR CRACKS/SPALLING

10
S.F.
REPAIR
PRIORITY 4
LEVEL 2

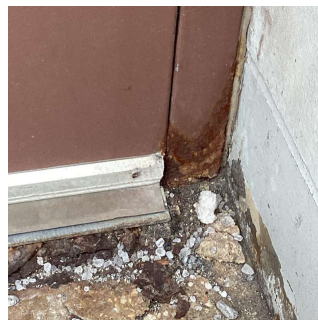
Facade C
No violations recorded.

METAL: DETERIORATED DOOR AND FRAME - MINOR DETERIORATION

MAINTENANCE

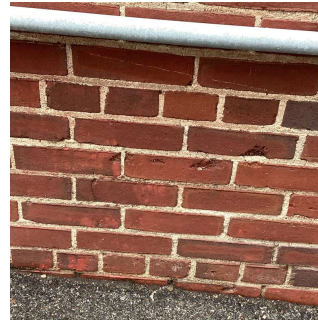
Facade B

BRICK: MINOR CRACKS AND SPALLING

10

RESTITCH

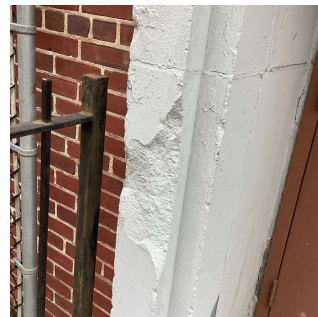
Facade A - West Entrance

**CAST IN PLACE / PRE-CAST CONCRETE: MAJOR
CRACKS/SPALLING**

30

REPLACE

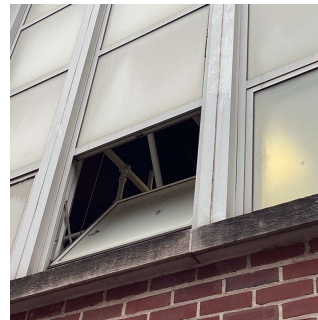
Facade A - Near AW1

BRICK: MASONRY SILLS - DETERIORATED JOINTS

10

REPOINT

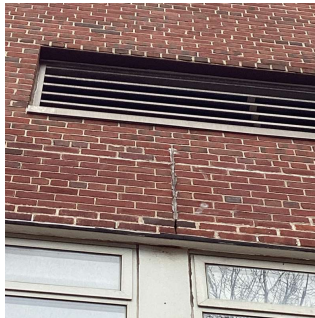
Facade A - Main Entrance

BRICK: DETERIORATED CONTROL/EXPANSION JOINTS

10

MAINTENANCE

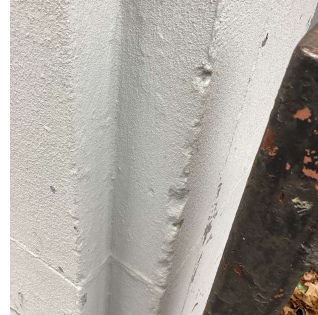
Facade A - Main Entrance

CAST IN PLACE / PRE-CAST CONCRETE: MINOR CRACKS/SPALLING

20

REPAIR
PRIORITY 3
LEVEL 2

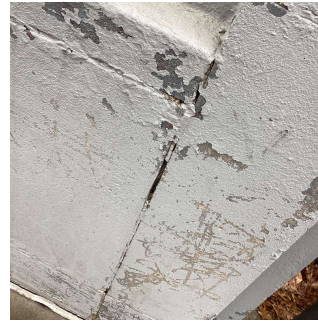
Facade A - Main Entrance

CAST IN PLACE / PRE-CAST CONCRETE: DETERIORATED JOINTS

30
L.F.
REPOINT
PRIORITY 4
LEVEL 2

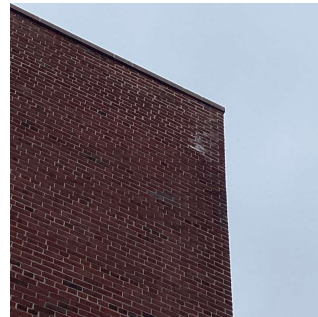
Facade A

BRICK: EFFLORESCENCE

20

MAINTENANCE

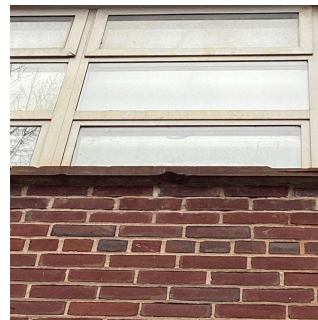
Facade A

BRICK: DETERIORATED MASONRY SILLS - MAJOR

20

REMOVE AND REPLACE

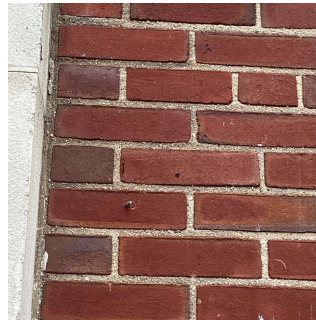
Facade C - Near Entrance

BRICK: DETERIORATED JOINTS

300

REPOINT

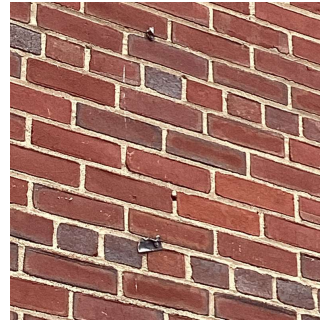
Facade A

BRICK: DETERIORATED JOINTS

20

REPOINT

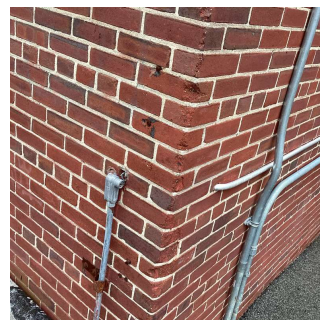
BRICK: CRACKS/DISPLACED/SPALLED BRICK AT BUILDING CORNERS

40
S.F.
REMOVE AND REBUILD
PRIORITY 4
LEVEL 2

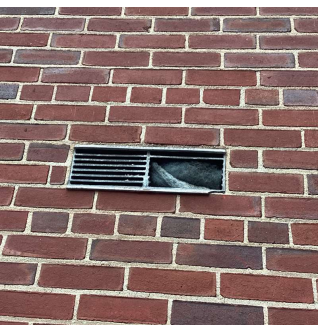
Question	Response
EXTERIOR	
EXTERIOR WALLS	Inspected
Violations	Corner of Facade B and Facade C No violations recorded.
EXTERIOR SOFFITS	Inspected
Condition	2 - Between Good and Fair
Deficiency	No deficiencies recorded
LOADING DOCK	Does not Exist
LOUVER	Inspected
Condition	3 - Fair
Deficiency	BROKEN/ DENTED BLADES
Roof Plan reference

<p>Crown Street</p>
Deficiency Quantity	10
Quantity Uom	S.F.
Potential Action	REPLACE
Urgency of Action	PRIORITY 4
Purpose of Action	LEVEL 2
Deficiency Photo1

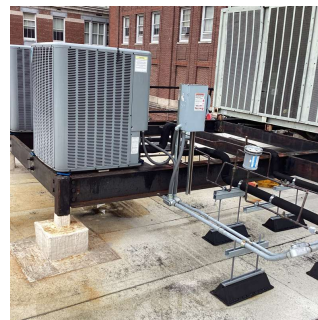
Roof 1
 No violations recorded.

Deficiency	No deficiencies recorded
ROOFING DRAINS	Inspected
Condition	2 - Between Good and Fair
Deficiency	No deficiencies recorded
Specialties	Inspected
BULKHEAD/PENTHOUSE	Does not Exist
CUPOLA/ SPIRES/ TOWERS	Does not Exist
DORMER	Does not Exist
DUNNAGE STEEL	Inspected
Condition	3 - Fair
Deficiency	HEIGHT LESS THAN 18"

50
 L.F.
 REPLACE
 PRIORITY 3
 LEVEL 2

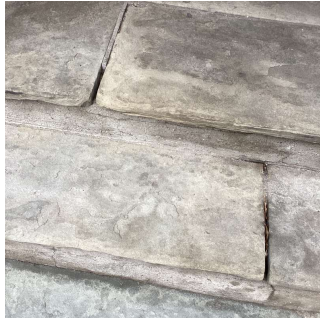
STONE: DETERIORATED JOINTS

20
 L.F.

Question	Response
EXTERIOR	
STAIRS/RAMPS: EXTERIOR	
STAIRS/RAMPS	
Potential Action	REPOINT
Urgency of Action	PRIORITY 4
Purpose of Action	LEVEL 2
Deficiency Photo1

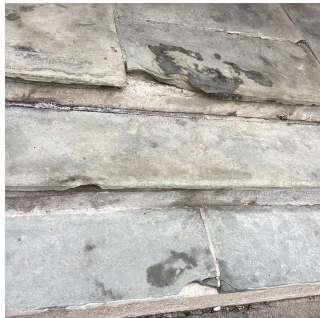
Yes	Tripping Hazard	Deteriorated stone stair treads are a potential tripping hazard.	EXTERIOR STAIRS/RAMP S: EXTERIOR STAIRS/RAMP S	Crown Street at Main Entrance stair	Eric Wright	Facility Manager

Violations	Facade A - Main Entrance No violations recorded.
Deficiency	STONE: CRACKS/SPALLING - MAJOR
Roof Plan reference

Deficiency Quantity	50
Quantity Uom	S.F.
Potential Action	REPLACE
Urgency of Action	PRIORITY 5
Purpose of Action	LEVEL 6
Deficiency Photo1

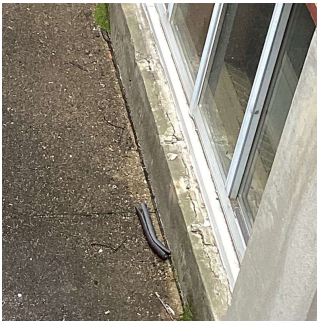
Violations	MER Room 227 No violations recorded.
FOUNDATION WALLS	
Material Type(s)	Inspected Concrete
Condition	3 - Fair
Deficiency	CONCRETE: CRACKED/SPALLED/REINFORCEMENT EXPOSED
Deficiency Location/Instance	Facade C - By Areaway
Deficiency Quantity	50
Quantity Uom	S.F.
Potential Action	REPAIR
Urgency of Action	PRIORITY 3
Purpose of Action	LEVEL 5
Deficiency Photo1

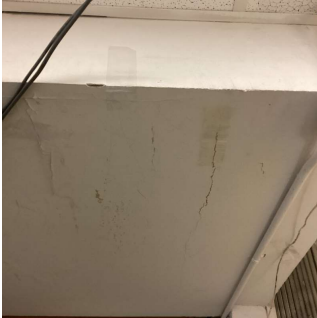
Question	Response
INTERIOR	
CLASSROOMS/CORRIDORS/ADMIN SPACES	
Ceiling	
Urgency of Action	PRIORITY 3
Purpose of Action	LEVEL 2
Deficiency Photo1

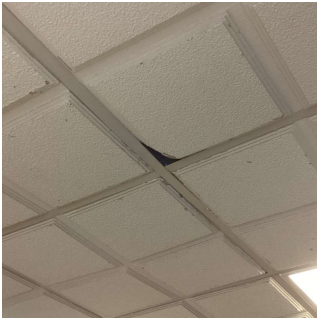
Main Lobby
Violations	No violations recorded.
Deficiency	ACOUSTIC TILES: DAMAGED/MISSING
Deficiency Location/Instance	Main Lobby
Deficiency Quantity	50
Quantity Uom	S.F.
Potential Action	REPLACE
Urgency of Action	PRIORITY 3
Purpose of Action	LEVEL 2
Deficiency Photo1

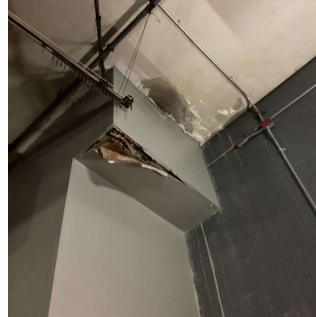
Stage
No violations recorded.

Yes	Potential Falling Debris	Severely damaged ceiling is a potential safety hazard.	INTERIOR GYMNASIUM Ceiling	Stage	Eric Wright	Facility Manager

Deficiency Location/Instance	Stage
Deficiency Quantity	40
Quantity Uom	S.F.
Potential Action	REPLACE
Urgency of Action	PRIORITY 5
Purpose of Action	LEVEL 6
Deficiency Photo1

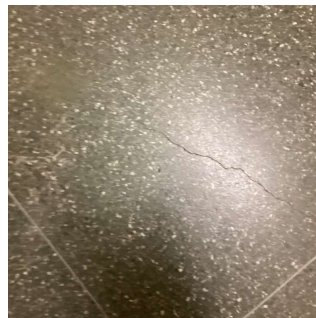
Right side stage vestibule
No violations recorded.

Instance on 1st Floor	Inspected
Condition	2 - Between Good and Fair
Deficiency	TERRAZZO: CRACKS
Deficiency Location/Instance	Right/Left side stage vestibule
Deficiency Quantity	75
Quantity Uom	S.F.
Potential Action	REPLACE
Urgency of Action	PRIORITY 3
Purpose of Action	LEVEL 2
Deficiency Photo1

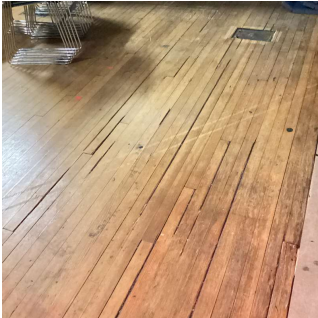
Question	Response
INTERIOR	
GYMNASIUM	
Seating	
Instance on 1st Floor	Inspected
Condition	2 - Between Good and Fair
Deficiency	No deficiencies recorded
Sliding-folding Partition	
Instance on 1st Floor	Does not Exist
Stage	
Instance on 1st Floor	Inspected
Stage	Inspected
Instance on 1st Floor	Inspected
Condition	4 - Between Fair and Poor
Deficiency	DAMAGED FLOOR
Deficiency Location/Instance	Center, right side, left side
Deficiency Quantity	500
Quantity Uom	S.F.
Potential Action	REPLACE
Urgency of Action	PRIORITY 3
Purpose of Action	LEVEL 2
Deficiency Photo1

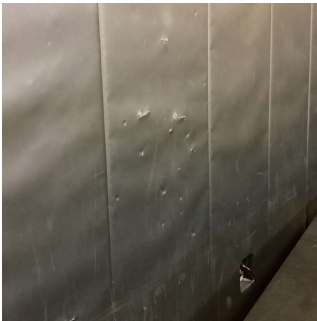
Deficiency	WALL PADDING: DETERIORATED
Deficiency Location/Instance	Near Entrance
Deficiency Quantity	25
Quantity Uom	S.F.
Potential Action	REPLACE
Urgency of Action	PRIORITY 3
Purpose of Action	LEVEL 2

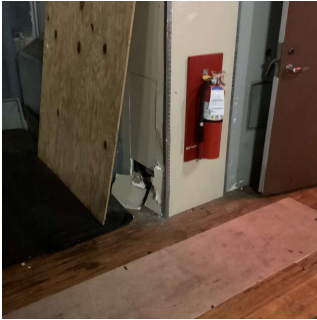
Near Entrance
Violations	No violations recorded.
Deficiency	GYPSUM BOARD: DETERIORATED
Deficiency Location/Instance	Stage
Deficiency Quantity	20
Quantity Uom	S.F.
Potential Action	REPLACE
Urgency of Action	PRIORITY 3
Purpose of Action	LEVEL 2
Deficiency Photo1

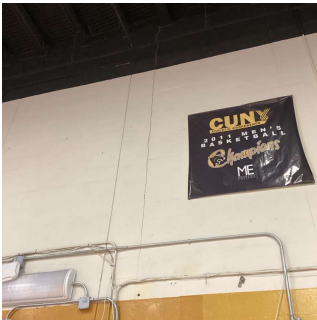
Near Entrance
Violations	No violations recorded.

Stage
Violations	No violations recorded.
Deficiency	MASONRY: CRACKS/SPALLING
Deficiency Location/Instance	Near Entrance, stage
Deficiency Quantity	50
Quantity Uom	S.F.
Potential Action	REPLACE
Urgency of Action	PRIORITY 3
Purpose of Action	LEVEL 2
Deficiency Photo1

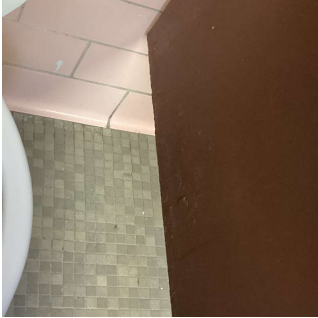
Question	Response
INTERIOR	
TOILET ROOMS - STUDENTS	Inspected
Stalls	Inspected
Condition	5 - Poor
Deficiency	RUST - MAJOR
Deficiency Location/Instance	1st Floor - Girls, Boys
Deficiency Quantity	4
Quantity Uom	EACH
Potential Action	REPLACE
Urgency of Action	PRIORITY 3
Purpose of Action	LEVEL 2
Deficiency Photo1

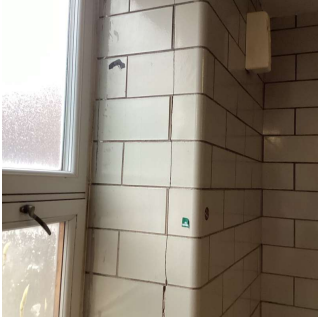
Violations	1st Floor - Girls No violations recorded.
Walls	Inspected
Condition	2 - Between Good and Fair
Deficiency	GLAZED BLOCK: CRACKS/SPALLING
Deficiency Location/Instance	1st Floor - Girls, Boys
Deficiency Quantity	20
Quantity Uom	S.F.
Potential Action	REPLACE
Urgency of Action	PRIORITY 3
Purpose of Action	LEVEL 2
Deficiency Photo1
