**NYC Department of Education**  
**Building Condition Assessment Survey 2023 - 2024**

Architectural Inspection

**Asset: P.S. 1 MINISCHOOL - BROOKLYN, 309 47 STREET, New York, 11220**

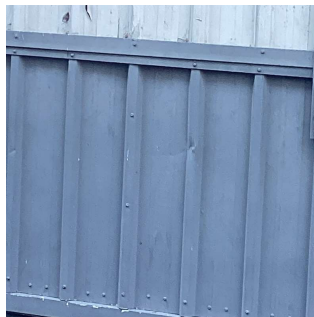
Facade A  
No violations recorded.

Material Type(s)	Steel
Replacement Quantity	6,200
Replacement Uom	S.F.
Instance on All Facades	Inspected
Instance Condition	3 - Fair
Instance Quantity	6,200
Instance Quantity Uom	S.F.
Deficiency	METAL PANEL: SEVERE DENTS
Roof Plan reference

Deficiency Quantity	20
Quantity Uom	S.F.
Potential Action	REPLACE
Urgency of Action	PRIORITY 4
Purpose of Action	LEVEL 2
Deficiency Photo1

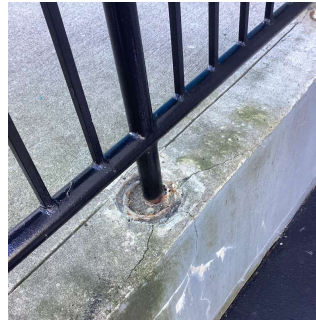
Facade D

Condition	3 - Fair
Deficiency	CONCRETE: CRACKS/SPALLING - MAJOR

Deficiency Quantity	15
Quantity Uom	S.F.
Potential Action	REPLACE
Urgency of Action	PRIORITY 4
Purpose of Action	LEVEL 2

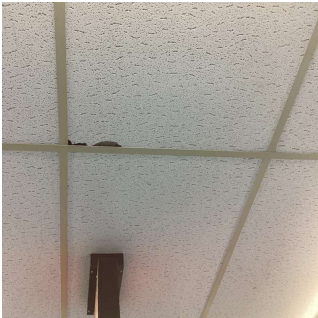
<b>Question</b>	<b>Response</b>
<b>INTERIOR</b>	
<b>CAFETERIA</b>	Does not Exist
<b>CLASSROOMS/CORRIDORS/ADMIN SPACES</b>	Inspected
<b>Ceiling</b>	Inspected
Condition	2 - Between Good and Fair
Deficiency	ACOUSTIC TILES: DAMAGED/MISSING
Deficiency Location/Instance	Corridor near Rooms 9, 14, Exit 5 - Vestibule
Deficiency Quantity	30
Quantity Uom	S.F.
Potential Action	REPLACE
Urgency of Action	PRIORITY 3
Purpose of Action	LEVEL 2
Deficiency Photo1

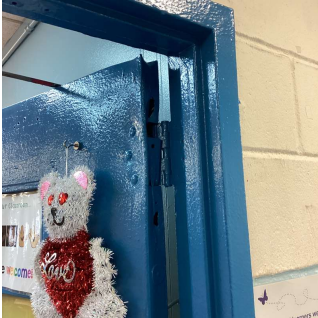
Violations	Corridor near Room 9 No violations recorded.
<b>Door(s)</b>	Inspected
Condition	5 - Poor
Deficiency	METAL: DETERIORATED DOOR
Deficiency Location/Instance	Rooms 2, 6
Deficiency Quantity	2
Quantity Uom	EACH
Potential Action	MAINTENANCE
Urgency of Action	PRIORITY 3
Purpose of Action	LEVEL 2
Deficiency Photo1

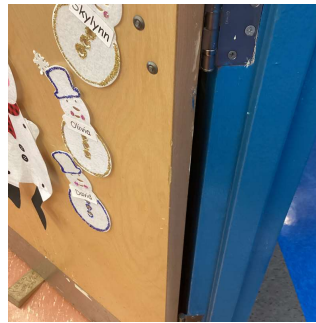
Violations	Room 2 No violations recorded.
Deficiency	WOOD: DETERIORATED DOOR
Deficiency Location/Instance	Room 3
Deficiency Quantity	1
Quantity Uom	EACH

Potential Action	MAINTENANCE
Urgency of Action	PRIORITY 3
Purpose of Action	LEVEL 2

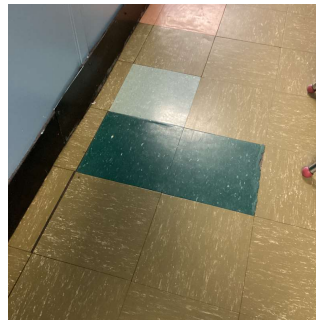
Room 9

VINYL TILES: BROKEN/DETERIORATED/MISSING TILES

Rooms 1, 3, 9

REPLACE

PRIORITY 3

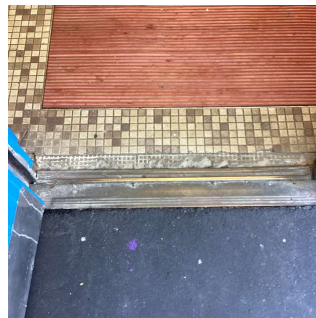
Main Entrance - Vestibule

CERAMIC TILE: BROKEN/MISSING TILES

REPLACE

PRIORITY 3

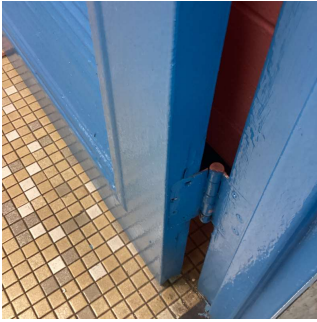
Room 13
Violations	No violations recorded.
<b>Floor Finish</b>	Inspected
Condition	2 - Between Good and Fair

Condition	5 - Poor
Deficiency	METAL: DETERIORATED DOOR
Deficiency Location/Instance	Rooms 13, 14
Deficiency Quantity	2
Quantity Uom	EACH
Potential Action	MAINTENANCE
Urgency of Action	PRIORITY 3
Purpose of Action	LEVEL 2
Deficiency Photo1

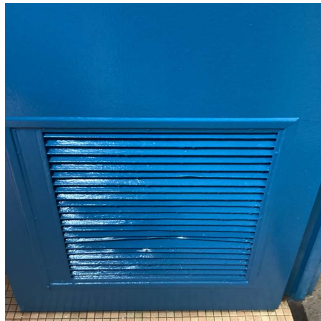
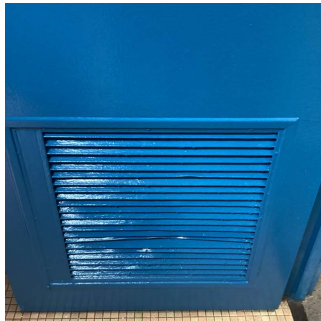
<b>Ceiling</b>	Inspected
Condition	2 - Between Good and Fair
Deficiency	No deficiencies recorded
<b>Door(s)</b>	Inspected
Condition	5 - Poor
Deficiency	METAL: DAMAGED LOUVER
Deficiency Location/Instance	Room 16
Deficiency Quantity	1
Quantity Uom	EACH
Potential Action	MAINTENANCE
Urgency of Action	PRIORITY 3
Purpose of Action	LEVEL 2
Deficiency Photo1

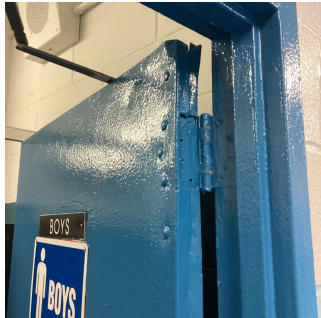
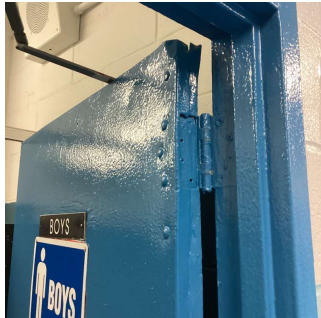
Deficiency	METAL: DETERIORATED DOOR
Deficiency Location/Instance	Room 15
Deficiency Quantity	1
Quantity Uom	EACH
Potential Action	MAINTENANCE
Urgency of Action	PRIORITY 3
Purpose of Action	LEVEL 2
Deficiency Photo1

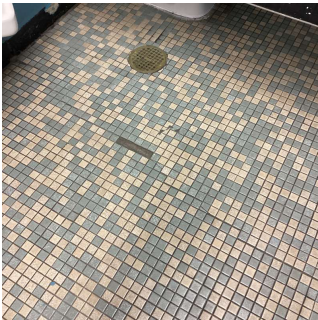
Question	Response
<b>INTERIOR</b>	
<b>TOILET ROOMS - STUDENTS</b>	
<b>Door(s)</b>	Inspected
	Room 15
Violations	No violations recorded.
<b>Floor Finish</b>	Inspected
Condition	2 - Between Good and Fair
Deficiency	CERAMIC TILE: BROKEN/MISSING TILES
Deficiency Location/Instance	Room 15
Deficiency Quantity	10
Quantity Uom	S.F.
Potential Action	REPLACE
Urgency of Action	PRIORITY 3
Purpose of Action	LEVEL 2
Deficiency Photo1
