**NYC Department of Education**  
**Building Condition Assessment Survey 2023 - 2024**

Architectural Inspection

**Asset: P.S. 884 - BROOKLYN, 15 SNYDER AVENUE, New York, 11226**

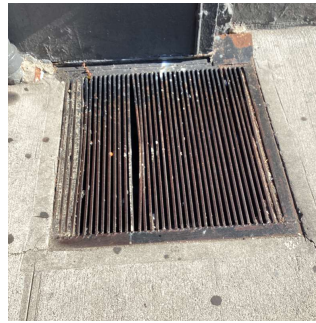
Facade A - AW1

| Question | Response |
|---|---|
| Deficiency | AREAWAY GRATINGS: MAJOR RUSTING / OR BROKEN |

| Potential Action | REPLACE |

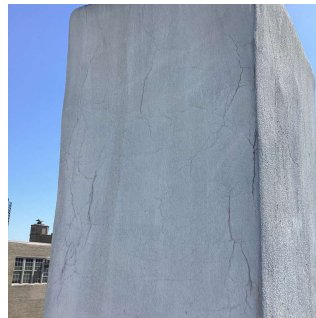
Roof 1 - CH

BRICK: MINOR CRACKS AND SPALLING

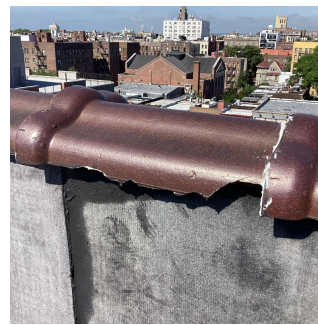
Roof 1 - Facade B  
No violations recorded.

TERRA COTTA: CRACKED/BROKEN PIECES

130  
L.F.  
REPLACE-IN-KIND  
PRIORITY 4  
LEVEL 2

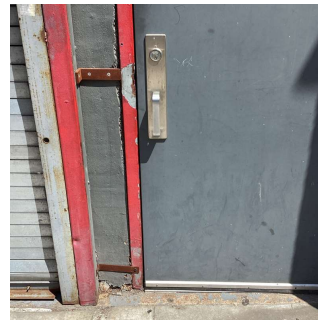
Facade A

**METAL: DETERIORATED DOOR AND FRAME - MAJOR DETERIORATION**

REPLACE

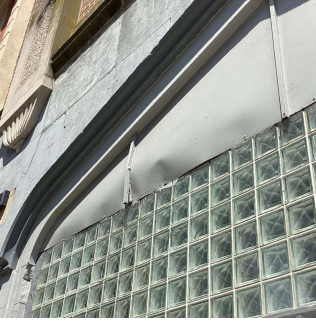
| Question | Response |
|---|---|
| Violations | Facade A<br>No violations recorded. |

| Question | Response |
|---|---|
| Deficiency | METAL PANEL: SEVERE DENTS |

| Question | Response |
|---|---|
| Potential Action | REPLACE |

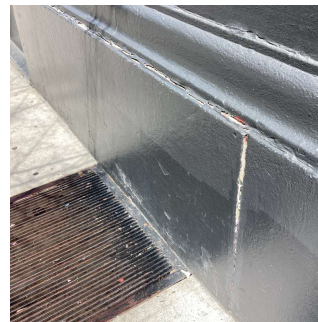
Facade A

| Question | Response |
|---|---|
| Deficiency | STONE: DISPLACED WITH STEEL DAMAGE |

REPLACE

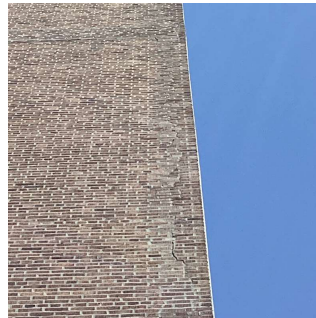
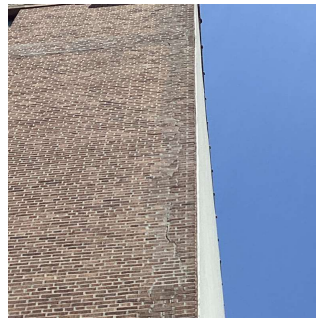
Corner of Facades A and D

**BRICK: CRACKS/DISPLACED/SPALLED BRICK AT BUILDING CORNERS**

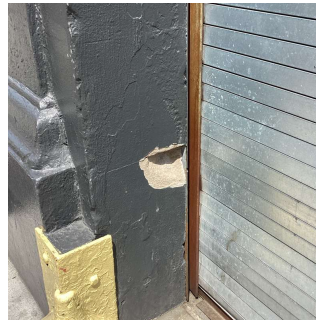
Facade A

STONE: CHIPPED/SPALLED/BROKEN PIECES - MAJOR

REPLACE

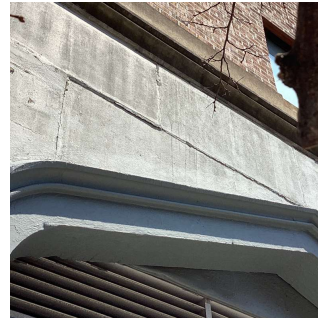
Facade A

STONE: DETERIORATED JOINTS

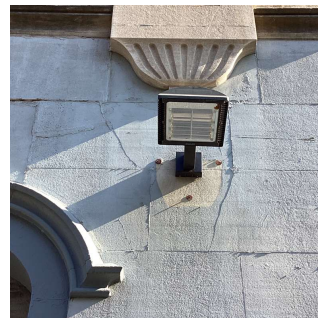
Facade A

STONE: CHIPPED/SPALLED/BROKEN PIECES - MINOR

REPAIR

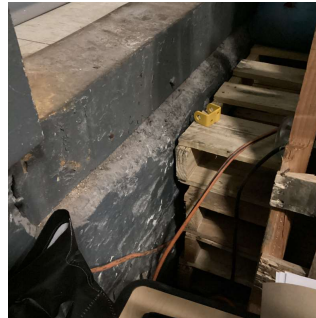
Loading Dock

CHEEK WALL/CRACKS, SPALLING - MINOR

REPAIR

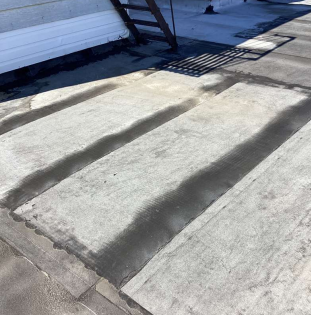
| Question | Response |
|---|--|
| Violations | Roof 1 - Near EMR1 |

| Question | Response |
|---|--|
| Deficiency | MODIFIED BITUMEN: ROOFING: DELAMINATION |

| Question | Response |
|---|--|
| Potential Action | REPLACE ROOFING WITHOUT MAJOR EQUIPMENT REMOVAL |

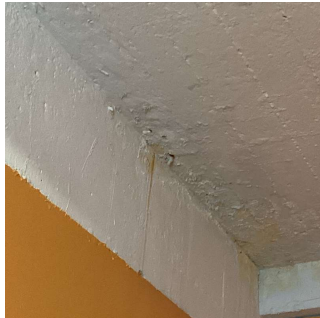
| Question | Response |
|---|--|
| Violations | Roof 1 - Stair A/6<br>No violations recorded. |

| Question | Response |
|---|--|
| Deficiency | MODIFIED BITUMEN: ROOFING: MINOR LEAKAGE |

| Question | Response |
|---|--|
| Potential Action | REPAIR |

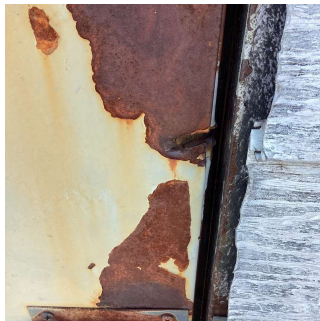
| Question | Response |
|---|--|
| Violations | Roof 1 - EMR1<br>No violations recorded. |

| Question | Response |
|---|--|
| Deficiency | BULKHEAD/PENTHOUSE DOORS: DETERIORATED DOOR |

| Question | Response |
|---|--|
| Potential Action | REPLACE DOOR |

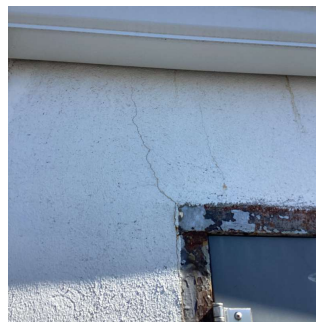
Roof 1 - BH

| Question | Response |
|---|--|
| Deficiency | BULKHEAD/PENTHOUSE WALLS/EXTERIOR:<br>CRACKS/SPALLING - MINOR |

30  
S.F.  
REPAIR  
PRIORITY 3  
LEVEL 2

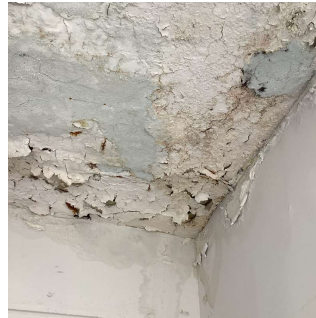
Roof 1 - BH

**BULKHEAD/PENTHOUSE CEILING: PLASTER DAMAGED/DETERIORATED**

50  
S.F.  
REPLACE  
PRIORITY 3  
LEVEL 2

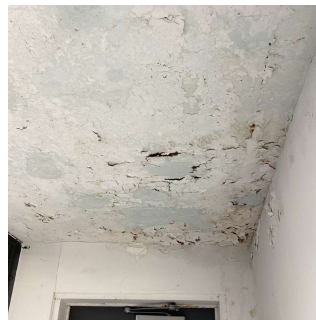
Roof 1 - BH

**BULKHEAD/PENTHOUSE ROOF: MAJOR LEAKAGE**

REPLACE

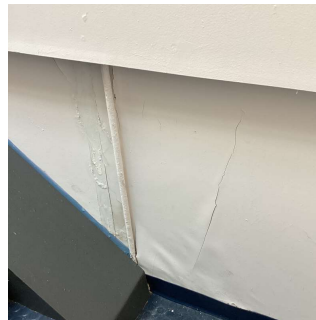
Roof 1 - BH

**BULKHEAD/PENTHOUSE WALLS/INTERIOR: GYPSUM BOARD DAMAGED/DETERIORATED**

20  
 S.F.  
 REPLACE  
 PRIORITY 3  
 LEVEL 2

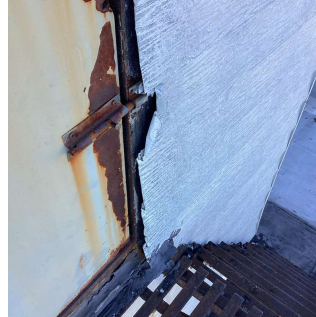
EMR1

Deficiency **BULKHEAD/PENTHOUSE WALLS/EXTERIOR: DAMAGED METAL SIDING**

20  
 S.F.  
 REPLACE  
 PRIORITY 4  
 LEVEL 2

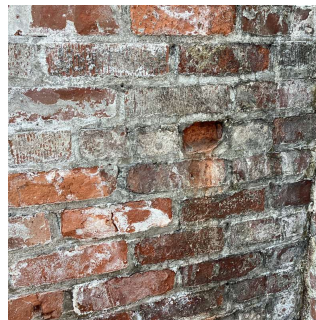
EMR1

**BULKHEAD/PENTHOUSE WALLS/INTERIOR: BRICK  
CRACKS/SPALLING**

REPLACE

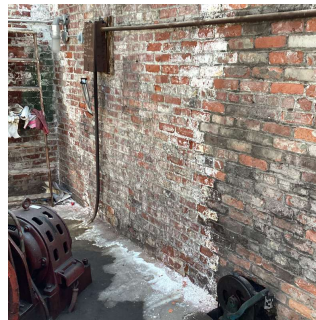
EMR1  
No violations recorded.

**BULKHEAD/PENTHOUSE WALLS/EXTERIOR: WATER  
INFILTRATION**

100  
S.F.  
REPAIR  
PRIORITY 5  
LEVEL 2

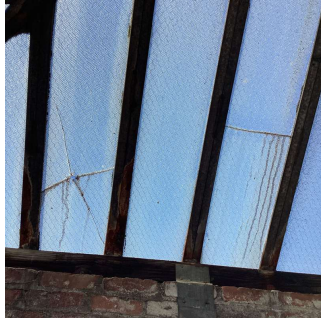
| Question | Response |
|--|--|
| Violations | EMR1<br>No violations recorded. |

BROKEN GLASS

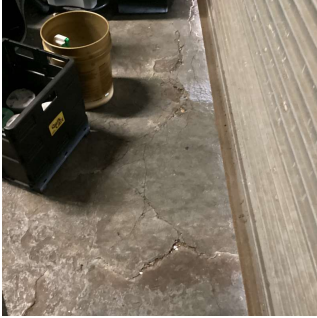
| Question | Response |
|---|--|
| | 1st Floor - Garage |

| Question | Response |
|---|--|
| Deficiency Location/Instance | CONCRETE SLAB ON GRADE: THRU CRACKS |

| Question | Response |
|---|--|
| Potential Action | REPLACE |

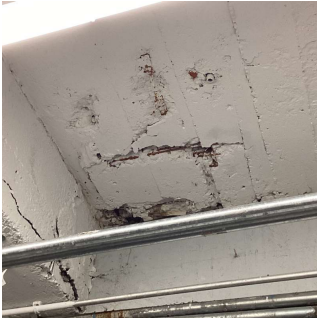
| Question | Response |
|---|--|
| | Room BS-11 |

| Question | Response |
|---|--|
| Deficiency | CONCRETE: CRACKS/SPALLED/REINFORCEMENT EXPOSED |

| Question | Response |
|---|--|
| Potential Action | REPAIR |

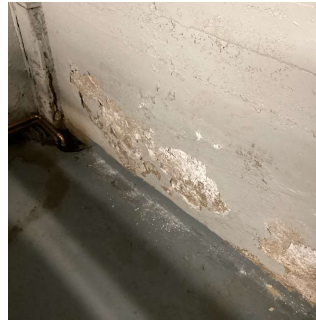
Room BS-09

| Question | Response |
|---|---|
| Deficiency | CONCRETE: WATER INFILTRATION IN NON- INSTRUCTIONAL SPACE |

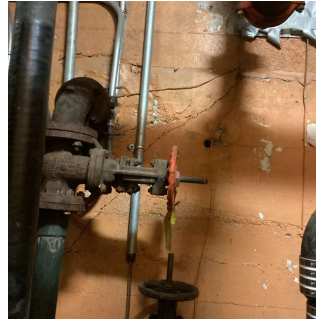
Room BS-01

CONCRETE: CRACKED/SPALLED/REINFORCEMENT EXPOSED

REPAIR

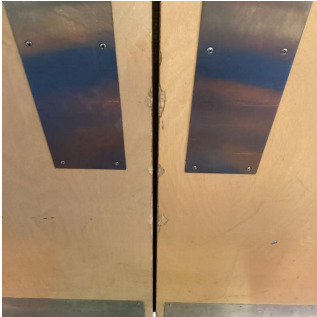
| Question | Response |
|--|--|
| Violations | Main Entrance Vestibule<br>No violations recorded. |

| Question | Response |
|--|--|
| Deficiency | WOOD: DETERIORATED DOOR |

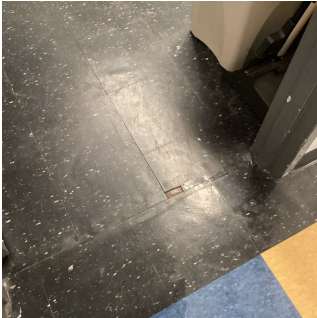
| Question | Response |
|--|--|
| Violations | Room 103<br>No violations recorded. |

| Question | Response |
|--|--|
| Deficiency | VINYL TILES: BROKEN/DETERIORATED/MISSING TILES |

| Question | Response |
|--|--|
| Potential Action | REPLACE |

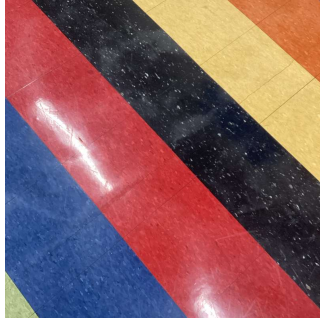
| Question | Response |
|--|--|
| Violations | Corridor near Girls Toilet Room - 2nd Floor<br>No violations recorded. |

| Question | Response |
|--|--|
| Deficiency | VINYL TILES: DETERIORATED SUBSTRATE |

| Question | Response |
|--|--|
| Potential Action | REPLACE |

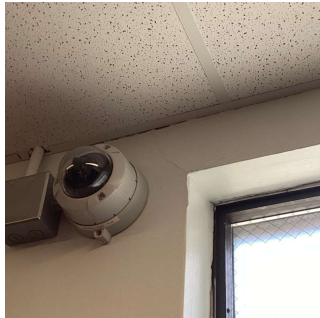
| Question | Response |
|--|--|
| Violations | Corridor near Room 201<br>No violations recorded. |

| Question | Response |
|--|--|
| Deficiency | PLASTER: CRACKS/SPALLING |

| Question | Response |
|--|--|
| Potential Action | REPLACE |

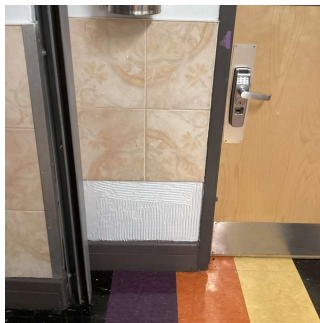
| Question | Response |
|--|--|
| Violations | Corridor near Room 304<br>No violations recorded. |

| Question | Response |
|--|--|
| Deficiency | CERAMIC TILE: BROKEN/ MISSING |

| Question | Response |
|--|--|
| Potential Action | REPLACE |

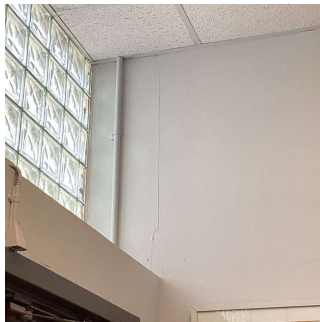
| Question | Response |
|--|--|
| Violations | Main Entrance Vestibule<br>No violations recorded. |

| Question | Response |
|--|--|
| Deficiency | GYPSUM BOARD: DETERIORATED |
