NYC Department of Education
Building Condition Assessment Survey 2023 - 2024

Architectural Inspection

Asset: P.S. 189 MINISCHOOL - BROOKLYN, 1100 EAST NEW YORK AVE, New York, 11212

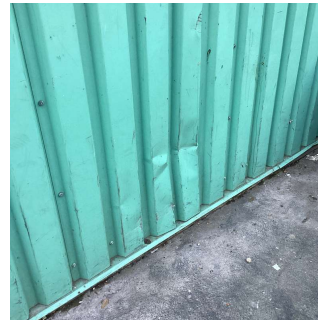
Facade D
No violations recorded.

Question	Response
Architectural	
EXTERIOR	Inspected
AREAWAY	Does not Exist
AWNINGS AND CANOPIES	Does not Exist
CHIMNEY	Does not Exist
COPING	Does not Exist
CORNICE	Does not Exist
DOORS	Inspected
DOORS AND FRAMES	Inspected
Condition	2 - Between Good and Fair
Deficiency	No deficiencies recorded
DOOR HARDWARE	Inspected
Condition	3 - Fair
Deficiency	No deficiencies recorded
LINTELS	Does not Exist
TRANSOM/SIDE LIGHT	Does not Exist
EXTERIOR WALLS	Inspected
Material Type(s)	Steel
Replacement Quantity	4,000
Replacement Uom	S.F.
Instance on All Facades	Inspected
Instance Condition	3 - Fair
Instance Quantity	4,000
Instance Quantity Uom	S.F.
Deficiency	METAL PANEL: SEVERE DENTS

30
S.F.
REPLACE
PRIORITY 4
LEVEL 2

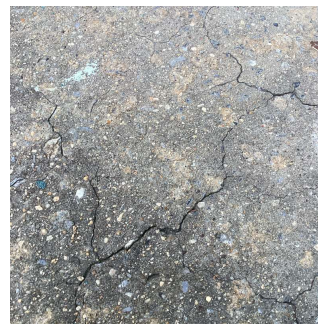
Facade B

Condition	5 - Poor
Deficiency	CONCRETE: CRACKS/SPALLING - MINOR

50
S.F.
REPAIR
PRIORITY 3
LEVEL 2

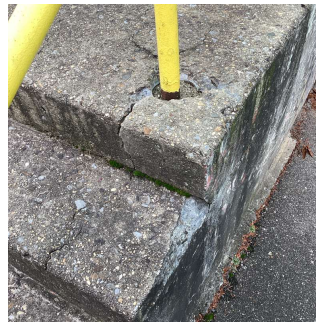
Facade B

CONCRETE: CRACKS/SPALLING - MAJOR

30
S.F.
REPLACE
PRIORITY 4
LEVEL 2

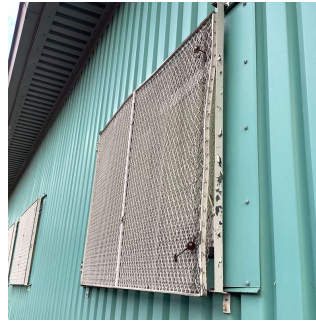
Facade C

DETERIORATED/TORN-OUT/MISSING

REPLACE

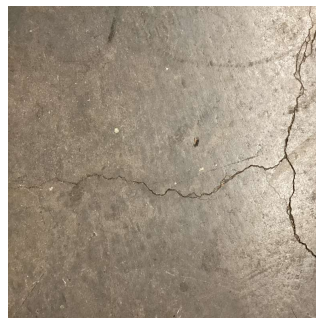
CONCRETE SLAB ON GRADE: THRU CRACKS

Room 8, Storage Space next to Room 8

REPAIR

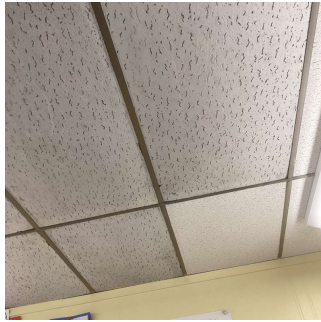
Question	Response
INTERIOR	
CAFETERIA	Does not Exist
CLASSROOMS/CORRIDORS/ADMIN SPACES	Inspected
Ceiling	Inspected
Condition	2 - Between Good and Fair
Deficiency	ACOUSTIC TILES: DAMAGED/MISSING - ACTIVE LEAK
Deficiency Location/Instance	Rooms 804, 802
Deficiency Quantity	40
Quantity Uom	S.F.
Potential Action	REPLACE
Urgency of Action	PRIORITY 5
Purpose of Action	LEVEL 2
Deficiency Photo1

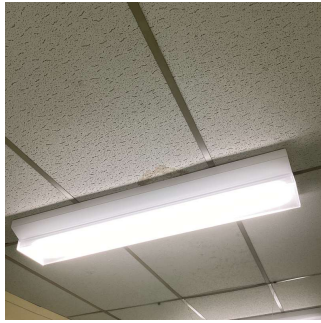
Room 804
Violations	No violations recorded.
Deficiency	ACOUSTIC TILES: DAMAGED/MISSING
Deficiency Location/Instance	Rooms 801, 804, Corridor near Rooms 1, 802, Exit 3 - Vestibule and others
Deficiency Quantity	60
Quantity Uom	S.F.
Potential Action	REPLACE
Urgency of Action	PRIORITY 3
Purpose of Action	LEVEL 2
Deficiency Photo1

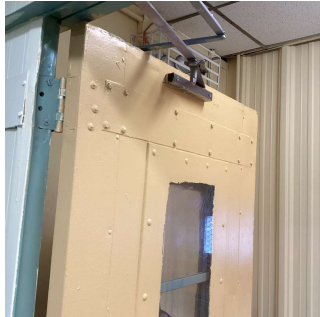
Corridor near Room 802
Violations	No violations recorded.
Door(s)	Inspected
Condition	5 - Poor
Deficiency	METAL: DETERIORATED DOOR
Deficiency Location/Instance	Exit 1 - Vestibule
Deficiency Quantity	2

Quantity Uom	EACH
Potential Action	MAINTENANCE
Urgency of Action	PRIORITY 3

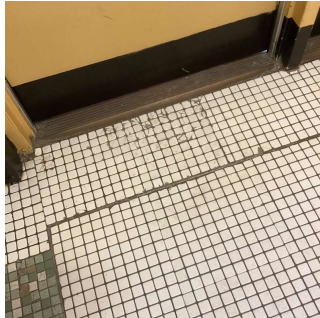
Violations	Exit 1 - Vestibule No violations recorded.
Floor Finish	Inspected
Condition	2 - Between Good and Fair
Deficiency	CERAMIC TILE: BROKEN/MISSING TILES
Deficiency Location/Instance	Exits 1, 3 - Vestibules
Deficiency Quantity	20
Quantity Uom	S.F.
Potential Action	REPLACE
Urgency of Action	PRIORITY 3
Purpose of Action	LEVEL 2
Deficiency Photo1

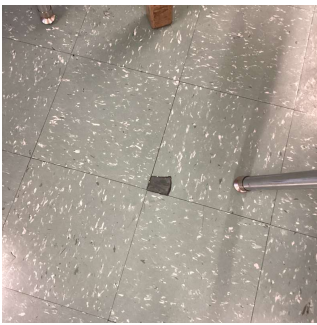
Violations	Exit 1 - Vestibule No violations recorded.
Deficiency	VINYL TILES: BROKEN/DETERIORATED/MISSING TILES
Deficiency Location/Instance	Room 804, Exit 3 - Vestibule
Deficiency Quantity	20
Quantity Uom	S.F.
Potential Action	REPLACE
Urgency of Action	PRIORITY 3
Purpose of Action	LEVEL 2

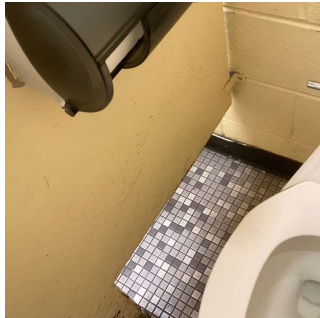
Violations	Room 4 No violations recorded.
Floor Finish	Inspected
Condition	2 - Between Good and Fair
Deficiency	No deficiencies recorded
Stalls	Inspected
Condition	5 - Poor
Deficiency	RUST - MAJOR
Deficiency Location/Instance	Rooms 3, 4
Deficiency Quantity	2
Quantity Uom	EACH
Potential Action	REPLACE
Urgency of Action	PRIORITY 3
Purpose of Action	LEVEL 2
Deficiency Photo1

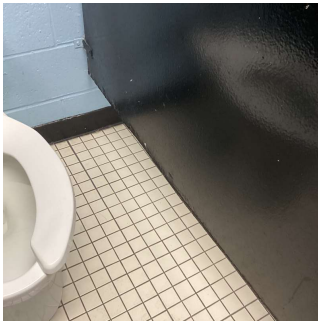
Question	Response
INTERIOR	
TOILET ROOMS - STUDENTS	
Ceiling	
Deficiency Photo1	 
	Room 1
Violations	No violations recorded.
Door(s)	
Condition	Inspected
Deficiency	2 - Between Good and Fair
Deficiency	No deficiencies recorded
Floor Finish	
Condition	Inspected
Condition	3 - Fair
Deficiency	CERAMIC TILE: BROKEN/MISSING TILES
Deficiency Location/Instance	Rooms 1, 2
Deficiency Quantity	20
Quantity Uom	S.F.
Potential Action	REPLACE
Urgency of Action	PRIORITY 3
Purpose of Action	LEVEL 2
Deficiency Photo1	 
	Room 2
Violations	No violations recorded.
Stalls	
Condition	Inspected
Condition	5 - Poor
Deficiency	RUST - MAJOR
Deficiency Location/Instance	Room 1
Deficiency Quantity	1
Quantity Uom	EACH
Potential Action	REPLACE
Urgency of Action	PRIORITY 3
Purpose of Action	LEVEL 2
