**NYC Department of Education**  
**Building Condition Assessment Survey 2023 - 2024**

Architectural Inspection

**K891**

**Asset: P.S. 91 MINISCHOOL - BROOKLYN, 532 ALBANY AVENUE, New York, 11213**

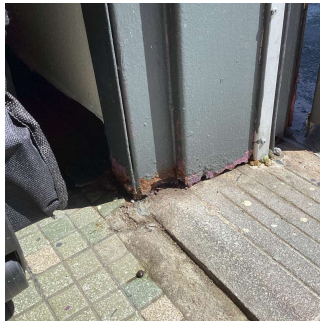
Deficiency METAL: DETERIORATED DOOR AND FRAME - MAJOR DETERIORATION

Violations	Facade A No violations recorded.
<b>DOOR HARDWARE</b>	Inspected
Condition	3 - Fair
Deficiency	No deficiencies recorded
<b>LINTELS</b>	Does not Exist
<b>TRANSOM/SIDE LIGHT</b>	Does not Exist
<b>EXTERIOR WALLS</b>	Inspected
Material Type(s)	Steel
Replacement Quantity	5,000
Replacement Uom	S.F.
Instance on All Facades	Inspected
Instance Condition	3 - Fair
Instance Quantity	5,000
Instance Quantity Uom	S.F.
Deficiency	METAL PANEL: SEVERE DENTS
Roof Plan reference	 
Elevation

REPLACE

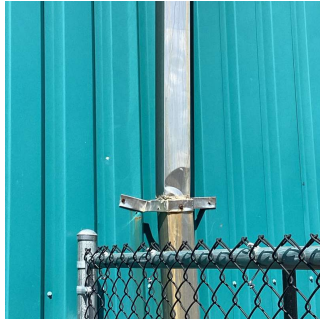
Violations	Roof 1 - Facade A No violations recorded.
Deficiency	DAMAGED/MISSING
Roof Plan reference	K891

Facade A
Violations	No violations recorded.
<b>EXTERIOR SOFFITS</b>	
Condition	Inspected
Deficiency	2 - Between Good and Fair
	No deficiencies recorded
<b>LOADING DOCK</b>	
	Does not Exist
<b>LOUVER</b>	
Condition	Inspected
Deficiency	2 - Between Good and Fair
	No deficiencies recorded
<b>PARAPETS</b>	
	Does not Exist
<b>PLAZA DECK</b>	
	Does not Exist
<b>ROOF</b>	
<b>Roofing</b>	
Condition	Inspected
Replacement Quantity	11,000
Replacement Uom	S.F.
<b>ROOF HATCH/SMOKE HATCH</b>	
	Does not Exist
<b>LEADERS, GUTTERS, DOWNSPOUTS, SCUPPERS</b>	
Condition	Inspected
Deficiency	4 - Between Fair and Poor
Deficiency	DAMAGED/MISSING
Roof Plan reference

Deficiency Quantity	100
Quantity Uom	L.F.
Potential Action	REPLACE
Urgency of Action	PRIORITY 4
Purpose of Action	LEVEL 2

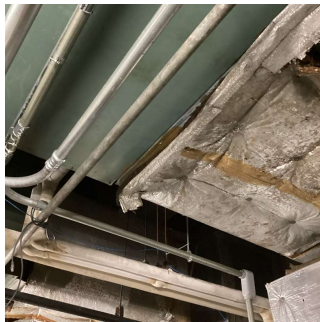
Roof 1 - Room 114
Violations	No violations recorded.
<b>ROOFING DRAINS</b>	Does not Exist
<b>Specialties</b>	Does not Exist
<b>STAIRS/RAMPS: EXTERIOR</b>	Inspected

Roof 1
Instance Quantity	11,000
Instance Quantity Uom	S.F.
Does the roof have major mechanical equipment sitting on Dunnage Steel less than 18" above the Roofing?	No
Does this roof instance have a Sustainable Roof System?	No
Do solar panels exist on these roofs?	No
Is/Are the roof(s) suitable for Solar Panel installation?	No
Installation Year	1996
Source of Installation	Custodial Staff
Deficiency	METAL: ROOFING: MAJOR ACTIVE ROOF LEAKS IN NON-INSTRUCTIONAL SPACE
Roof Plan reference

Deficiency Quantity	100
Quantity Uom	S.F.
Potential Action	REPLACE
Urgency of Action	PRIORITY 5
Purpose of Action	LEVEL 2
Deficiency Photo1

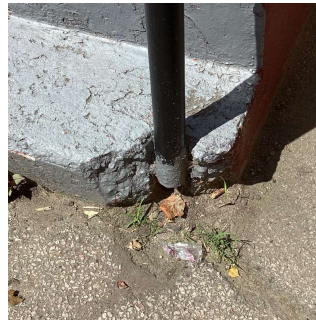
Facade B

CONCRETE: CRACKS/SPALLING - MAJOR

REPLACE

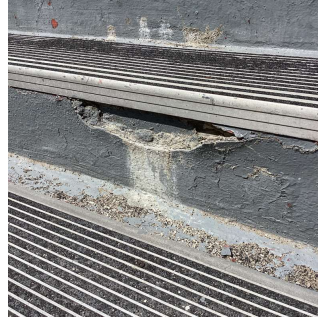
Facade A

CONCRETE: CRACKS/SPALLING - MINOR

REPAIR

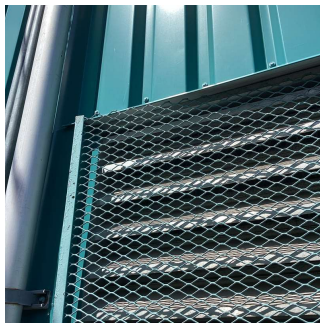
DETERIORATED/TORN-OUT/MISSING

Violations	Facade A No violations recorded.
<b>LINTELS</b>	Does not Exist
<b>WINDOWS</b>	Inspected
Material Type(s)	Aluminum
Instance on Aluminum - Double Hung: Facades A and C	Inspected
Instance Condition	3 - Fair
Instance Quantity	600
Instance Quantity Uom	S.F.
Are these windows insulated	No
Installation Year	1996
Source of Installation	Custodial Staff
Deficiency	ALUMINUM - DOUBLE HUNG: INOPERABLE BALANCE
Roof Plan reference

20  
S.F.  
REPLACE  
PRIORITY 4  
LEVEL 2

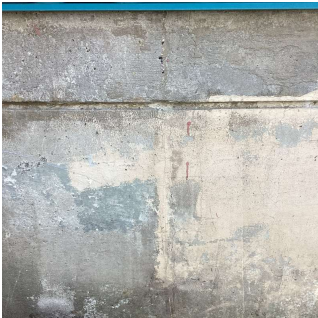
<b>Question</b>	<b>Response</b>
<b>EXTERIOR</b>	Inspected
<b>WINDOWS</b>	Inspected
<b>WINDOWS</b>	
Violations	No violations recorded.
<b>INTERIOR</b>	Inspected
<b>POOLS</b>	Does not Exist
<b>STRUCTURAL</b>	Inspected
<b>COLUMNS/BEAMS/BEARING WALLS</b>	Inspected
Condition	2 - Between Good and Fair
Deficiency	No deficiencies recorded
<b>FLOOR STRUCTURE</b>	Inspected
Condition	2 - Between Good and Fair
Deficiency	No deficiencies recorded
<b>FOUNDATION WALLS</b>	Inspected
Material Type(s)	Concrete
Condition	3 - Fair
Deficiency	CONCRETE: CRACKED/SPALLED/REINFORCEMENT EXPOSED
Deficiency Location/Instance	Facade C
Deficiency Quantity	40
Quantity Uom	S.F.
Potential Action	REPAIR
Urgency of Action	PRIORITY 3
Purpose of Action	LEVEL 5
Deficiency Photo1

Violations	Facade C No violations recorded.
<b>ROOF STRUCTURE</b>	Inspected
Condition	2 - Between Good and Fair
Deficiency	No deficiencies recorded
<b>VAULTS-BUNKERS</b>	Does not Exist
