**NYC Department of Education  
Building Condition Assessment Survey 2023 - 2024**

Architectural Inspection

**K892**

**Asset:** P.S. 221 MINISCHOOL - BROOKLYN, 791 EMPIRE BLVD, New York, 11213

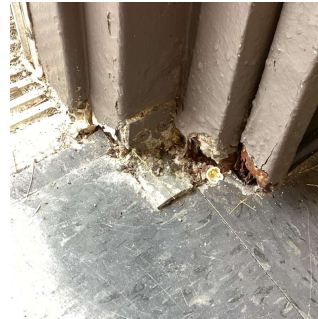
Facade A

METAL: DETERIORATED DOOR AND FRAME - MAJOR DETERIORATION

REPLACE

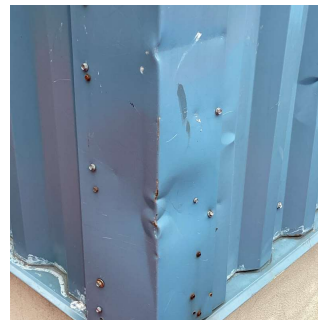
Facade C

METAL PANEL: DAMAGED TRIM

REPLACE

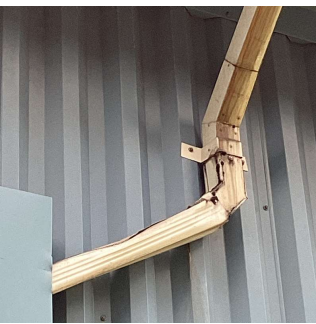
Question	Response
<b>EXTERIOR</b>	
<b>EXTERIOR WALLS</b>	
Elevation	 
Deficiency Quantity	300
Quantity Uom	S.F.
Potential Action	REPLACE
Urgency of Action	PRIORITY 4
Purpose of Action	LEVEL 2
Deficiency Photo1	 
Violations	Facade A No violations recorded.
<b>EXTERIOR SOFFITS</b>	Inspected
Condition	2 - Between Good and Fair
Deficiency	No deficiencies recorded
<b>LOADING DOCK</b>	Does not Exist
<b>LOUVER</b>	Inspected
Condition	2 - Between Good and Fair
Deficiency	No deficiencies recorded
<b>PARAPETS</b>	Does not Exist
<b>PLAZA DECK</b>	Does not Exist
<b>ROOF</b>	Inspected
<b>Roofing</b>	Inspected
Replacement Quantity	10,400
Replacement Uom	S.F.
<b>ROOF HATCH/SMOKE HATCH</b>	Does not Exist
<b>LEADERS, GUTTERS, DOWNSPOUTS, SCUPPERS</b>	Inspected
Condition	3 - Fair
Deficiency	DAMAGED/MISSING

Deficiency Quantity	10
Quantity Uom	L.F.
Potential Action	REPLACE
Urgency of Action	PRIORITY 4
Purpose of Action	LEVEL 2
Deficiency Photo1

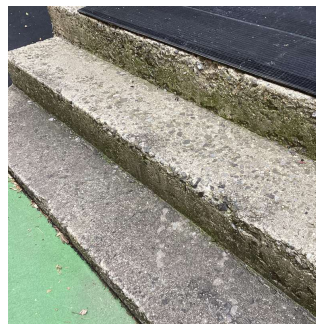
Facade D

Question	Response
<b>EXTERIOR</b>	
<b>ROOF</b>	
<b>Roofing</b>	
<b>ROOFING</b>	
Deficiency	METAL: ROOFING: MAJOR ACTIVE ROOF LEAKS IN INSTRUCTIONAL SPACE
Roof Plan reference	
Deficiency Quantity	400
Quantity Uom	S.F.
Potential Action	REPLACE
Urgency of Action	PRIORITY 5
Purpose of Action	LEVEL 2
Deficiency Photo1	
Violations	Roof 1 - Corridor near Rooms 015, 018 (Shown) and Staff Bathroom, Staff Toilet Room near Room 016 No violations recorded.
<b>ROOFING DRAINS</b>	Does not Exist
<b>Specialties</b>	Does not Exist
<b>STAIRS/RAMPS: EXTERIOR</b>	Inspected
<b>BUILDING CHEEK/FLANK WALLS</b>	Does not Exist
<b>RAILINGS</b>	Inspected
Condition	2 - Between Good and Fair
Deficiency	No deficiencies recorded
<b>STAIRS/RAMPS</b>	Inspected
Condition	5 - Poor
Deficiency	CONCRETE: WORN-OUT TREAD/RISER/NOSING

20  
S.F.  
REPLACE  
PRIORITY 4  
LEVEL 2

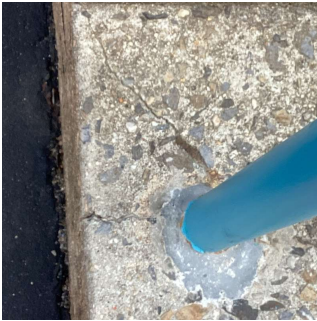
CONCRETE: CRACKS/SPALLING - MINOR

Violations	Facade B No violations recorded.
Deficiency	<b>CONCRETE: CRACKS/SPALLING - MAJOR</b>
Roof Plan reference	<p align="center">Montgomery Street</p>

10  
S.F.  
REPAIR  
PRIORITY 3  
LEVEL 2

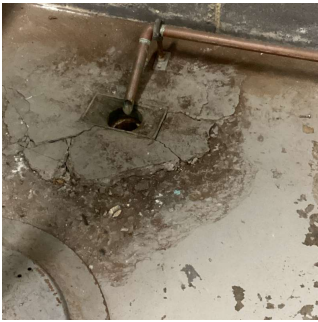
Question	Response
<b>INTERIOR</b>	
<b>POOLS</b>	Does not Exist
<b>STRUCTURAL</b>	Inspected
<b>COLUMNS/BEAMS/BEARING WALLS</b>	Inspected
Condition	2 - Between Good and Fair
Deficiency	No deficiencies recorded
<b>FLOOR STRUCTURE</b>	Inspected
Condition	3 - Fair
Deficiency	CONCRETE SLAB ON GRADE: THRU CRACKS
Deficiency Location/Instance	1st Floor - Mechanical Room
Deficiency Quantity	30
Quantity Uom	S.F.
Potential Action	REPLACE
Urgency of Action	PRIORITY 4
Purpose of Action	LEVEL 5
Deficiency Photo1

1st Floor - Mechanical Room
Violations	No violations recorded.
<b>FOUNDATION WALLS</b>	Inspected
Material Type(s)	Concrete
Condition	3 - Fair
Deficiency	CONCRETE: CRACKED/SPALLED/REINFORCEMENT EXPOSED
Deficiency Location/Instance	Facade C
Deficiency Quantity	40
Quantity Uom	S.F.
Potential Action	REPAIR
Urgency of Action	PRIORITY 4
Purpose of Action	LEVEL 5
Deficiency Photo1

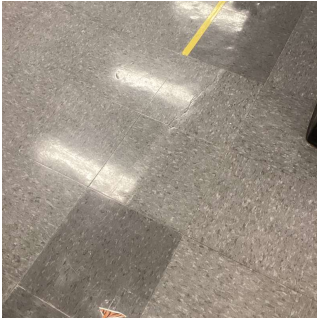
Question	Response
<b>INTERIOR</b>	
<b>CLASSROOMS/CORRIDORS/ADMIN SPACES</b>	
<b>Floor Finish</b>	
Deficiency	VINYL TILES: DETERIORATED SUBSTRATE
Deficiency Location/Instance	Main Entrance Lobby
Deficiency Quantity	10
Quantity Uom	S.F.
Potential Action	REPLACE
Urgency of Action	PRIORITY 3
Purpose of Action	LEVEL 2
Deficiency Photo1

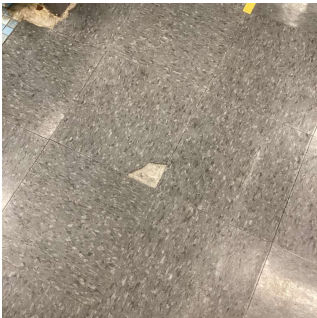
Violations	Main Entrance Lobby No violations recorded.
Deficiency	VINYL TILES: BROKEN/DETERIORATED/MISSING TILES
Deficiency Location/Instance	Corridor near Boys Toilet Room, Room 021
Deficiency Quantity	20
Quantity Uom	S.F.
Potential Action	REPLACE
Urgency of Action	PRIORITY 3
Purpose of Action	LEVEL 2
Deficiency Photo1

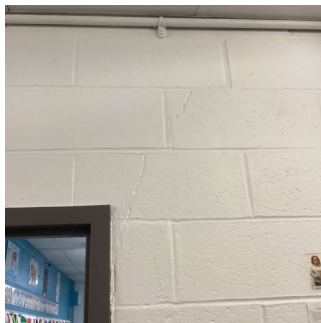
Violations	Near Boys Toilet Room No violations recorded.
<b>Walls</b>	Inspected
Condition	2 - Between Good and Fair
Deficiency	MASONRY: CRACKS/SPALLING
Deficiency Location/Instance	Corridor near Rooms 001, 021
Deficiency Quantity	20
Quantity Uom	S.F.
Potential Action	REPLACE

Violations	Corridor near Room 021 No violations recorded.
<b>Specialties</b>	Does not Exist
<b>GYMNASIUM</b>	Does not Exist
<b>INTERIOR DOOR HARDWARE</b>	Inspected
Condition	3 - Fair
Deficiency	No deficiencies recorded
<b>INTERIOR GUARDS</b>	Does not Exist
<b>KITCHEN</b>	Does not Exist
<b>LIBRARY</b>	Does not Exist
<b>LOCKER ROOM</b>	Does not Exist
<b>MULTI-PURPOSE ROOM</b>	Does not Exist
<b>SCIENCE DEMO ROOM</b>	Does not Exist
<b>SCIENCE LAB</b>	Does not Exist
<b>SCIENCE PREP ROOM</b>	Does not Exist
<b>SHOWER ROOM</b>	Does not Exist
<b>STAIRS/RAMPS: INTERIOR</b>	Does not Exist
<b>TOILET ROOMS - STAFF</b>	Inspected
<b>Ceiling</b>	Inspected
Condition	5 - Poor
Deficiency	ACOUSTIC TILES: DAMAGED/MISSING - ACTIVE LEAK
Deficiency Location/Instance	Staff Toilet Room near Room 016
Deficiency Quantity	10
Quantity Uom	S.F.

Urgency of Action	PRIORITY 3
Purpose of Action	LEVEL 2
