**NYC Department of Education**  
**Building Condition Assessment Survey 2023 - 2024**

Architectural Inspection

**Asset: P.S. 213 MINISCHOOL - BROOKLYN, 1965 LINDEN BOULEVARD, New York, 11207**

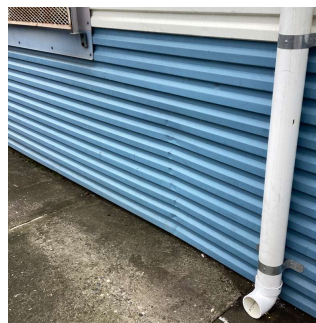
Facade C

Deficiency	METAL PANEL: SEVERE DENTS
Roof Plan reference

Deficiency Quantity	30
Quantity Uom	S.F.
Potential Action	REPLACE
Urgency of Action	PRIORITY 4
Purpose of Action	LEVEL 2
Deficiency Photo1

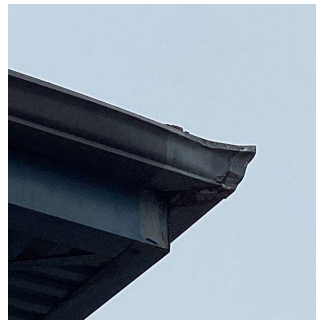
Facade C

<b>LEADERS, GUTTERS, DOWNSPOUTS, SCUPPERS</b>	Inspected
---	-----------

Condition	3 - Fair
-----------	----------

Deficiency	DAMAGED/MISSING
------------	-----------------

10

L.F.

REPLACE

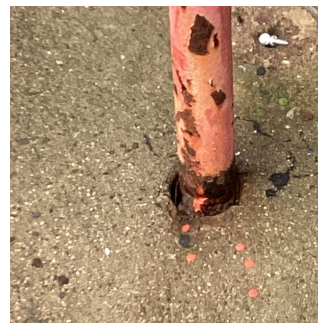
Facade C  
 No violations recorded.

<b>RAILINGS</b>	Inspected
Condition	3 - Fair
Deficiency	RUST - MAJOR

10  
 L.F.  
 REPLACE  
 PRIORITY 4  
 LEVEL 2

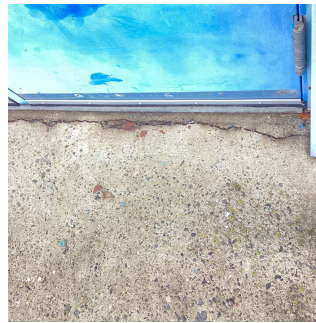
Facade D

4 - Between Fair and Poor

CONCRETE: CRACKS/SPALLING - MAJOR

20  
 S.F.  
 REPLACE  
 PRIORITY 4  
 LEVEL 2

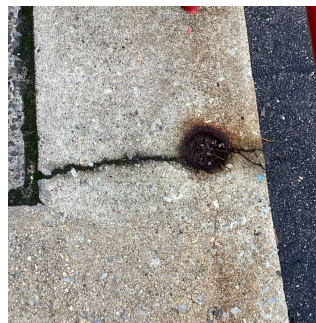
Facade A

CONCRETE: CRACKS/SPALLING - MINOR

30

REPAIR

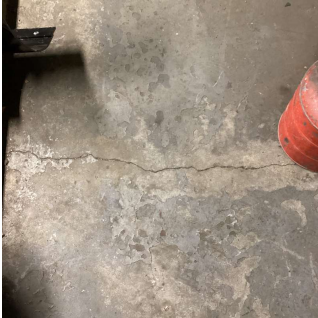
Question	Response
<b>EXTERIOR</b>	
<b>WINDOWS</b>	
<b>WINDOWS</b>	
Instance on Aluminum - Other: Facades A, C	Inspected
Instance Condition	3 - Fair
Instance Quantity	550
Instance Quantity Uom	S.F.
Are these windows insulated	No
Installation Year	1968
Source of Installation	Custodial Staff
Deficiency	No deficiencies recorded
<b>INTERIOR</b>	Inspected
<b>POOLS</b>	Does not Exist
<b>STRUCTURAL</b>	Inspected
<b>COLUMNS/BEAMS/BEARING WALLS</b>	Inspected
Condition	2 - Between Good and Fair
Deficiency	No deficiencies recorded
<b>FLOOR STRUCTURE</b>	Inspected
Condition	3 - Fair
Deficiency	CONCRETE SLAB ON GRADE: THRU CRACKS
Deficiency Location/Instance	1st Floor
Deficiency Quantity	60
Quantity Uom	S.F.
Potential Action	REPAIR
Urgency of Action	PRIORITY 3
Purpose of Action	LEVEL 5
Deficiency Photo1

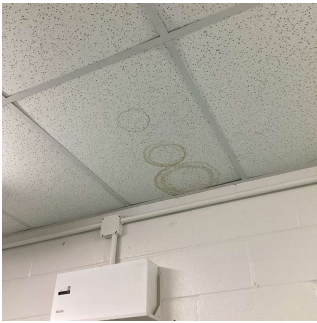
Question	Response
<b>INTERIOR</b>	
<b>STRUCTURAL</b>	
<b>FOUNDATION WALLS</b>	
Deficiency Photo1	 
Violations	Facade A No violations recorded.
<b>ROOF STRUCTURE</b>	
Condition	Inspected 2 - Between Good and Fair
Deficiency	No deficiencies recorded
<b>VAULTS-BUNKERS</b>	
Does not Exist	
<b>AUDITORIUM</b>	
Does not Exist	
<b>CAFETERIA</b>	
Does not Exist	
<b>CLASSROOMS/CORRIDORS/ADMIN SPACES</b>	
<b>Ceiling</b>	
Condition	Inspected 2 - Between Good and Fair
Deficiency	ACOUSTIC TILES: DAMAGED/MISSING - ACTIVE LEAK
Deficiency Location/Instance	Room 11
Deficiency Quantity	15
Quantity Uom	S.F.
Potential Action	REPLACE
Urgency of Action	PRIORITY 5
Purpose of Action	LEVEL 2
Deficiency Photo1	 
Violations	Room 11 No violations recorded.
Deficiency	ACOUSTIC TILES: DAMAGED/MISSING
Deficiency Location/Instance	Corridor near room 2,5, 8, 9, 11 and others
Deficiency Quantity	80
Quantity Uom	S.F.
Potential Action	REPLACE
Urgency of Action	PRIORITY 3

Corridor near room 2
Violations	No violations recorded.
<b>Door(s)</b>	Inspected
Condition	5 - Poor
Deficiency	METAL: DETERIORATED DOOR
Deficiency Location/Instance	Room 11, 10
Deficiency Quantity	2
Quantity Uom	EACH
Potential Action	MAINTENANCE
Urgency of Action	PRIORITY 3
Purpose of Action	LEVEL 2
Deficiency Photo1

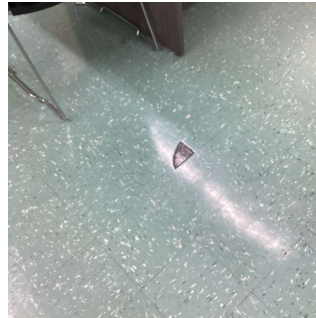
VINYL TILES: BROKEN/DETERIORATED/MISSING TILES

Room 10

REPLACE

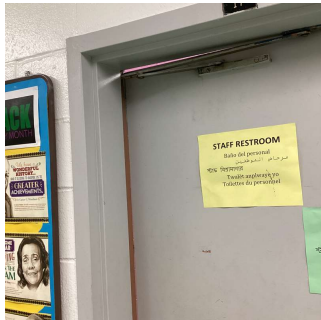
Question	Response
<b>INTERIOR</b>	
<b>CLASSROOMS/CORRIDORS/ADMIN SPACES</b>	Inspected
<b>Walls</b>	Inspected
Violations	Room 8 No violations recorded.
<b>Specialties</b>	Does not Exist
<b>GYMNASIUM</b>	Does not Exist
<b>INTERIOR DOOR HARDWARE</b>	Inspected
Condition	3 - Fair
Deficiency	No deficiencies recorded
<b>INTERIOR GUARDS</b>	Does not Exist
<b>KITCHEN</b>	Does not Exist
<b>LIBRARY</b>	Does not Exist
<b>LOCKER ROOM</b>	Does not Exist
<b>MULTI-PURPOSE ROOM</b>	Does not Exist
<b>SCIENCE DEMO ROOM</b>	Does not Exist
<b>SCIENCE LAB</b>	Does not Exist
<b>SCIENCE PREP ROOM</b>	Does not Exist
<b>SHOWER ROOM</b>	Does not Exist
<b>STAIRS/RAMPS: INTERIOR</b>	Does not Exist
<b>TOILET ROOMS - STAFF</b>	Inspected
<b>Ceiling</b>	Inspected
Condition	2 - Between Good and Fair
Deficiency	No deficiencies recorded
<b>Door(s)</b>	Inspected
Condition	5 - Poor
Deficiency	METAL: DETERIORATED DOOR AND FRAME
Deficiency Location/Instance	Room 17

Deficiency Quantity	1
Quantity Uom	EACH
Potential Action	MAINTENANCE
Urgency of Action	PRIORITY 4
Purpose of Action	LEVEL 4
Deficiency Photo1

Violations	Room 17 35665566N
<b>Floor Finish</b>	Inspected
Condition	2 - Between Good and Fair
Deficiency	No deficiencies recorded
<b>Stalls</b>	Inspected
Condition	5 - Poor

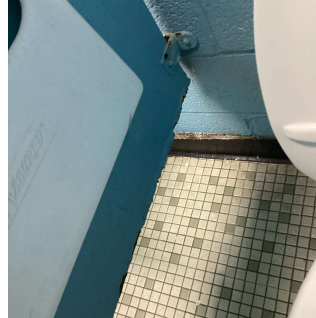
Deficiency	RUST - MAJOR
Deficiency Location/Instance	Room 14
Deficiency Quantity	1
Quantity Uom	EACH
Potential Action	REPLACE
Urgency of Action	PRIORITY 3
Purpose of Action	LEVEL 2
Deficiency Photo1

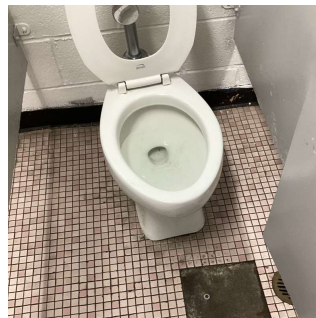
Condition	Inspected
Deficiency	2 - Between Good and Fair
Deficiency	CERAMIC TILE: BROKEN/MISSING TILES
Deficiency Location/Instance	Room 16
Deficiency Quantity	10
Quantity Uom	S.F.
Potential Action	REPLACE
Urgency of Action	PRIORITY 3
Purpose of Action	LEVEL 2
Deficiency Photo1
