NYC Department of Education
Building Condition Assessment Survey 2023 - 2024

Architectural Inspection

Asset: P.S. 321 MINISCHOOL - BROOKLYN, 180 7TH AVENUE, New York, 11215

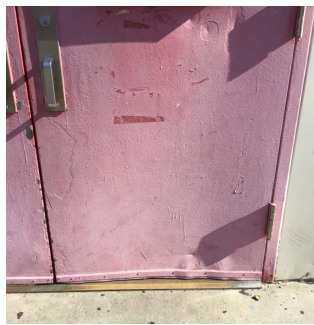
Facade A

Question	Response
Architectural	
EXTERIOR	Inspected
AREAWAY	Does not Exist
AWNINGS AND CANOPIES	Does not Exist
CHIMNEY	Does not Exist
COPING	Does not Exist
CORNICE	Does not Exist
DOORS	Inspected
DOORS AND FRAMES	Inspected
Condition	4 - Between Fair and Poor
Deficiency	METAL CLAD: DETERIORATED DOOR - MAJOR DETERIORATION

1
EACH
REPLACE
PRIORITY 4
LEVEL 2

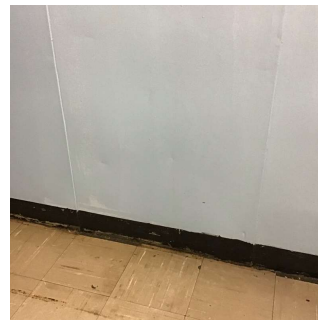
METAL PANEL: WATER INFILTRATION IN INSTRUCTIONAL SPACE

600

PRIORITY 5

Facade A - Room 9 (Facade A - Room 8, Facade C - Rooms 6,7, Facade D - Rooms 8, 9 similar)

REPAIR

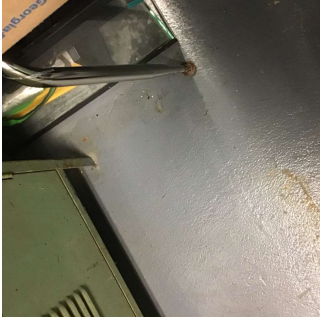
Question	Response
INTERIOR	Inspected
POOLS	Does not Exist
STRUCTURAL	Inspected
COLUMNS/BEAMS/BEARING WALLS	Inspected
Condition	2 - Between Good and Fair
Deficiency	No deficiencies recorded
FLOOR STRUCTURE	Inspected
Condition	3 - Fair
Deficiency	CONCRETE SLAB ON GRADE: THRU CRACKS
Deficiency Location/Instance	Room A17
Deficiency Quantity	40
Quantity Uom	S.F.
Potential Action	REPAIR
Urgency of Action	PRIORITY 3
Purpose of Action	LEVEL 5
Deficiency Photo1

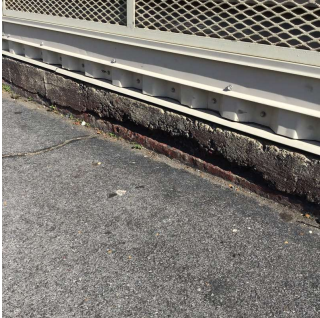
Violations	Room A17 No violations recorded.
FOUNDATION WALLS	Inspected
Material Type(s)	Concrete
Condition	3 - Fair
Deficiency	CONCRETE: CRACKED/SPALLED/REINFORCEMENT EXPOSED
Deficiency Location/Instance	Facade A
Deficiency Quantity	40
Quantity Uom	S.F.
Potential Action	REPAIR
Urgency of Action	PRIORITY 4
Purpose of Action	LEVEL 5
Deficiency Photo1

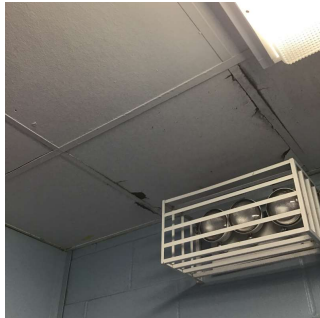
Question	Response
INTERIOR	
STRUCTURAL	Inspected
ROOF STRUCTURE	Inspected
Deficiency	No deficiencies recorded
VAULTS-BUNKERS	Does not Exist
AUDITORIUM	Does not Exist
CAFETERIA	Does not Exist
CLASSROOMS/CORRIDORS/ADMIN SPACES	Inspected
Ceiling	Inspected
Condition	2 - Between Good and Fair
Deficiency	ACOUSTIC TILES: DAMAGED/MISSING
Deficiency Location/Instance	Rooms 3, 4, 8, Exit 2, Corridor near Staff Toilet, Corridor near Room 5
Deficiency Quantity	50
Quantity Uom	S.F.
Potential Action	REPLACE
Urgency of Action	PRIORITY 3
Purpose of Action	LEVEL 2
Deficiency Photo1

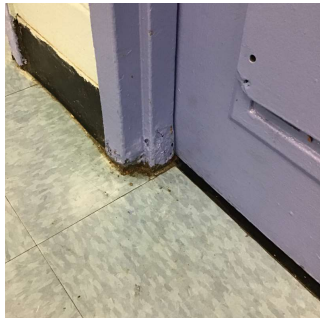
Near Entrance
Violations	No violations recorded.

Near Exit 2
Violations	No violations recorded.
Door(s)	Inspected
Condition	5 - Poor
Deficiency	METAL: DETERIORATED DOOR AND FRAME
Deficiency Location/Instance	Near Entrance
Deficiency Quantity	1
Quantity Uom	EACH
Potential Action	MAINTENANCE
Urgency of Action	PRIORITY 3
Purpose of Action	LEVEL 2
Deficiency Photo1

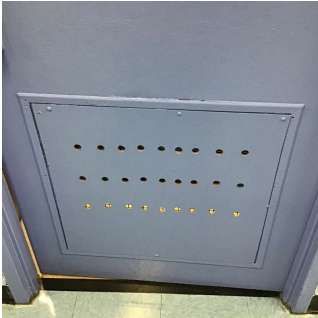
Deficiency	METAL: DAMAGED LOUVER
Deficiency Location/Instance	Rooms 4, 5, 6, 8, 10, and others

Question	Response
INTERIOR	
CLASSROOMS/CORRIDORS/ADMIN SPACES	
Door(s)	
Deficiency Quantity	10
Quantity Uom	EACH
Potential Action	MAINTENANCE
Urgency of Action	PRIORITY 3
Purpose of Action	LEVEL 2
Deficiency Photo1

Room 8
Violations	No violations recorded.
Deficiency	METAL: DETERIORATED DOOR
Deficiency Location/Instance	Rooms 7, 9, SBST Office
Deficiency Quantity	3
Quantity Uom	EACH
Potential Action	MAINTENANCE
Urgency of Action	PRIORITY 3
Purpose of Action	LEVEL 2
Deficiency Photo1

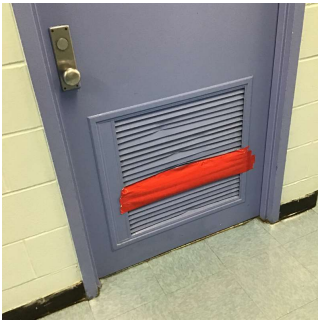
Question	Response
INTERIOR	
STAIRS/RAMPS: INTERIOR	Does not Exist
TOILET ROOMS - STAFF	Inspected
Ceiling	Inspected
Condition	2 - Between Good and Fair
Deficiency	No deficiencies recorded
Door(s)	Inspected
Condition	5 - Poor
Deficiency	METAL: DAMAGED LOUVER
Deficiency Location/Instance	Staff Toilet
Deficiency Quantity	1
Quantity Uom	EACH
Potential Action	MAINTENANCE
Urgency of Action	PRIORITY 3
Purpose of Action	LEVEL 2
Deficiency Photo1

Staff Toilet
Violations	No violations recorded.
Floor Finish	Inspected
Condition	2 - Between Good and Fair
Deficiency	No deficiencies recorded
Stalls	Does not Exist
Walls	Inspected
Condition	2 - Between Good and Fair
Deficiency	No deficiencies recorded
TOILET ROOMS - STUDENTS	Inspected
Ceiling	Inspected
Condition	2 - Between Good and Fair
Deficiency	METAL PAN: DAMAGED/MISSING
Deficiency Location/Instance	Room 14
Deficiency Quantity	10
Quantity Uom	S.F.
Potential Action	REPLACE
Urgency of Action	PRIORITY 3

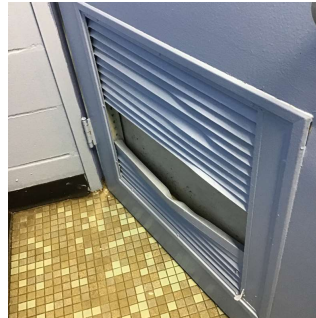
Unisex Toilet

METAL: DAMAGED LOUVER

MAINTENANCE

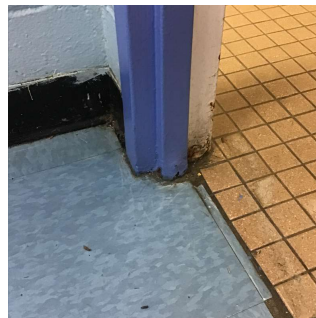
METAL: DETERIORATED DOOR AND FRAME

Rooms 14, 15

Question	Response
INTERIOR	
TOILET ROOMS - STUDENTS	
Door(s)	Inspected Room 14
Violations	No violations recorded.
Floor Finish	Inspected
Condition	3 - Fair
Deficiency	CERAMIC TILE: DETERIORATED SUBSTRATE
Deficiency Location/Instance	Room 14
Deficiency Quantity	20
Quantity Uom	S.F.
Potential Action	REPLACE
Urgency of Action	PRIORITY 3
Purpose of Action	LEVEL 2
Deficiency Photo1

MAINTENANCE

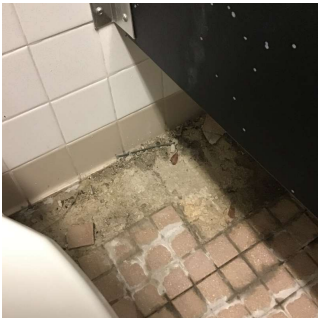
Violations	Room 14 No violations recorded.
Stalls	Inspected
Condition	2 - Between Good and Fair
Deficiency	No deficiencies recorded
Walls	Inspected
Condition	2 - Between Good and Fair
Deficiency	No deficiencies recorded
LIFE SAFETY	Inspected
F.D. HOLDING AREA	Does not Exist
STEEL STAIRS	Does not Exist
SITE	Not Required
ARTWORK	Does not Exist
