NYC Department of Education
Building Condition Assessment Survey 2023 - 2024

Architectural Inspection

Asset: P.S. 77 ANNEX - BROOKLYN, 62 PARK PLACE, New York, 11217

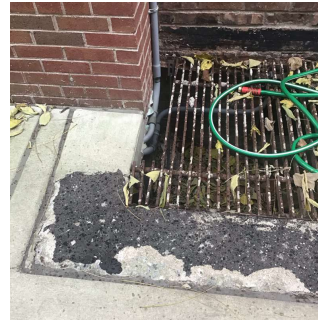
AW1

AREAWAY WALLS: DETERIORATED JOINTS

REPAIR

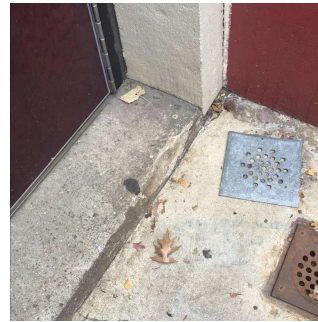
AW4

AREAWAY SLAB: CRACKS AND SPALLING

50
S.F.
REPAIR
PRIORITY 3
LEVEL 2

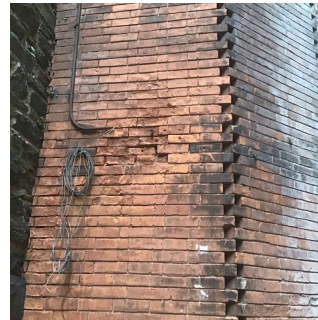
CH2
No violations recorded.

BRICK: MINOR CRACKS AND SPALLING

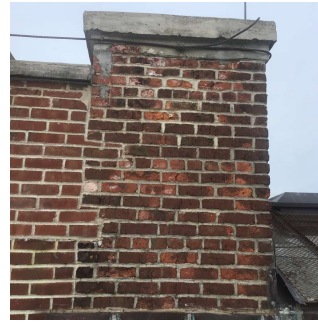
CH1

BRICK: DETERIORATED JOINTS

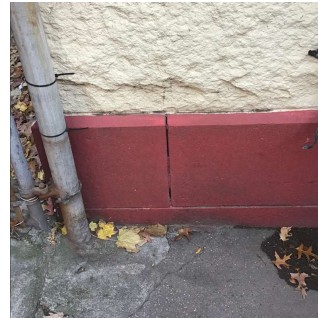
Facade A

STONE: CHIPPED/SPALLED/BROKEN PIECES - MAJOR

REPLACE

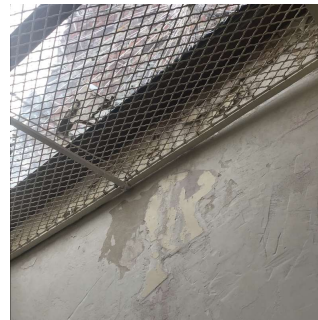
BH5/SK

BROKEN GLASS

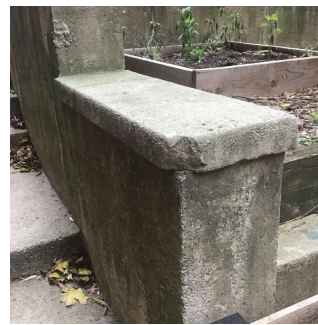
Facade C

CAST IN PLACE CONCRETE: CRACKS/SPALLING - MAJOR

10
 S.F.
 REPLACE
 PRIORITY 4
 LEVEL 2

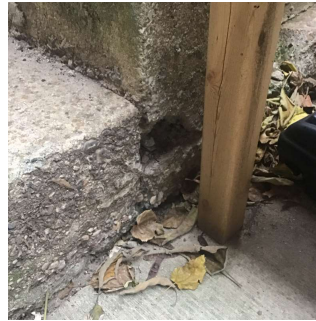
Facade C

STONE: DETERIORATED JOINTS AT COPING STONES

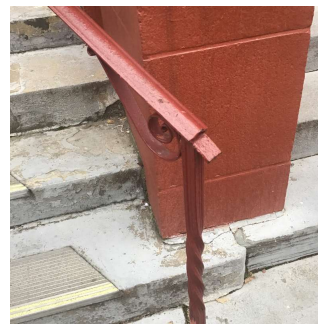
Facade E - Exit 5
No violations recorded.

10
L.F.
REPLACE
PRIORITY 4
LEVEL 2

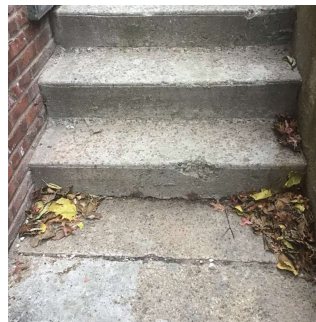
Northeast corner stair in Courtyard

CONCRETE: CRACKS/SPALLING - MAJOR

40
S.F.
REPLACE
PRIORITY 4
LEVEL 2

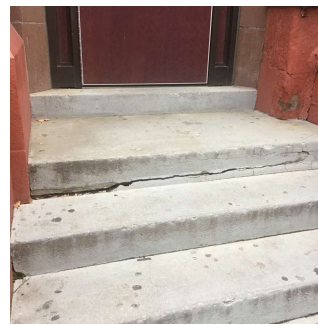
Facade E - Exit 6

STONE: DETERIORATED JOINTS

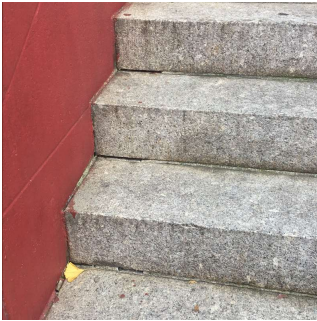
Violations	Facade A No violations recorded.
Deficiency	CONCRETE: CRACKS/SPALLING - MINOR
Roof Plan reference	K902 Sterling Place

Deficiency Quantity	30
Quantity Uom	S.F.
Potential Action	REPAIR
Urgency of Action	PRIORITY 3
Purpose of Action	LEVEL 2
Deficiency Photo1

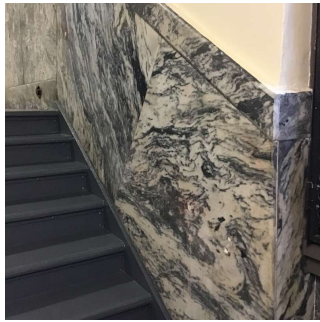
Violations	Stair B/3 No violations recorded.
Deficiency	METAL: BROKEN BRACKET
Deficiency Location/Instance	Stairs A/2, C/Basement
Deficiency Quantity	2
Quantity Uom	EACH
Potential Action	REPLACE
Urgency of Action	PRIORITY 3
Purpose of Action	LEVEL 2

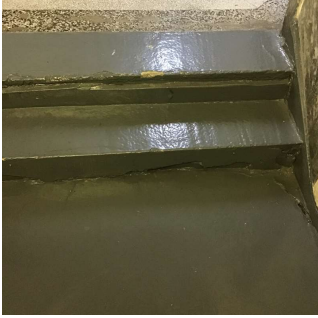
Stair C/1
Violations	No violations recorded.
Deficiency	STONE: BROKEN/MISSING
Deficiency Location/Instance	Corridor near Rooms 312,304, Stairs A/1, B/1, C/4 and others
Deficiency Quantity	150
Quantity Uom	S.F.
Potential Action	REPLACE
Urgency of Action	PRIORITY 3
Purpose of Action	LEVEL 2

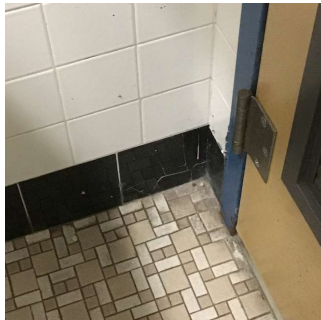
Violations	Women Toilet Room in Gymnasium No violations recorded.
TOILET ROOMS - STUDENTS	
	Inspected
Ceiling	Inspected
Condition	2 - Between Good and Fair
Deficiency	No deficiencies recorded
Door(s)	Inspected

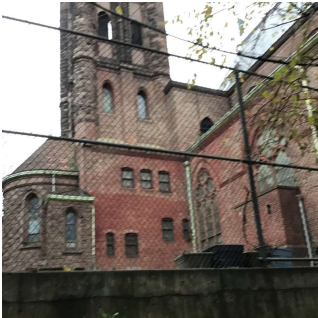
Violations	Courtyard No violations recorded.
IRRIGATION SYSTEM	Does not Exist
PAVING	Inspected
Student Non-Use	Inspected
Gravel Exists?	No
Asphalt	Does not Exist
Concrete	Inspected
Condition	2 - Between Good and Fair
Deficiency	No deficiencies recorded
Pavers	Does not Exist
Student Use	Does not Exist
Site Sidewalks & Walkways	Inspected
Asphalt	Does not Exist
Concrete	Inspected
