NYC Department of Education
Building Condition Assessment Survey 2023 - 2024

Architectural Inspection

K907

Asset: BROWNSVILLE DIPLOMA PLUS HS - K, 1150 EAST NEW YORK AVE, New York, 11212

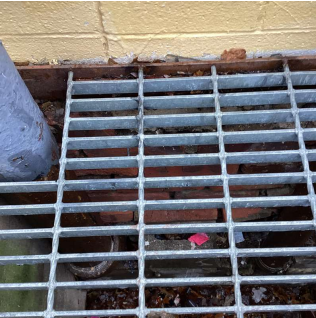
Question	Response
EXTERIOR	Inspected
AREAWAY	Inspected
Instance on AW1	Inspected
Instance Condition	3 - Fair
Instance Quantity	1
Instance Quantity Uom	EACH
Deficiency	AREAWAY WALLS: DETERIORATED JOINTS
Roof Plan reference	<p>K907</p>

<p>E. New York Avenue</p> <p>E. 98th Street</p>
Deficiency Quantity	10
Quantity Uom	S.F.
Potential Action	REPAIR
Urgency of Action	PRIORITY 4
Purpose of Action	LEVEL 2
Deficiency Photo1

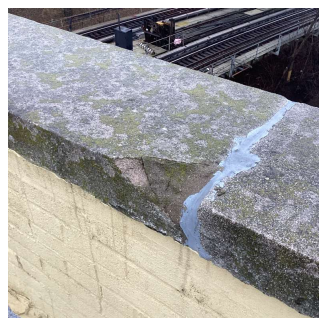
Violations	No violations recorded.
AWNINGS AND CANOPIES	Does not Exist
CHIMNEY	Inspected
Material Type(s)	Masonry
Condition	2 - Between Good and Fair
Deficiency	No deficiencies recorded
COPING	Inspected
Condition	3 - Fair
Deficiency	CAST STONE: CRACKED/BROKEN PIECES

Deficiency Quantity	40
Quantity Uom	L.F.
Potential Action	REPLACE-IN-KIND
Urgency of Action	PRIORITY 4
Purpose of Action	LEVEL 2
Deficiency Photo1

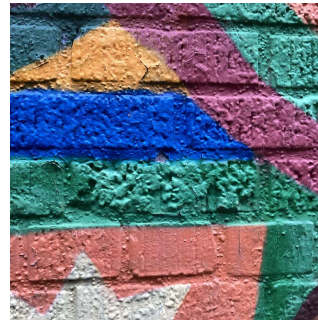
Facade D

Elevation	 
Deficiency Quantity	30
Quantity Uom	L.F.
Potential Action	REMOVE AND REPLACE
Urgency of Action	PRIORITY 4
Purpose of Action	LEVEL 2
Deficiency Photo1	 
Violations	Facade B No violations recorded.
Deficiency	BRICK: MINOR CRACKS AND SPALLING

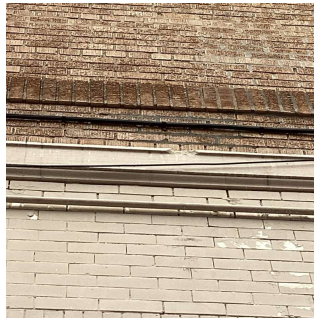
Facade A

TERRA COTTA: CHIPPED/SPALLED/BROKEN PIECES - MINOR

REPAIR

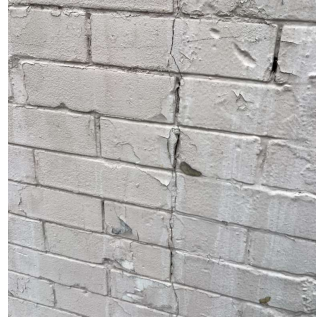
Facade A

BRICK: MAJOR / THRU CRACKS

PRIORITY 4
LEVEL 2

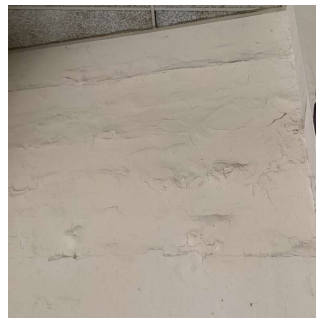
Facade A

STUCCO CEMENT SURFACE: CRACKS, SPALLING

20
S.F.
REPLACE
PRIORITY 4
LEVEL 2

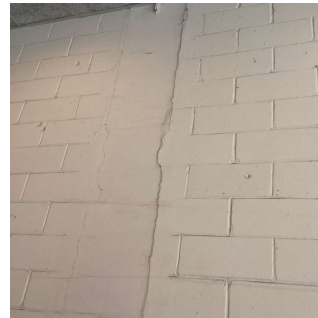
Facade A

CONCRETE MASONRY UNIT: MAJOR / THRU CRACKS

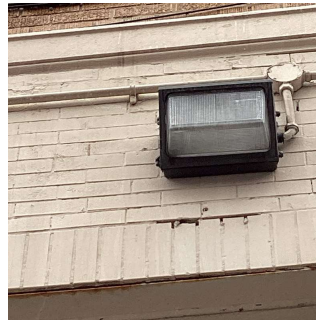
Facade A

BRICK: DETERIORATED JOINTS

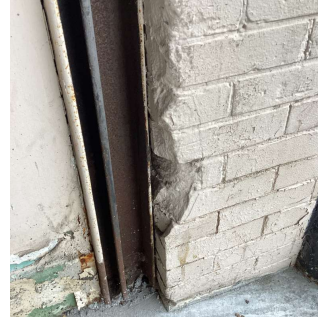
Facade A

BRICK: CRACKS/DISPLACED/SPALLED BRICK AT BUILDING CORNERS

REMOVE AND REBUILD
PRIORITY 4
LEVEL 2

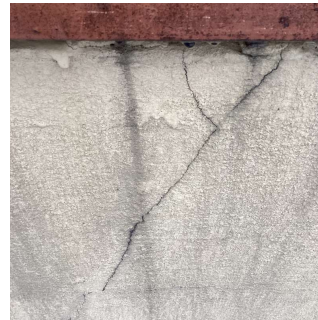
CONCRETE: MINOR CRACKS, SPALLING

30
S.F.
REPAIR
PRIORITY 3
LEVEL 2

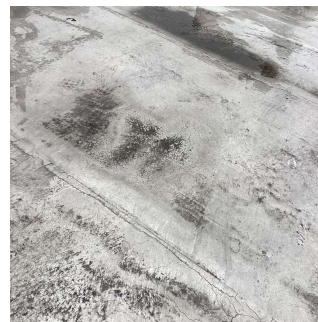
Deficiency	MODIFIED BITUMEN: ROOFING: DELAMINATION
------------	---

Deficiency Quantity	20
Quantity Uom	S.F.
Potential Action	REPLACE ROOFING WITHOUT MAJOR EQUIPMENT REMOVAL
Urgency of Action	PRIORITY 4
Purpose of Action	LEVEL 2

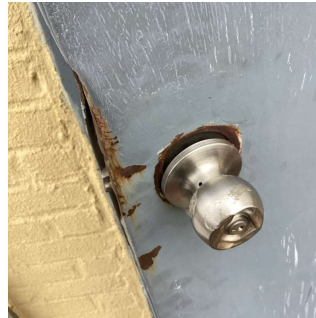
Roof 1 - Elevator Machine Room

BULKHEAD/PENTHOUSE DOORS: DETERIORATED DOOR AND FRAME

1
EACH
REPLACE DOOR AND FRAME
PRIORITY 4
LEVEL 2

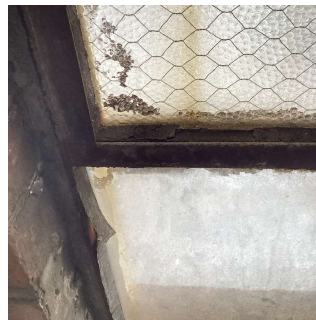
Roof 1 - Elevator Machine Room

BULKHEAD/PENTHOUSE WINDOWS: DAMAGED, DETERIORATED WINDOWS

REPLACE

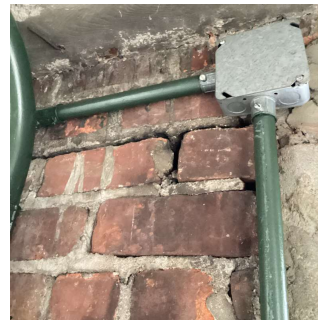
Roof 1 - Elevator Machine Room

BULKHEAD/PENTHOUSE WALLS/INTERIOR: BRICK DETERIORATED JOINTS

50
S.F.
REPOINT
PRIORITY 3
LEVEL 2

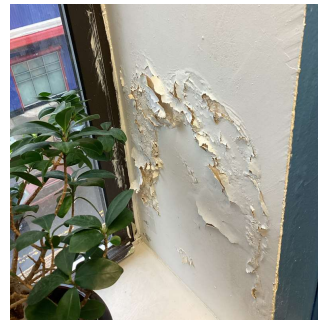
Facade A - Room 413 (Shown), Room 300

Violations	<p>Facade A</p> <p>No violations recorded.</p>
WINDOWS	
Replacement Quantity	900
Replacement Uom	S.F.
EXTERIOR GUARDS	
Condition	2 - Between Good and Fair
Deficiency	No deficiencies recorded
LINTELS	
Condition	2 - Between Good and Fair
Deficiency	No deficiencies recorded
WINDOWS	
Material Type(s)	Aluminum
Instance on Aluminum - Double Hung: All Facades	Inspected
Instance Condition	4 - Between Fair and Poor
Instance Quantity	900
Instance Quantity Uom	S.F.
Are these windows insulated	No
Installation Year	1994
Source of Installation	Custodial Staff
Deficiency	ALUMINUM - DOUBLE HUNG: AIR/WATER INFILTRATION

REPLACE TRIM, SILLS OR WEATHERSTRIPPING

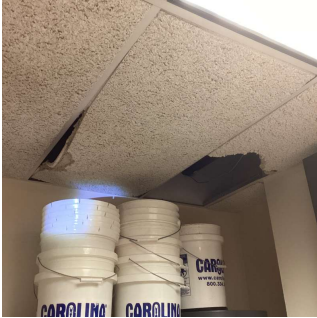
Question	Response
INTERIOR	
CLASSROOMS/CORRIDORS/ADMIN SPACES	
Ceiling	Inspected
Condition	2 - Between Good and Fair
Deficiency	TECTUM: DAMAGED/MISSING
Deficiency Location/Instance	Rooms 406, 201A, Corridor near Rooms 413, 405, 401 and others
Deficiency Quantity	170
Quantity Uom	S.F.
Potential Action	REPLACE
Urgency of Action	PRIORITY 3
Purpose of Action	LEVEL 2
Deficiency Photo1

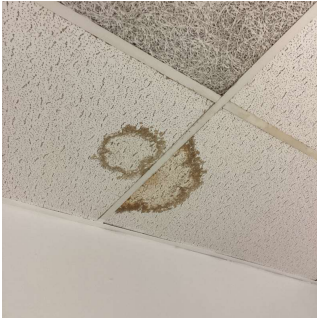
Violations	Room 201A No violations recorded.
Deficiency	ACOUSTIC TILES: DAMAGED/MISSING
Deficiency Location/Instance	Room 406, Main Entrance - Vestibule, Corridor near Stair C/2, by Room 206A
Deficiency Quantity	80
Quantity Uom	S.F.
Potential Action	REPLACE
Urgency of Action	PRIORITY 3
Purpose of Action	LEVEL 2
Deficiency Photo1

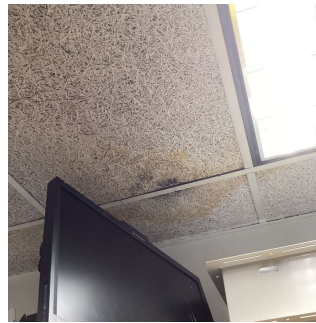
Violations	Room 406 No violations recorded.
Deficiency	TECTUM: DAMAGED/MISSING - ACTIVE LEAK
Deficiency Location/Instance	Room 413
Deficiency Quantity	30
Quantity Uom	S.F.
Potential Action	REPLACE
Urgency of Action	PRIORITY 5

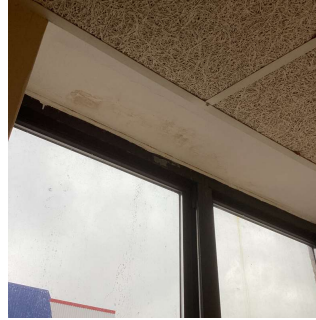
Violations	Near Main Entrance No violations recorded.
LIBRARY	
	Inspected
Instance on Room 300 (2000 SF)	Inspected
Built-in Furnishing	
Instance on Room 300 (2000 SF)	Does not Exist
Ceiling	
Instance on Room 300 (2000 SF)	Inspected
Condition	3 - Fair
Deficiency	PLASTER: CRACKS/SPALLING - ACTIVE LEAK
Deficiency Location/Instance	Near Windows
Deficiency Quantity	20

Potential Action	REPLACE
Urgency of Action	PRIORITY 5
Purpose of Action	LEVEL 2
Deficiency Photo1

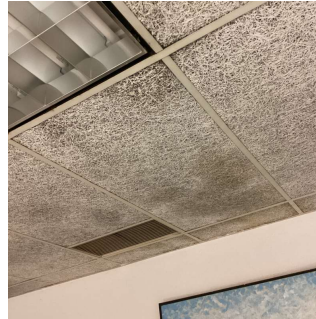
Deficiency	TECTUM: DAMAGED/MISSING
Deficiency Location/Instance	Right Side
Deficiency Quantity	45
Quantity Uom	S.F.
Potential Action	REPLACE
Urgency of Action	PRIORITY 3
Purpose of Action	LEVEL 2
Deficiency Photo1
