NYC Department of Education
Building Condition Assessment Survey 2023 - 2024

Architectural Inspection

Asset: ACORN COMMUNITY HS - K, 561 GRAND AVENUE, New York, 11238

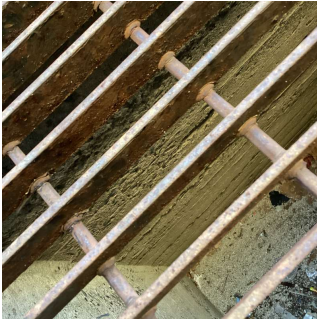
Question	Response
Architectural	
EXTERIOR	Inspected
AREAWAY	Inspected
Instance on AW1, AW2	Inspected
Instance Condition	2 - Between Good and Fair
Instance Quantity	2
Instance Quantity Uom	EACH
Deficiency	AREAWAY WALLS: CRACKS AND SPALLING
Roof Plan reference	
Deficiency Quantity	10
Quantity Uom	S.F.
Potential Action	REPAIR
Urgency of Action	PRIORITY 3
Purpose of Action	LEVEL 2

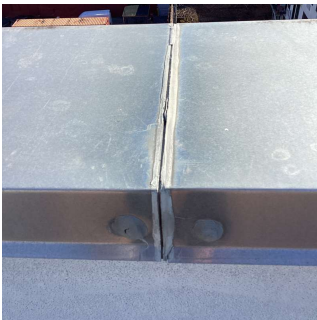
Violations	AW2 No violations recorded.
AWNINGS AND CANOPIES	
	Does not Exist
CHIMNEY	
Material Type(s)	Inspected Masonry
Condition	2 - Between Good and Fair
Deficiency	No deficiencies recorded
COPING	
Condition	Inspected 2 - Between Good and Fair
Deficiency	METAL: DETERIORATED TRANSVERSE JOINTS
Roof Plan reference

Deficiency Quantity	30
Quantity Uom	L.F.
Potential Action	MAINTENANCE
Urgency of Action	PRIORITY 3
Purpose of Action	LEVEL 2
Deficiency Photo1

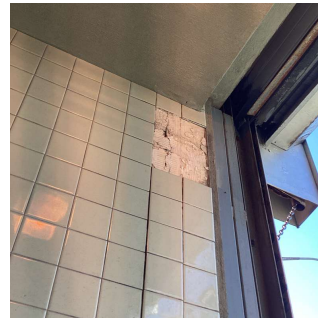
Facade A - Main Entrance

Question	Response
EXTERIOR	
DOORS	Inspected
DOORS AND FRAMES	Inspected
Condition	3 - Fair
Deficiency	METAL CLAD: DETERIORATED DOOR AND FRAME - MINOR DETERIORATION
Roof Plan reference	
Deficiency Quantity	1
Quantity Uom	EACH
Potential Action	MAINTENANCE
Urgency of Action	PRIORITY 3
Purpose of Action	LEVEL 2
Deficiency Photo1	
Violations	<p>Facade C - Exit 5</p> <p>No violations recorded.</p>
DOOR HARDWARE	Inspected
Condition	3 - Fair
Deficiency	No deficiencies recorded
LINTELS	Inspected
Condition	2 - Between Good and Fair
Deficiency	No deficiencies recorded
TRANSOM/SIDE LIGHT	Does not Exist
EXTERIOR WALLS	Inspected
Material Type(s)	Concrete, Masonry
Replacement Quantity	32,000
Replacement Uom	S.F.
Instance on All Facades	Inspected
Instance Condition	3 - Fair
Instance Quantity	32,000
Instance Quantity Uom	S.F.
Deficiency	CERAMIC TILE: CHIPPED, SPALLED, BROKEN PIECES

REPLACE

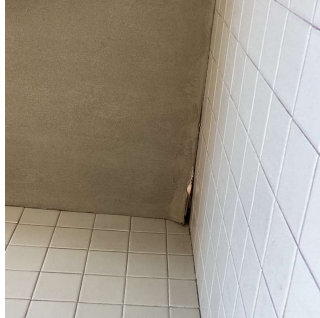
STUCCO/PLASTER: MINOR CRACKS/SPALLING

Question	Response
EXTERIOR	
EXTERIOR SOFFITS	
Quantity Uom	S.F.
Potential Action	REPAIR
Urgency of Action	PRIORITY 3
Purpose of Action	LEVEL 2
Deficiency Photo1

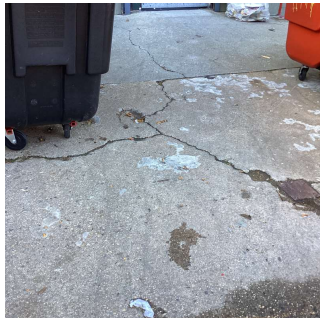
Violations	Facade A - Main Entrance No violations recorded.
LOADING DOCK	
Condition	Inspected 5 - Poor
Deficiency	DETERIORATED CONCRETE PLATFORM WITH CRACKED, SPALLED CONCRETE OR EXPOSED REINFORCING
Roof Plan reference

Deficiency Quantity	100
Quantity Uom	S.F.
Potential Action	REPAIR
Urgency of Action	PRIORITY 4
Purpose of Action	LEVEL 2
Deficiency Photo1

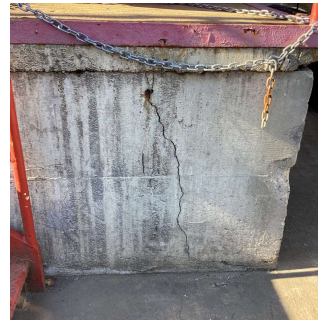
Violations	Facade C No violations recorded.
Deficiency	CHEEK WALL/CRACKS, SPALLING - MAJOR

40
S.F.
REPLACE
PRIORITY 4
LEVEL 2

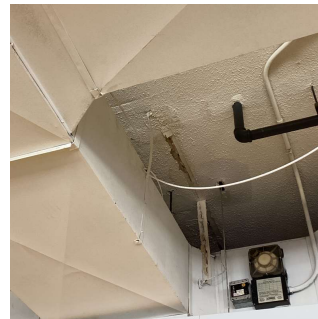
Roof 1 - Room 609 - Shown (Similar: Rooms 617, 619, 619B)

Deficiency MODIFIED BITUMEN: ROOFING: MAJOR ACTIVE ROOF LEAKS IN INSTRUCTIONAL SPACE

Potential Action REPLACE ROOFING WITHOUT MAJOR EQUIPMENT REMOVAL

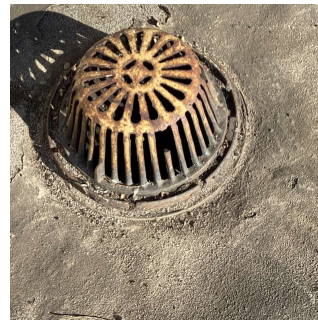
Roof 1 - Near BH2

Deficiency DETERIORATED

1
EACH
REPLACE
PRIORITY 4
LEVEL 2

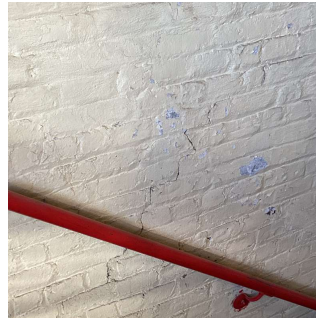
BH2

BULKHEAD/PENTHOUSE WALLS/INTERIOR: BRICK
CRACKS/SPALLING

40
S.F.
REPLACE
PRIORITY 3
LEVEL 2

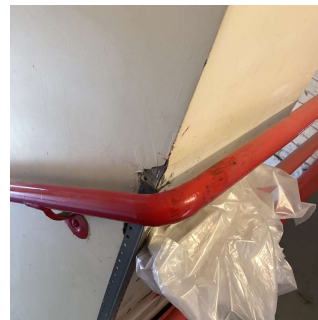
BH2

BULKHEAD/PENTHOUSE WALLS/INTERIOR: GYPSUM BOARD DAMAGED/DETERIORATED

REPLACE

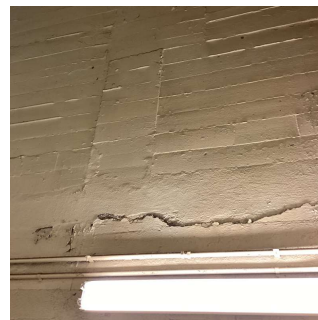
BH1

BULKHEAD/PENTHOUSE WALLS/INTERIOR: PLASTER CRACKS/SPALLING

30
S.F.
REPLACE
PRIORITY 4
LEVEL 2

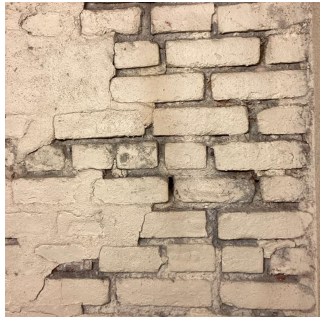
Deficiency	BULKHEAD/PENTHOUSE WALLS/INTERIOR: BRICK DETERIORATED JOINTS
------------	---

Question	Response
EXTERIOR	
ROOF	
Specialties	
BULKHEAD/PENTHOUSE	
Deficiency Photo1

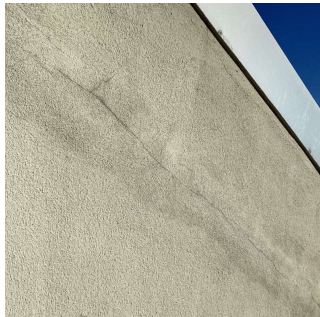
Violations	BH1 No violations recorded.
Deficiency	BULKHEAD/PENTHOUSE WALLS/EXTERIOR: CRACKS/SPALLING - MINOR
Roof Plan reference	K909

Deficiency Quantity	60
Quantity Uom	S.F.
Potential Action	REPAIR
Urgency of Action	PRIORITY 3
Purpose of Action	LEVEL 2
Deficiency Photo1

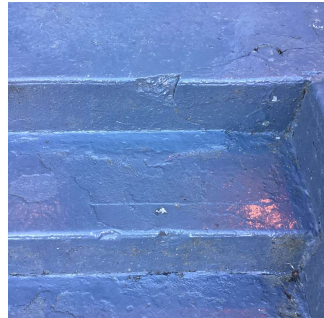
Question	Response
EXTERIOR	
STAIRS/RAMPS: EXTERIOR	Inspected
BUILDING CHEEK/FLANK WALLS	Inspected
Condition	2 - Between Good and Fair
Deficiency	No deficiencies recorded
RAILINGS	Inspected
Condition	2 - Between Good and Fair
Deficiency	No deficiencies recorded
STAIRS/RAMPS	Inspected
Condition	4 - Between Fair and Poor
Deficiency	CONCRETE: CRACKS/SPALLING - MAJOR
Roof Plan reference

<p>K909</p> <p>Dean Street</p> <p>Grand Avenue</p> <p>Facade A - Main Entrance</p>
Deficiency Quantity	20
Quantity Uom	S.F.
Potential Action	REPLACE
Urgency of Action	PRIORITY 4
Purpose of Action	LEVEL 2
Deficiency Photo1

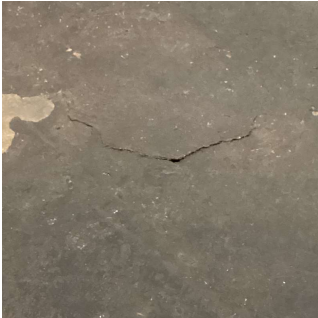
Basement - Electrical Room
Violations	No violations recorded.
FLOOR STRUCTURE	Inspected
Condition	3 - Fair
Deficiency	CONCRETE SLAB ON GRADE: THRU CRACKS
Deficiency Location/Instance	Basement - Electrical Room
Deficiency Quantity	10
Quantity Uom	S.F.
Potential Action	REPAIR
Urgency of Action	PRIORITY 3
Purpose of Action	LEVEL 5
Deficiency Photo1

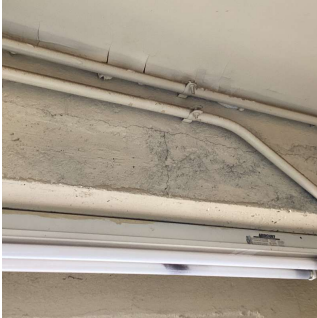
Violations	Basement - Boiler Room No violations recorded.
ROOF STRUCTURE	
Condition	Inspected 3 - Fair
Deficiency	CONCRETE COLUMNS AND BEAMS: CRACKED/SPALLED/REINFORCEMENT EXPOSED
Deficiency Location/Instance	BH2

Deficiency Quantity	10

Question	Response
INTERIOR	
STRUCTURAL	
ROOF STRUCTURE	
Quantity Uom	S.F.
Potential Action	REPAIR
Urgency of Action	PRIORITY 3
Purpose of Action	LEVEL 5
Deficiency Photo1

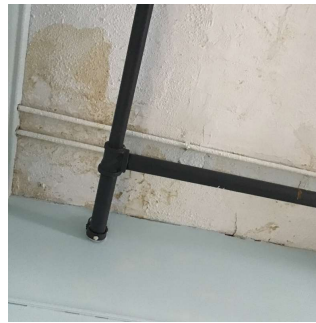
Room 619

Room 615
Violations	No violations recorded.
Deficiency	PLASTER: CRACKS/SPALLING - ACTIVE LEAK
Deficiency Location/Instance	Room 619,619B,617
Deficiency Quantity	40
Quantity Uom	S.F.
Potential Action	REPLACE
Urgency of Action	PRIORITY 5
Purpose of Action	LEVEL 2

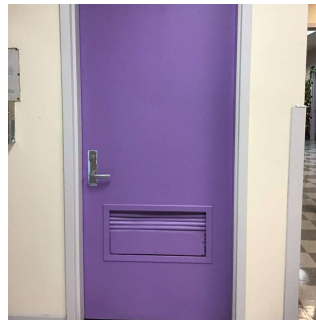
Room 517

WOOD: DAMAGED LOUVER

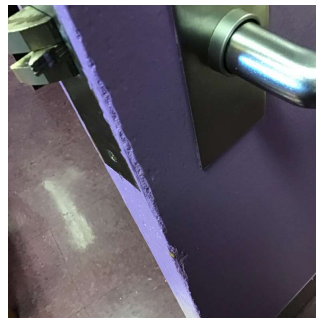
WOOD: DETERIORATED DOOR

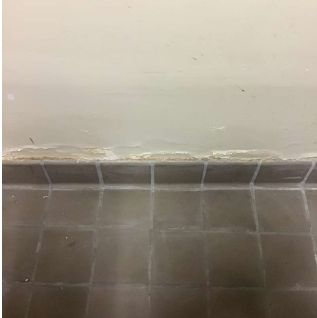
Violations	Near Entrance No violations recorded.
Walls	
Instance on 1st Floor	Inspected
Condition	2 - Between Good and Fair
Deficiency	PLASTER: CRACKS/SPALLING

Question	Response
INTERIOR	
KITCHEN	
Walls	
Deficiency Location/Instance	Room 121, 117
Deficiency Quantity	20
Quantity Uom	S.F.
Potential Action	REPLACE
Urgency of Action	PRIORITY 3
Purpose of Action	LEVEL 2
Deficiency Photo1

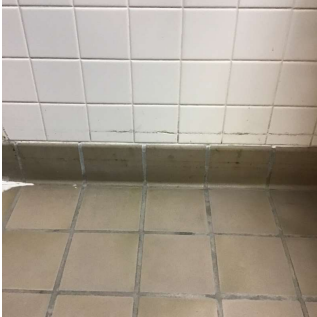
Room 121
Violations	No violations recorded.
Deficiency	CERAMIC TILE: BROKEN/ MISSING
Deficiency Location/Instance	Near Servery
Deficiency Quantity	10
Quantity Uom	S.F.
Potential Action	REPLACE
Urgency of Action	PRIORITY 3
Purpose of Action	LEVEL 2
Deficiency Photo1

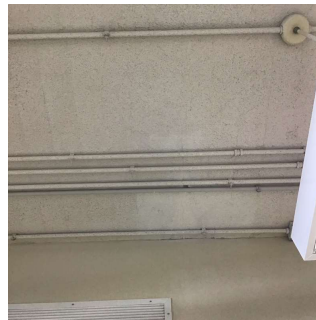
Near Entrance

Deficiency	PLASTER: CRACKS/SPALLING
Deficiency Location/Instance	Near Entrance, windows
Deficiency Quantity	10
Quantity Uom	S.F.
Potential Action	REPLACE
Urgency of Action	PRIORITY 3
Purpose of Action	LEVEL 2
Deficiency Photo1

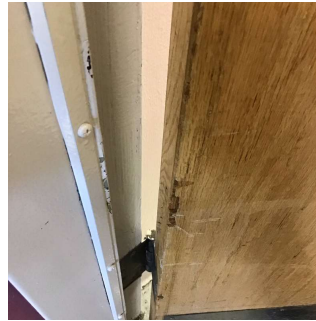
Deficiency	WOOD: DETERIORATED DOOR
Deficiency Location/Instance	Entrance
Deficiency Quantity	1
Quantity Uom	EACH
Potential Action	MAINTENANCE
Urgency of Action	PRIORITY 3
Purpose of Action	LEVEL 2

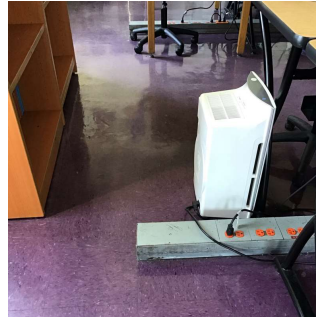
Room 611

VINYL TILES: TRIPPING HAZARD - ELECTRICAL OUTLET

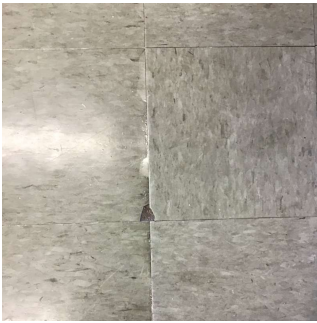
VINYL TILES: BROKEN/DETERIORATED/MISSING TILES

REPLACE

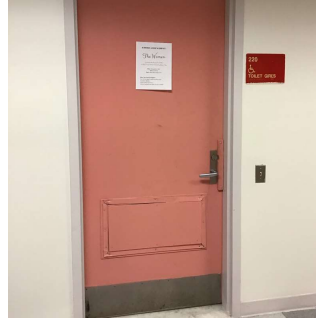
Room 220

Violations	Room 120 No violations recorded.
Door(s)	Inspected
Condition	5 - Poor
Deficiency	WOOD: DAMAGED LOUVER
Deficiency Location/Instance	Rooms 220,214,114
Deficiency Quantity	3
Quantity Uom	EACH

MAINTENANCE
PRIORITY 3
LEVEL 2

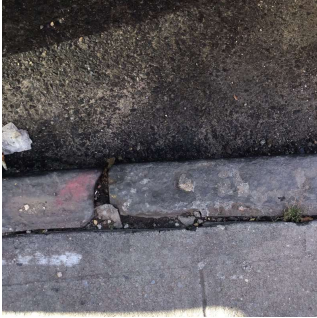
Along Grand Avenue
Violations	No violations recorded.
Deficiency	DAMAGED CURBS
Deficiency Location/Instance	Along Grand Avenue, Dean Street
Deficiency Quantity	20
Quantity Uom	L.F.
Potential Action	REPLACE
Urgency of Action	PRIORITY 3
Purpose of Action	LEVEL 2
Deficiency Photo1
