**NYC Department of Education
Building Condition Assessment Survey 2023 - 2024**

Architectural Inspection

K913

Asset: EBC HS FOR PUB. SERV. - BUSHWICK-K, 1155 DEKALB AVENUE, New York, 11221

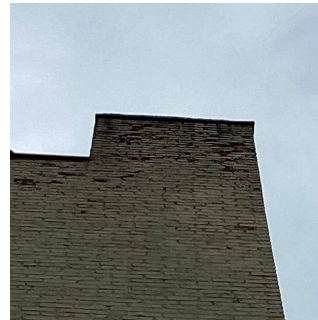
Question	Response
Architectural	
EXTERIOR	Inspected
AREAWAY	Does not Exist
AWNINGS AND CANOPIES	Does not Exist
CHIMNEY	Inspected
Material Type(s)	Masonry
Condition	3 - Fair
Deficiency	BRICK: MINOR CRACKS AND SPALLING

K913
 30
 S.F.
 RESTITCH
 PRIORITY 3
 LEVEL 2

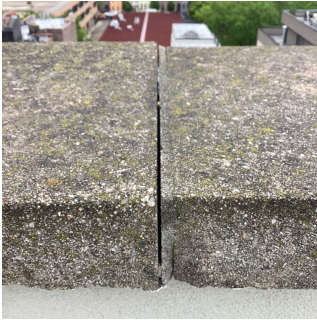
CAST STONE: DETERIORATED TRANSVERSE JOINTS

K913
 20
 L.F.
 MAINTENANCE
 PRIORITY 3
 LEVEL 2

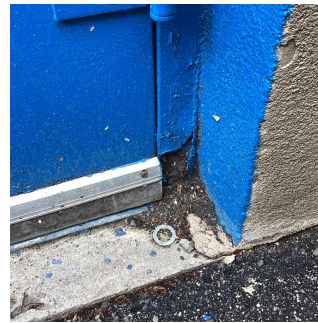
Facade D - Exit 4

Violations	Facade C - Exit 3 No violations recorded.
Deficiency	METAL: DETERIORATED DOOR AND FRAME - MAJOR DETERIORATION

6
EACH
REPLACE
PRIORITY 4
LEVEL 2

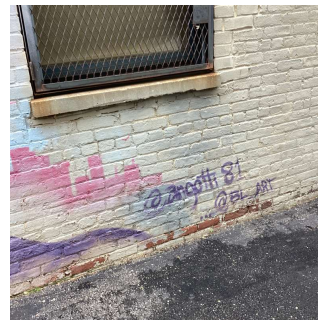
Facade B

BRICK: DETERIORATED JOINTS

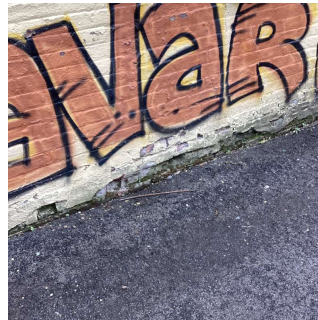
Facade C

BRICK: MAJOR / THRU CRACKS

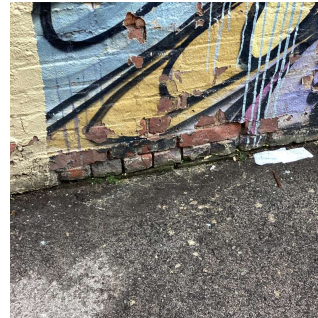
Facade C

BRICK: DETERIORATED JOINTS

PRIORITY 4
LEVEL 2

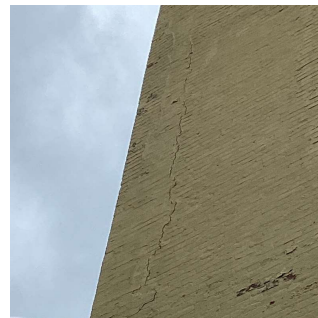
BRICK: CRACKS/DISPLACED/SPALLED BRICK AT BUILDING CORNERS

100
S.F.
REMOVE AND REBUILD
PRIORITY 4
LEVEL 4

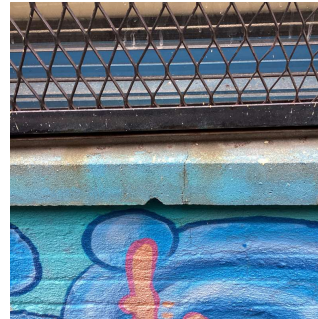
Facade D

BRICK: DETERIORATED MASONRY SILLS - MINOR

REPAIR

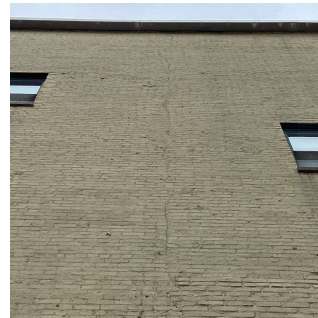
Facade C

BRICK: MINOR CRACKS AND SPALLING

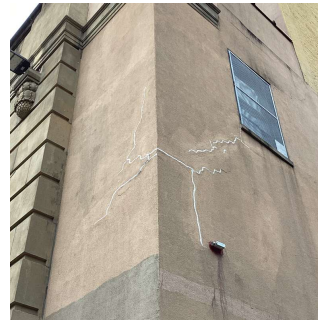
Corner of Facades A and D

STUCCO CEMENT SURFACE: CRACKS, SPALLING

REPLACE

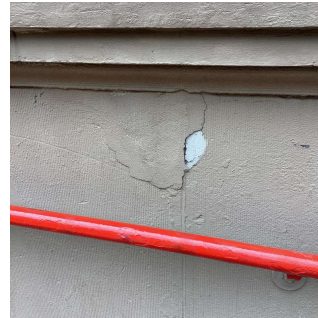
Facade A

TERRA COTTA: CHIPPED/SPALLED/BROKEN PIECES - MINOR

REPAIR

PRIORITY 3
LEVEL 4

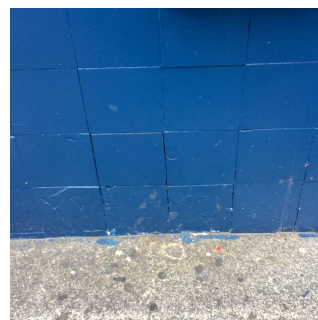
Facade A

CERAMIC TILE: DETERIORATED JOINTS

10
S.F.
REPOINT
PRIORITY 3
LEVEL 2

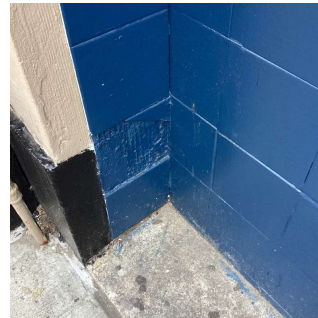
Facade A

CERAMIC TILE: CHIPPED, SPALLED, BROKEN PIECES

REPLACE

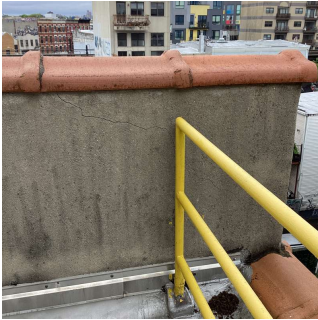
Deficiency	CONCRETE: MINOR CRACKS, SPALLING
------------	----------------------------------

Deficiency Quantity	50
Quantity Uom	S.F.
Potential Action	REPAIR
Urgency of Action	PRIORITY 3
Purpose of Action	LEVEL 2

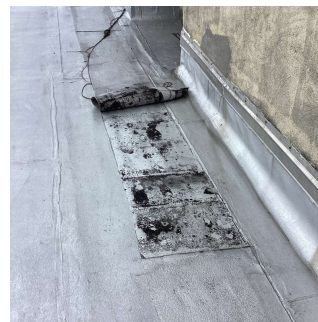
Roof 1

Deficiency

REPLACE ROOFING WITHOUT MAJOR EQUIPMENT REMOVAL

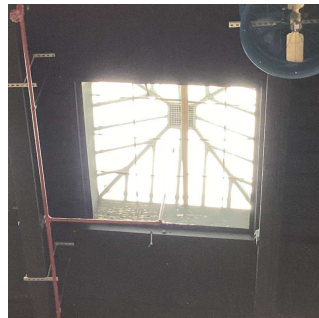
Question	Response
EXTERIOR	
ROOF	
Specialties	Inspected
BULKHEAD/PENTHOUSE	Does not Exist
CUPOLA/ SPIRES/ TOWERS	Does not Exist
DORMER	Does not Exist
DUNNAGE STEEL	Inspected
Condition	2 - Between Good and Fair
Deficiency	No deficiencies recorded
SKYLIGHT/ROOF VENT	Inspected
Material Type(s)	Glass
Condition	3 - Fair
Deficiency	WATER INFILTRATION
Roof Plan reference

Deficiency Quantity	100
Quantity Uom	S.F.
Potential Action	MAINTENANCE
Urgency of Action	PRIORITY 3
Purpose of Action	LEVEL 2
Deficiency Photo1

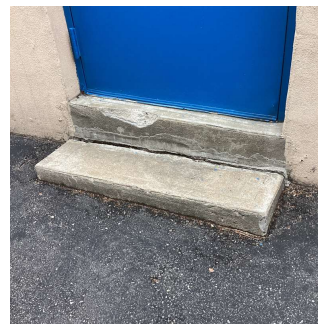
Facade B

Violations	No violations recorded.
ROOF/GRAVITY TANK	Does not Exist
STAIRS/RAMPS: EXTERIOR	Inspected
BUILDING CHEEK/FLANK WALLS	Does not Exist
RAILINGS	Inspected
Condition	2 - Between Good and Fair
Deficiency	No deficiencies recorded
STAIRS/RAMPS	Inspected
Condition	5 - Poor
Deficiency	CONCRETE: DETERIORATED SUBSTRATE

10
 S.F.
 REPLACE SUBSTRATE AND RESET
 PRIORITY 4
 LEVEL 2

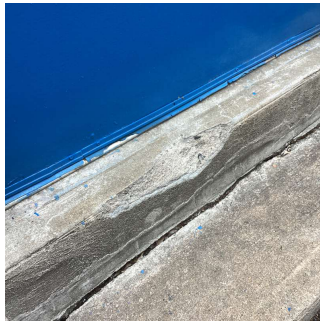
CONCRETE: CRACKS/SPALLING - MAJOR

10
 S.F.
 REPLACE
 PRIORITY 5
 LEVEL 6

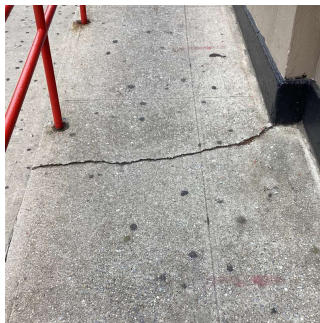
Violations	Facade B No violations recorded.
Deficiency	CONCRETE: CRACKS/SPALLING - MAJOR
Roof Plan reference	<p>K913</p>

Deficiency Quantity	75
Quantity Uom	S.F.
Potential Action	REPLACE
Urgency of Action	PRIORITY 4
Purpose of Action	LEVEL 2
Deficiency Photo1

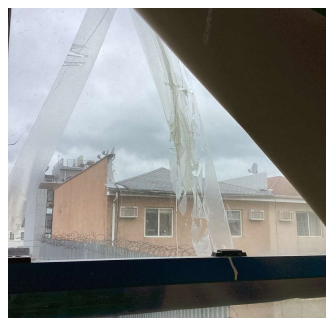
Question	Response
EXTERIOR	
WINDOWS	
WINDOWS	Inspected
Material Type(s)	Aluminum
Instance on Aluminum - Double Hung: All Facades	Inspected
Instance Condition	3 - Fair
Instance Quantity	6,000
Instance Quantity Uom	S.F.
Are these windows insulated	Yes
Installation Year	1998
Source of Installation	Custodial Staff
Deficiency	ALUMINUM - DOUBLE HUNG: BROKEN PANE
Roof Plan reference

Elevation	 
Deficiency Quantity	30
Quantity Uom	S.F.
Potential Action	MAINTENANCE
Urgency of Action	PRIORITY 3
Purpose of Action	LEVEL 2
Deficiency Photo1

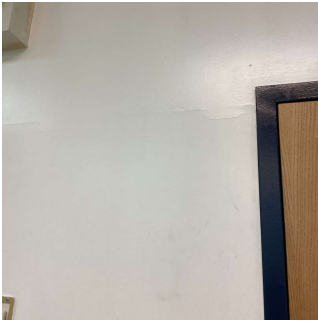
Deficiency	GYPSUM BOARD: DETERIORATED
Deficiency Location/Instance	Near Main Entrance
Deficiency Quantity	10
Quantity Uom	S.F.
Potential Action	REPLACE
Urgency of Action	PRIORITY 3
Purpose of Action	LEVEL 2

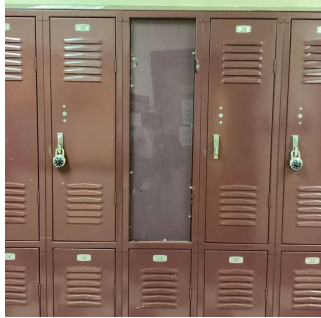
Violations	Locker 17 - Corridor near Room 328 No violations recorded.

Walls	Inspected
Violations	No violations recorded.
Specialties	Inspected
Classroom Locker(s)	Inspected
Condition	2 - Between Good and Fair
Deficiency	DAMAGED UNITS
Deficiency Location/Instance	Locker 17 - Corridor near Room 328, Lockers 51, 52 - Corridor near Room 318, Locker 79 - Corridor near Room 337
Deficiency Quantity	4
Quantity Uom	EACH
Potential Action	REPLACE
Urgency of Action	PRIORITY 3
Purpose of Action	LEVEL 2
Deficiency Photo1

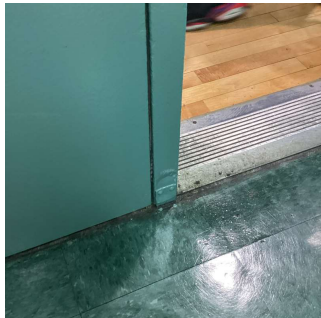
Door(s)	
Instance on 4th Floor	Inspected
Condition	4 - Between Fair and Poor
Deficiency	METAL: DETERIORATED DOOR AND FRAME
Deficiency Location/Instance	Right Side Main Entrance
Deficiency Quantity	2
Quantity Uom	EACH
Potential Action	MAINTENANCE
Urgency of Action	PRIORITY 3
Purpose of Action	LEVEL 2
Deficiency Photo1

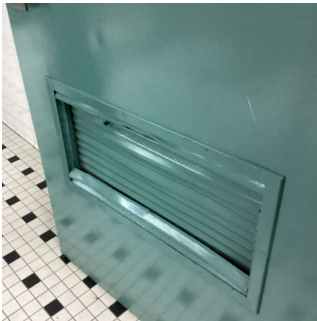
Violations	In Boys Locker Room No violations recorded.
Floor Finish	
Instance on 4th Floor - Boys(46 Lockers)	Inspected
Condition	2 - Between Good and Fair
Deficiency	No deficiencies recorded
Locker Room Lockers	
Instance on 4th Floor - Boys(46 Lockers)	Inspected
Condition	2 - Between Good and Fair
Deficiency	DAMAGED UNITS
Deficiency Location/Instance	Lockers 55
Deficiency Quantity	1
Quantity Uom	EACH
Potential Action	REPLACE
Urgency of Action	PRIORITY 3
Purpose of Action	LEVEL 2
Deficiency Photo1

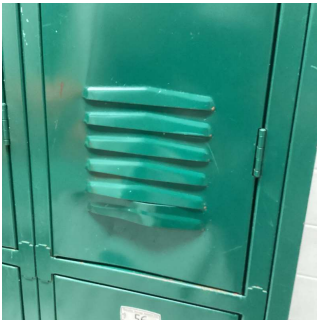
Violations	Locker 55 No violations recorded.
Walls	
Instance on 4th Floor - Boys(46 Lockers)	Inspected
Condition	2 - Between Good and Fair
Deficiency	No deficiencies recorded
MULTI-PURPOSE ROOM	
Instance on 3rd Floor	Inspected
Ceiling	
Instance on 3rd Floor	Inspected
Condition	2 - Between Good and Fair
Deficiency	GYPSUM BOARD: DAMAGED/DETERIORATED
Deficiency Location/Instance	Near Main Entrance, Right Side and Left Side, Room 315D

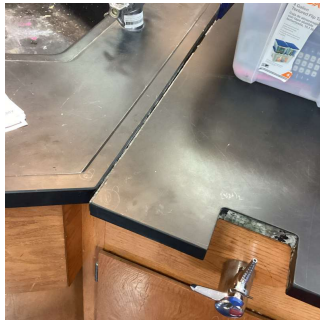
Question	Response
INTERIOR	
SCIENCE LAB	
Alternative use	No
Instance on Room 431	Inspected
Alternative use	No
Fixed Equipment	
Instance on Room 431	Inspected
Condition	5 - Poor
Deficiency	TRI-FACIAL TABLE: DAMAGED
Deficiency Location/Instance	Room 431
Deficiency Quantity	2
Quantity Uom	EACH
Potential Action	REPLACE
Urgency of Action	PRIORITY 3
Purpose of Action	LEVEL 2
Deficiency Photo1

Room 431
Violations	No violations recorded.
Instance on Room 439	Inspected
Condition	3 - Fair
Deficiency	CABINETRY: MISSING/DAMAGED
Deficiency Location/Instance	Room 439
Deficiency Quantity	10
Quantity Uom	L.F.
Potential Action	REPLACE
Urgency of Action	PRIORITY 3
Purpose of Action	LEVEL 2
Deficiency Photo1

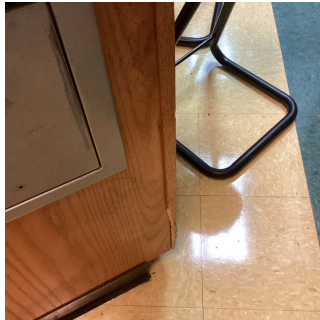
Room 439
Violations	No violations recorded.
SCIENCE PREP ROOM	
Instance on Rooms 437, 437A	Inspected
Alternative use	No
Fixed Equipment

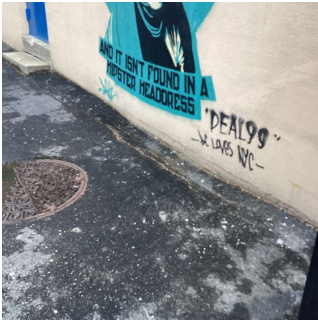
Question	Response
SITE	
PAVING	
Student Non-Use	Does not Exist
Student Use	Does not Exist
Site Sidewalks & Walkways	Inspected
Asphalt	Inspected
Condition	3 - Fair
Deficiency	LOCALIZED SINK AREA
Deficiency Location/Instance	Dekalb Avenue, Right and Left Side
Deficiency Quantity	50
Quantity Uom	S.F.
Potential Action	REPAIR
Urgency of Action	PRIORITY 3
Purpose of Action	LEVEL 2
Deficiency Photo1

Violations	Dekalb Avenue No violations recorded.
Deficiency	CRACKS - MAJOR
Deficiency Location/Instance	Rear part of Building, Right and Left Side
Deficiency Quantity	200
Quantity Uom	S.F.
Potential Action	REPLACE
Urgency of Action	PRIORITY 3
Purpose of Action	LEVEL 2
Deficiency Photo1

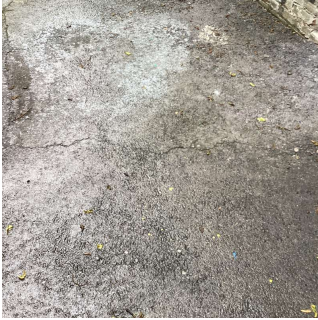
Violations	Rear part of Building No violations recorded.
Concrete	Does not Exist
Pavers	Does not Exist
DOT Sidewalk	Inspected
Asphalt	Does not Exist
Concrete	Inspected
Condition	4 - Between Fair and Poor

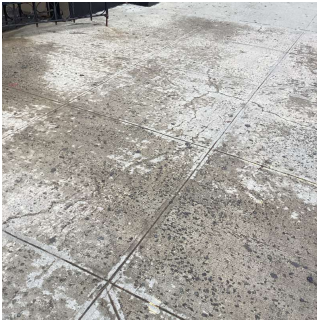
Question	Response
SITE	
PAVING	
DOT Sidewalk	
Concrete	
Deficiency	DAMAGED/DETERIORATED/MISSING SECTIONS
Deficiency Location/Instance	Dekalb Avenue
Deficiency Quantity	600
Quantity Uom	S.F.
Potential Action	REPLACE
Urgency of Action	PRIORITY 3
Purpose of Action	LEVEL 2
Deficiency Photo1

Violations	Dekalb Avenue No violations recorded.
Deficiency	DAMAGED CURBS
Deficiency Location/Instance	Dekalb Avenue
Deficiency Quantity	60
Quantity Uom	L.F.
Potential Action	REPLACE
Urgency of Action	PRIORITY 3
Purpose of Action	LEVEL 2
Deficiency Photo1

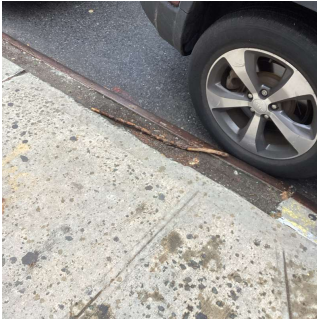
Violations	Dekalb Avenue No violations recorded.
Pavers	Does not Exist
PLAYGROUNDS	Does not Exist
PLAYING SURFACE	Does not Exist
RETAINING WALLS	Does not Exist
SEATING	Does not Exist
SITE WALLS (NOT RETAINING WALLS)	Does not Exist
STAIRS/RAMPS: EXTERIOR	Does not Exist
ARTWORK	Does not Exist
