**NYC Department of Education**  
**Building Condition Assessment Survey 2023 - 2024**

Architectural Inspection

**K917**

**Asset:** **BKLYN COLL ACAD (BRIDGES TO K)-K, 350 CONEY ISLAND AVENUE, New York, 11218**

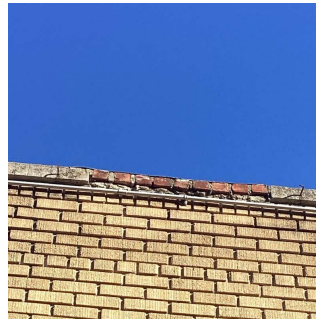
Roof 4

STONE: DETERIORATED TRANSVERSE JOINTS

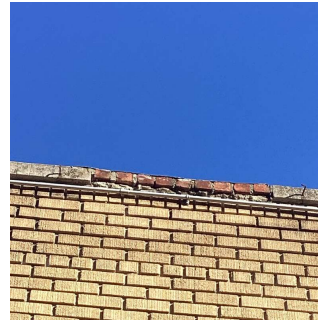
Roof 4

STONE: DETERIORATED BED JOINT

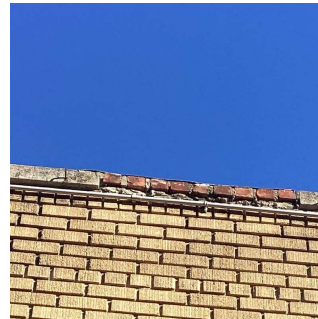
Roof 4

STONE: CRACKED/BROKEN PIECES

REPLACE-IN-KIND

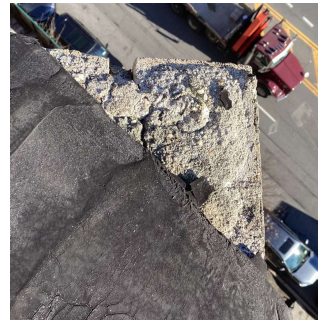
Roof 3

CAST STONE: CRACKED/BROKEN PIECES

REPLACE-IN-KIND

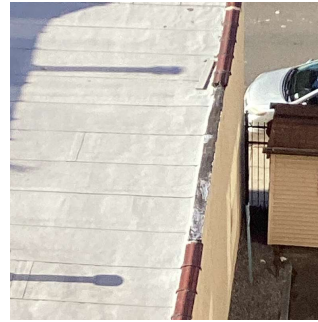
Roof 4

TERRA COTTA: CRACKED/BROKEN PIECES

REPLACE-IN-KIND

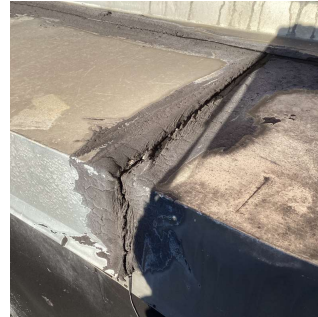
Roof 3

**METAL: DETERIORATED TRANSVERSE JOINTS**

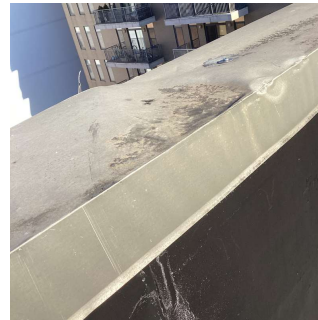
Roof 2  
No violations recorded.

**METAL: DETERIORATED**

200  
L.F.  
REPLACE-IN-KIND  
PRIORITY 4  
LEVEL 2

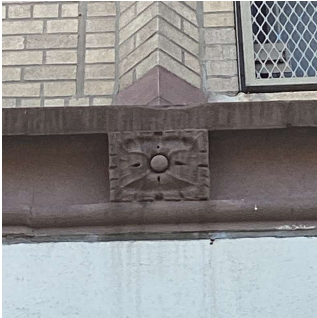
STONE: MAJOR CRACKS, SPALLING

20  
S.F.  
REPLACE  
PRIORITY 4  
LEVEL 2

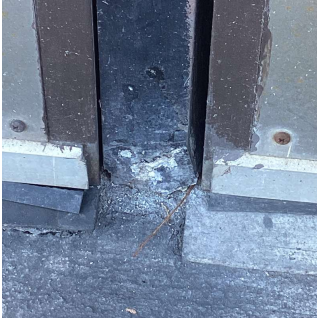
Violations	Facade A No violations recorded.
<b>DOORS</b>	Inspected
<b>DOORS AND FRAMES</b>	Inspected
Condition	5 - Poor
Deficiency	METAL: DETERIORATED DOOR AND FRAME - MINOR DETERIORATION
Roof Plan reference

Deficiency Quantity	4
Quantity Uom	EACH
Potential Action	MAINTENANCE
Urgency of Action	PRIORITY 3
Purpose of Action	LEVEL 2
Deficiency Photo1

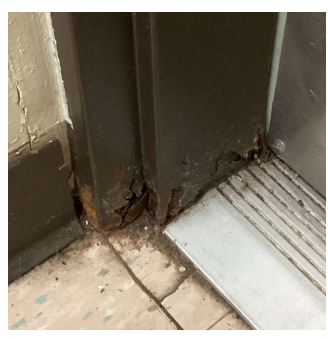
Violations	Facade A No violations recorded.
Deficiency	METAL: DETERIORATED DOOR AND FRAME - MAJOR DETERIORATION

Deficiency Quantity	3
Quantity Uom	EACH
Potential Action	REPLACE
Urgency of Action	PRIORITY 4
Purpose of Action	LEVEL 2
Deficiency Photo1

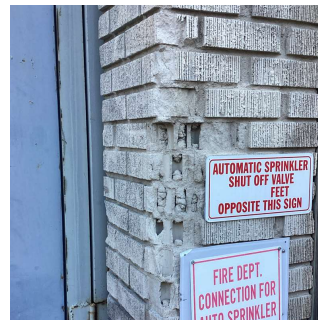
Facade C

Violations	Facade B No violations recorded.
<b>DOOR HARDWARE</b>	Inspected
Condition	3 - Fair
Deficiency	No deficiencies recorded
<b>LINTELS</b>	Inspected
Condition	2 - Between Good and Fair
Deficiency	No deficiencies recorded
<b>TRANSOM/SIDE LIGHT</b>	Inspected
Condition	2 - Between Good and Fair
Deficiency	No deficiencies recorded
<b>EXTERIOR WALLS</b>	Inspected
Material Type(s)	Masonry
Replacement Quantity	30,000
Replacement Uom	S.F.
Instance on All Facades	Inspected
Instance Condition	4 - Between Fair and Poor
Instance Quantity	30,000
Instance Quantity Uom	S.F.
Deficiency	BRICK: CRACKS/DISPLACED/SPALLED BRICK AT BUILDING CORNERS

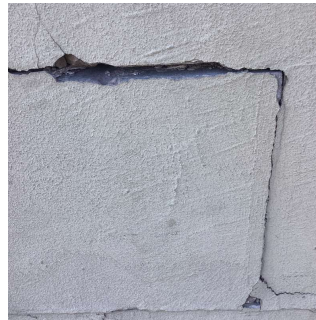
Facade A

STONE: CHIPPED/SPALLED/BROKEN PIECES - MAJOR

REPLACE

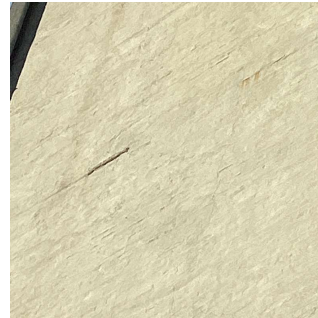
Facade B

BRICK: MAJOR / THRU CRACKS

PRIORITY 4  
LEVEL 4

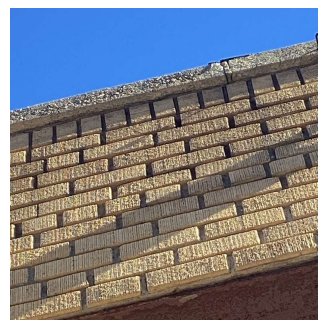
Facade C

BRICK: DETERIORATED JOINTS

80  
S.F.  
REPOINT  
PRIORITY 4  
LEVEL 2

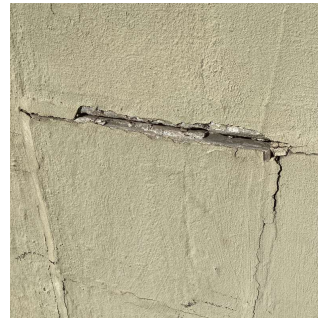
Facade B

STONE: DETERIORATED JOINTS

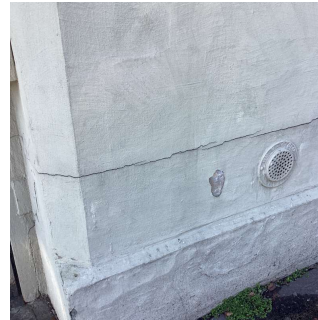
Facade A

STUCCO CEMENT SURFACE: CRACKS, SPALLING

REPLACE

PRIORITY 4  
LEVEL 4

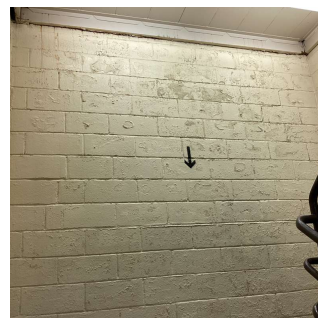
**CONCRETE MASONRY UNIT: WATER INFILTRATION IN INSTRUCTIONAL SPACE**

300  
S.F.  
REPAIR  
PRIORITY 5  
LEVEL 2

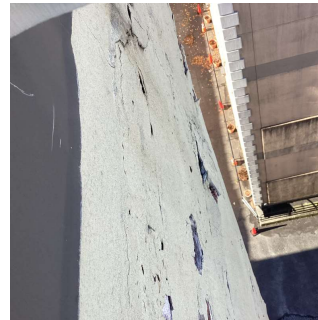
Roof 2
Violations	35461188K
Deficiency	<b>BRICK: MAJOR DETERIORATION/CRACKS</b>

30  
S.F.  
REMOVE AND REBUILD  
PRIORITY 5  
LEVEL 6

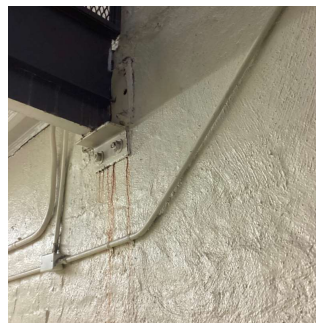
Roof 2 - Stair A/5

Deficiency	MODIFIED BITUMEN: ROOFING: MAJOR ACTIVE ROOF LEAKS IN INSTRUCTIONAL SPACE
------------	---

Deficiency Quantity	100
Quantity Uom	S.F.
Potential Action	REPLACE ROOFING WITHOUT MAJOR EQUIPMENT REMOVAL
Urgency of Action	PRIORITY 5
Purpose of Action	LEVEL 2

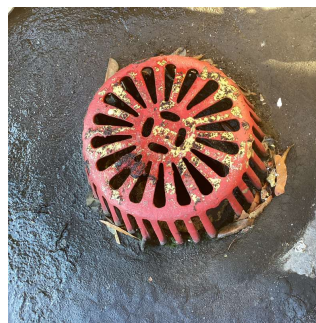
Roof 1	No violations recorded.
Violations

Inspected
Condition	4 - Between Fair and Poor
Deficiency	DETERIORATED
Roof Plan reference

Deficiency Quantity	2
Quantity Uom	EACH
Potential Action	REPLACE
Urgency of Action	PRIORITY 4
Purpose of Action	LEVEL 2
Deficiency Photo1

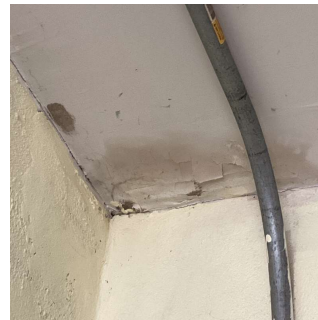
BH2  
35461187Z

Inspected
Condition	5 - Poor
Deficiency	BULKHEAD/PENTHOUSE ROOF: MAJOR LEAKAGE

200  
S.F.  
REPLACE  
PRIORITY 5  
LEVEL 4

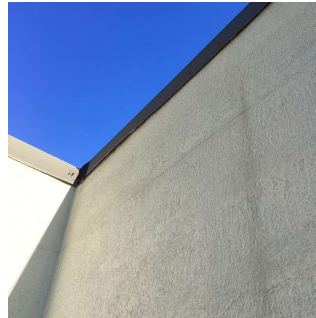
BH2

**BULKHEAD/PENTHOUSE WALLS/EXTERIOR:  
CRACKS/SPALLING - MINOR**

20  
S.F.  
REPAIR  
PRIORITY 3  
LEVEL 2

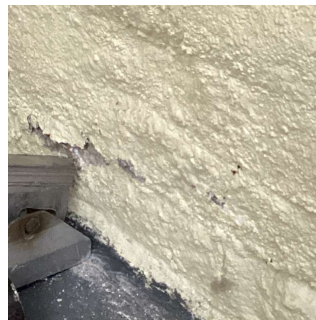
BH1

**BULKHEAD/PENTHOUSE WALLS/INTERIOR: PLASTER  
CRACKS/SPALLING**

REPLACE

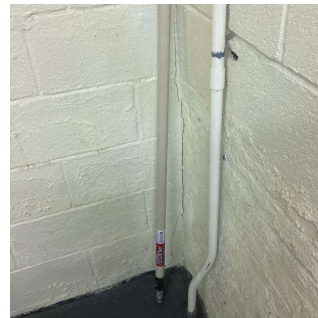
BH1

**BULKHEAD/PENTHOUSE WALLS/INTERIOR: CMU  
CRACKS/SPALLING**

50  
S.F.  
REPLACE  
PRIORITY 4  
LEVEL 2

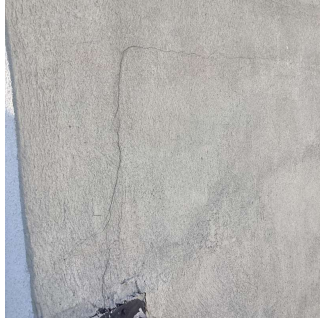
**BULKHEAD/PENTHOUSE WALLS/EXTERIOR:  
CRACKS/SPALLING - MAJOR**

10  
S.F.  
REPLACE  
PRIORITY 4  
LEVEL 2

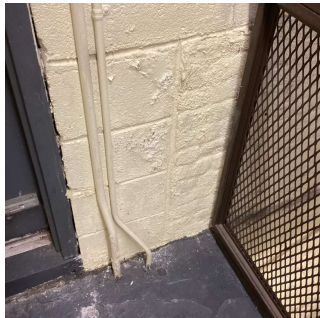
Violations	BH1 No violations recorded.
Deficiency	BULKHEAD/PENTHOUSE WALLS/EXTERIOR: WATER INFILTRATION
Roof Plan reference

Deficiency Quantity	200
Quantity Uom	S.F.
Potential Action	REPAIR
Urgency of Action	PRIORITY 5
Purpose of Action	LEVEL 2
Deficiency Photo1

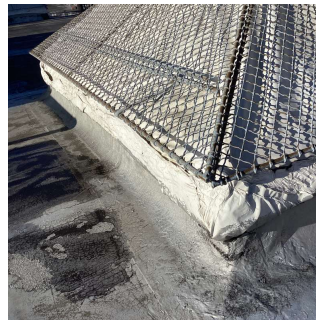
Roof 2

**BROKEN FRAMING**

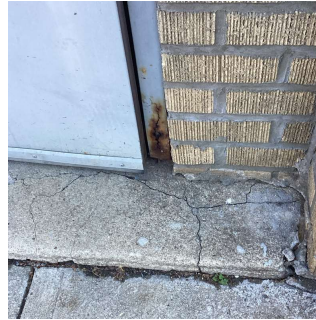
Facade C  
No violations recorded.

**STONE: CRACKS/SPALLING - MAJOR**

Quantity Uom	S.F.
Potential Action	REPLACE
Urgency of Action	PRIORITY 4
Purpose of Action	LEVEL 2
Deficiency Photo1

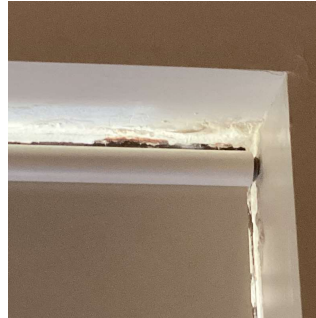
Facade D - Room 507-1, Facade E - Room 406-1

Material Type(s)	Inspected
	Aluminum
Instance on Aluminum - Double Hung: All Facades	Inspected
Instance Condition	4 - Between Fair and Poor
Instance Quantity	800
Instance Quantity Uom	S.F.
Are these windows insulated	No
Installation Year	1920
Source of Installation	Custodial Staff
Deficiency	ALUMINUM - DOUBLE HUNG: AIR/WATER INFILTRATION
Roof Plan reference

REPLACE TRIM, SILLS OR WEATHERSTRIPPING

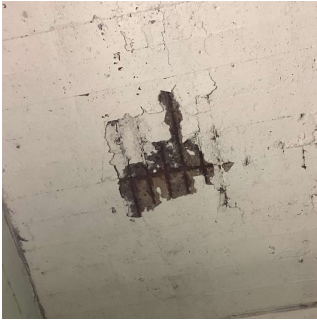
Basement - Electrical Meter Room
Violations	No violations recorded.
Deficiency	CONCRETE: CRACKS/SPALLED/REINFORCEMENT EXPOSED
Deficiency Location/Instance	Basement - Storage niche along corridor, Corridor, Corridor leading Electrical Meter Room
Deficiency Quantity	60
Quantity Uom	S.F.
Potential Action	REPAIR
Urgency of Action	PRIORITY 4
Purpose of Action	LEVEL 5
Deficiency Photo1

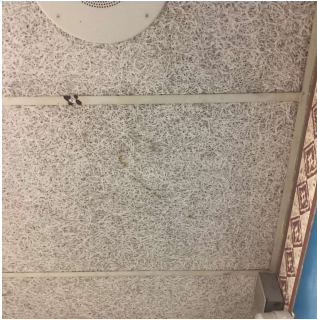
Violations	Basement - Ash Hoist Door No violations recorded.
<b>AUDITORIUM</b>	Does not Exist
<b>CAFETERIA</b>	Inspected
Instance on 4th Floor	Inspected
<b>Ceiling</b>	
Instance on 4th Floor	Inspected
Condition	2 - Between Good and Fair
Deficiency	TECTUM: DAMAGED/MISSING
Deficiency Location/Instance	Rear Wall
Deficiency Quantity	10
Quantity Uom	S.F.
Potential Action	REPLACE
Urgency of Action	PRIORITY 3
Purpose of Action	LEVEL 2
Deficiency Photo1

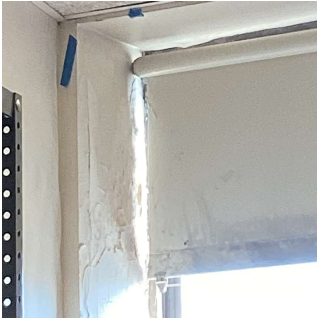
Violations	Rear Wall No violations recorded.
Deficiency	GYPSUM BOARD: DAMAGED/DETERIORATED

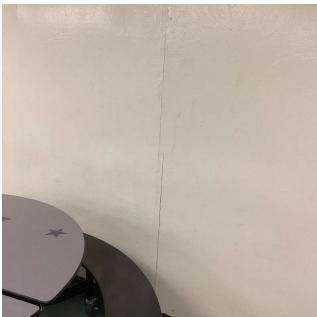
Violations	Room 403-1 No violations recorded.
Deficiency	GYPSUM BOARD: DETERIORATED
Deficiency Location/Instance	Near Kitchen, By Servery, Rear Wall
Deficiency Quantity	40
Quantity Uom	S.F.
Potential Action	REPLACE
Urgency of Action	PRIORITY 3
Purpose of Action	LEVEL 2
Deficiency Photo1

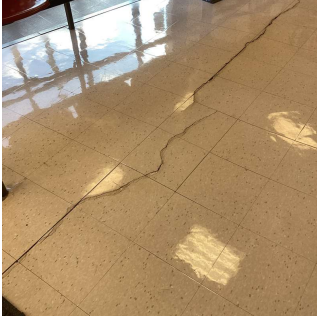
Question	Response
<b>INTERIOR</b>	
<b>CLASSROOMS/CORRIDORS/ADMIN SPACES</b>	
<b>Floor Finish</b>	
Violations	Corridor near Room 230-1 No violations recorded.
Deficiency	VINYL TILES: DETERIORATED SUBSTRATE
Deficiency Location/Instance	Corridor near Rooms 110-1, 105-1, 102-1, by Elevator P/1, Main Entrance Lobby
Deficiency Quantity	420
Quantity Uom	S.F.
Potential Action	REPLACE
Urgency of Action	PRIORITY 3
Purpose of Action	LEVEL 2
Deficiency Photo1

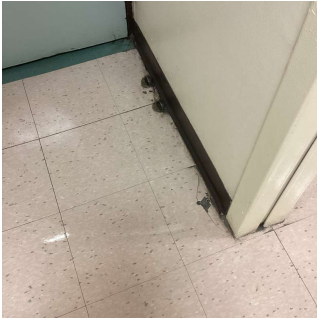
Violations	Corridor near Room 110-1 No violations recorded.
Deficiency	VINYL TILES: BROKEN/DETERIORATED/MISSING TILES
Deficiency Location/Instance	Corridor near Stairs A/5, B/1, By Room 416-1
Deficiency Quantity	40
Quantity Uom	S.F.
Potential Action	REPLACE
Urgency of Action	PRIORITY 3
Purpose of Action	LEVEL 2
Deficiency Photo1

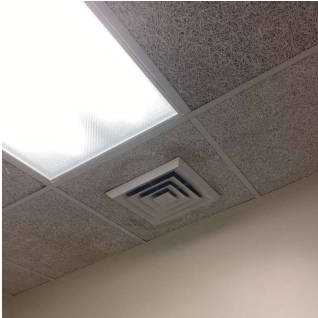
Violations	Near Sink No violations recorded.
Deficiency	TECTUM: DAMAGED/MISSING
Deficiency Location/Instance	Room 402A-1
Deficiency Quantity	10
Quantity Uom	S.F.
Potential Action	REPLACE
Urgency of Action	PRIORITY 3
Purpose of Action	LEVEL 2
Deficiency Photo1

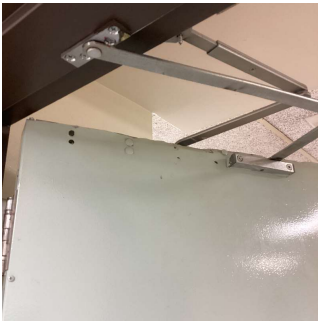
Violations	In Room 405-1 No violations recorded.
<b>Door(s)</b>	Inspected
Condition	5 - Poor
Deficiency	METAL: DETERIORATED DOOR
Deficiency Location/Instance	Room 325-1
Deficiency Quantity	1
Quantity Uom	EACH
Potential Action	MAINTENANCE
Urgency of Action	PRIORITY 3
Purpose of Action	LEVEL 2

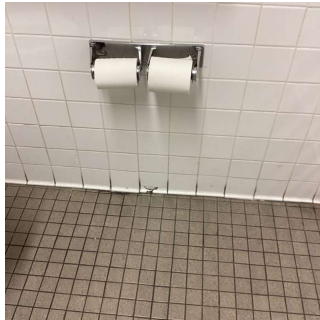
Violations	Room 404-1 No violations recorded.
Deficiency	CERAMIC TILE: BROKEN/ MISSING
Deficiency Location/Instance	Room 428-1
Deficiency Quantity	10
Quantity Uom	S.F.
Potential Action	REPLACE
Urgency of Action	PRIORITY 3
Purpose of Action	LEVEL 2
Deficiency Photo1

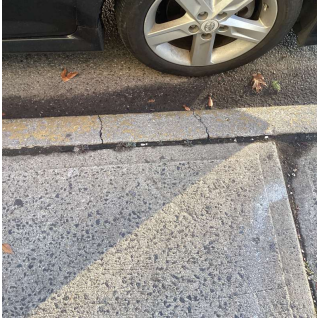
Violations	Coney Island Avenue No violations recorded.
Deficiency	DAMAGED CURBS
Deficiency Location/Instance	Coney Island Avenue
Deficiency Quantity	20
Quantity Uom	L.F.
Potential Action	REPLACE
Urgency of Action	PRIORITY 3
Purpose of Action	LEVEL 2
Deficiency Photo1
