NYC Department of Education
Building Condition Assessment Survey 2023 - 2024

Architectural Inspection

K932

Asset: HIGH SCHOOL SUSPENSION CENTER - K, 619 BELMONT AVENUE, New York, 11207

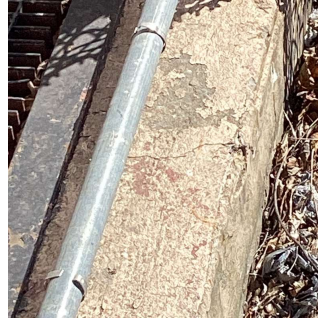
Question	Response
Architectural	
EXTERIOR	Inspected
AREAWAY	Inspected
Instance on AW1	Inspected
Instance Condition	5 - Poor
Instance Quantity	1
Instance Quantity Uom	EACH
Deficiency	AREAWAY WALLS: CRACKS AND SPALLING
Roof Plan reference

Deficiency Quantity

15

Quantity Uom
Potential Action
Urgency of Action
Purpose of Action
Deficiency Photo1

S.F.
REPAIR
PRIORITY 3
LEVEL 2

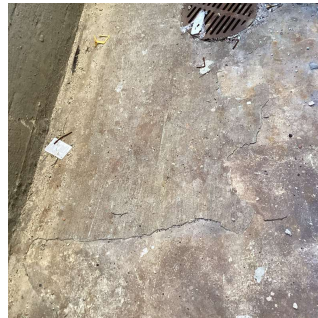
AW1

AREAWAY SLAB: CRACKS AND SPALLING

Deficiency Quantity
Quantity Uom
Potential Action
Urgency of Action
Purpose of Action
Deficiency Photo1

50
S.F.
REPLACE
PRIORITY 4
LEVEL 2

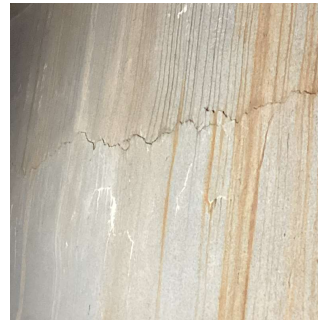
AW1

AREAWAY WALLS: CRACKS AND SPALLING

Deficiency Quantity

30

Quantity Uom

S.F.

Potential Action

REPLACE

Urgency of Action

PRIORITY 4

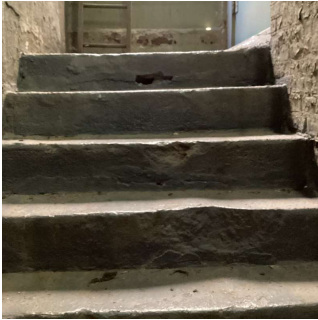
**AREAWAY STAIRS: DETERIORATED
TREADS/RISERS/NOSINGS**

Deficiency Quantity

35

Quantity Uom

S.F.

Potential Action

REPLACE

Urgency of Action

PRIORITY 4

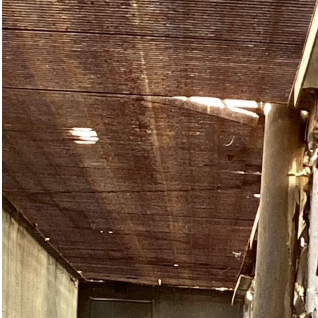
Violations	AW1 No violations recorded.
Deficiency	AREAWAY GRATINGS: MAJOR RUSTING / OR BROKEN
Roof Plan reference	K932

Deficiency Quantity	25
Quantity Uom	S.F.
Potential Action	REPLACE
Urgency of Action	PRIORITY 4
Purpose of Action	LEVEL 2
Deficiency Photo1

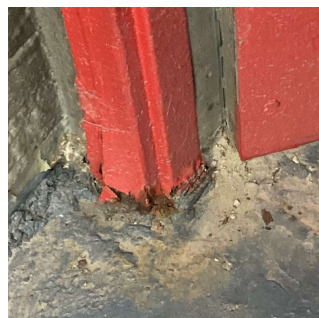
Question	Response
EXTERIOR	
COPING	Inspected
Deficiency	No deficiencies recorded
CORNICE	Inspected
Condition	2 - Between Good and Fair
Deficiency	No deficiencies recorded
DOORS	Inspected
DOORS AND FRAMES	Inspected
Condition	5 - Poor
Deficiency	METAL: DETERIORATED DOOR AND FRAME - MAJOR DETERIORATION
Roof Plan reference	<p>K932</p>

<p>Belmont Avenue</p> <p>Jerome Avenue</p>
Deficiency Quantity	1
Quantity Uom	EACH
Potential Action	REPLACE
Urgency of Action	PRIORITY 4
Purpose of Action	LEVEL 2
Deficiency Photo1

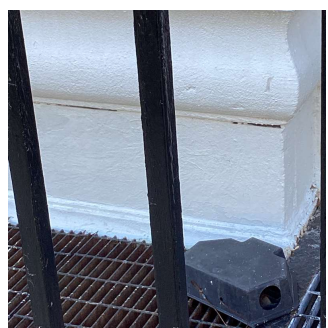
Question	Response
EXTERIOR	
EXTERIOR WALLS	
Instance Condition	3 - Fair
Instance Quantity	12,000
Instance Quantity Uom	S.F.
Deficiency	STONE: DETERIORATED JOINTS
Roof Plan reference	<p>K932</p>

Deficiency Quantity	10
Quantity Uom	L.F.
Potential Action	REPOINT
Urgency of Action	PRIORITY 4
Purpose of Action	LEVEL 2
Deficiency Photo1

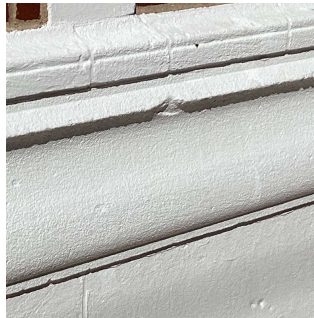
Facade A

Violations	Facade D No violations recorded.
Deficiency	STONE: CHIPPED/SPALLED/BROKEN PIECES - MINOR

Deficiency Quantity

10

Quantity Uom

S.F.

Potential Action

REPAIR

Urgency of Action

PRIORITY 3

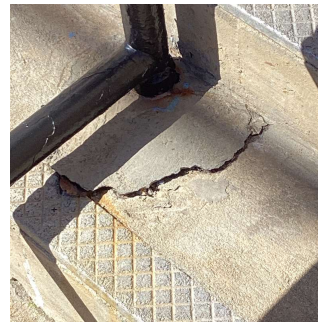
Facade A
No violations recorded.

Solar Panel Location (Roof Number)	Roof 1
Is/Are the roof(s) suitable for Solar Panel installation?	No
Installation Year	2024
Source of Installation	Custodial Staff
Deficiency	No deficiencies recorded
ROOFING DRAINS	Does not Exist
Specialties	Does not Exist
STAIRS/RAMPS: EXTERIOR	Inspected
BUILDING CHEEK/FLANK WALLS	Inspected
Condition	1 - Good
Deficiency	No deficiencies recorded
RAILINGS	Inspected
Condition	2 - Between Good and Fair
Deficiency	No deficiencies recorded
STAIRS/RAMPS	Inspected
Condition	3 - Fair
Deficiency	CONCRETE: CRACKS/SPALLING - MAJOR

Deficiency Quantity
Quantity Uom
Potential Action
Urgency of Action
Purpose of Action
Deficiency Photo1

10
S.F.
REPLACE
PRIORITY 4
LEVEL 2

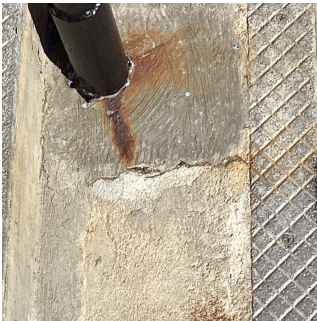
CONCRETE: CRACKS/SPALLING - MINOR

Deficiency Quantity
Quantity Uom
Potential Action
Urgency of Action
Purpose of Action

20
S.F.
REPAIR
PRIORITY 3
LEVEL 2

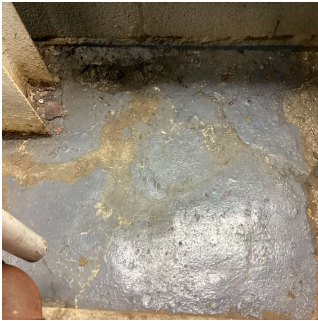
Violations	Facade A No violations recorded.
WINDOWS	Inspected
Replacement Quantity	2,600
Replacement Uom	S.F.
EXTERIOR GUARDS	Inspected
Condition	1 - Good
Deficiency	No deficiencies recorded
LINTELS	Inspected
Condition	2 - Between Good and Fair
Deficiency	No deficiencies recorded
WINDOWS	Inspected
Material Type(s)	Aluminum
Instance on Aluminum - Double Hung: All Facades	Inspected
Instance Condition	1 - Good
Instance Quantity	2,600
Instance Quantity Uom	S.F.
Are these windows insulated	Yes
Installation Year	2024
Source of Installation	Custodial Staff
Deficiency	No deficiencies recorded
INTERIOR	Inspected
POOLS	Does not Exist
STRUCTURAL	Inspected
COLUMNS/BEAMS/BEARING WALLS	Inspected
Condition	2 - Between Good and Fair
Deficiency	No deficiencies recorded
FLOOR STRUCTURE	Inspected
Condition	3 - Fair
Deficiency	CONCRETE SLAB ON GRADE: THRU CRACKS

Deficiency Location/Instance	Sub-Basement
Deficiency Quantity	25
Quantity Uom	S.F.
Potential Action	REPAIR
Urgency of Action	PRIORITY 3
Purpose of Action	LEVEL 5

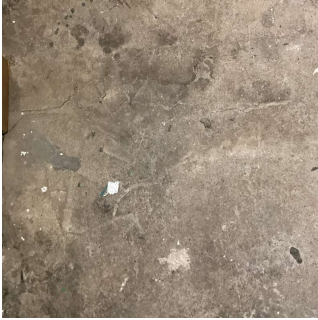
Boiler Room
Violations	No violations recorded.
Deficiency	CONCRETE: CRACKS/SPALLED/REINFORCEMENT EXPOSED
Deficiency Location/Instance	Basement
Deficiency Quantity	30
Quantity Uom	S.F.
Potential Action	REPAIR
Urgency of Action	PRIORITY 3
Purpose of Action	LEVEL 5
Deficiency Photo1

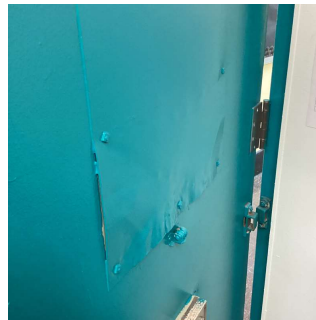
METAL: DETERIORATED DOOR

Deficiency Location/Instance

Room 205

Deficiency Quantity

1

Quantity Uom

EACH

Potential Action

MAINTENANCE

Urgency of Action

PRIORITY 3

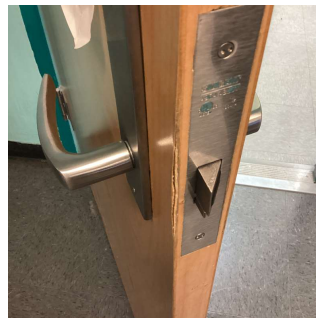
WOOD: DETERIORATED DOOR

Deficiency Location/Instance

Room 304

Deficiency Quantity

1

Quantity Uom

EACH

Potential Action

MAINTENANCE

Urgency of Action

PRIORITY 3

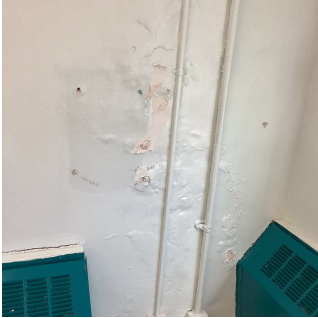
Violations	No violations recorded.
Walls	Inspected
Condition	2 - Between Good and Fair
Deficiency	PLASTER: CRACKS/SPALLING
Deficiency Location/Instance	Rooms 305, 306, Corridor near Room Main Entrance
Deficiency Quantity	50
Quantity Uom	S.F.
Potential Action	REPLACE
Urgency of Action	PRIORITY 3
Purpose of Action	LEVEL 2
Deficiency Photo1

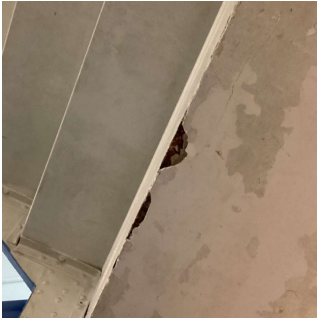
Question	Response
INTERIOR	
STAIRS/RAMPS: INTERIOR	
Ceiling	
Deficiency	PLASTER: CRACKS/SPALLING
Deficiency Location/Instance	Stair D/1
Deficiency Quantity	10
Quantity Uom	S.F.
Potential Action	REPLACE
Urgency of Action	PRIORITY 3
Purpose of Action	LEVEL 2
Deficiency Photo1

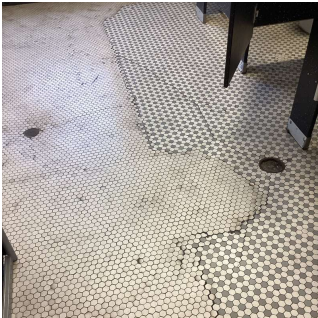
Question	Response
INTERIOR	
STAIRS/RAMPS: INTERIOR	
Stairs and Landings	
Deficiency Quantity	100
Quantity Uom	S.F.
Potential Action	REPLACE
Urgency of Action	PRIORITY 3
Purpose of Action	LEVEL 2
Deficiency Photo1	 
Violations	Lobby Grand Stair No violations recorded.
Walls	Inspected
Condition	2 - Between Good and Fair
Deficiency	PLASTER: CRACKS/SPALLING
Deficiency Location/Instance	Stair D/Basement
Deficiency Quantity	30
Quantity Uom	S.F.
Potential Action	REPLACE
Urgency of Action	PRIORITY 3
Purpose of Action	LEVEL 2
Deficiency Photo1	 
Violations	Stair D/Basement No violations recorded.
TOILET ROOMS - STAFF	
Inspected	
Ceiling	
Inspected	
Condition	2 - Between Good and Fair
Deficiency	No deficiencies recorded
Door(s)	
Inspected	
Condition	2 - Between Good and Fair
Deficiency	No deficiencies recorded
Floor Finish	
Inspected	
Condition	5 - Poor
Deficiency	CERAMIC TILE: DETERIORATED SUBSTRATE
Deficiency Location/Instance	2nd Floor Staff

Question	Response
INTERIOR	
TOILET ROOMS - STAFF	
Floor Finish	
Deficiency Quantity	50
Quantity Uom	S.F.
Potential Action	REPLACE
Urgency of Action	PRIORITY 3
Purpose of Action	LEVEL 2
Deficiency Photo1

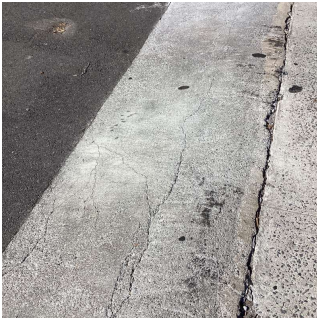
Schoolyard	No violations recorded.
Violations	
Concrete	Inspected
Condition	2 - Between Good and Fair
Deficiency	CRACKS - MAJOR
Deficiency Location/Instance	Schoolyard
Deficiency Quantity	30
Quantity Uom	S.F.
Potential Action	REPLACE
Urgency of Action	PRIORITY 3
Purpose of Action	LEVEL 2
