NYC Department of Education
Building Condition Assessment Survey 2023 - 2024

Architectural Inspection

Asset: FORT HAMILTON HS MODULAR UNIT - K, 8301 SHORE ROAD, New York, 11209

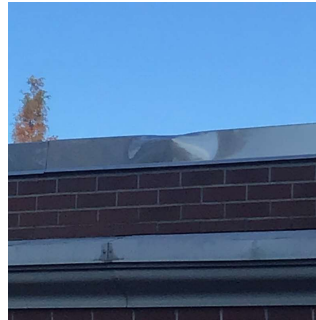
Facade E

Deficiency METAL: DETERIORATED

REPLACE-IN-KIND

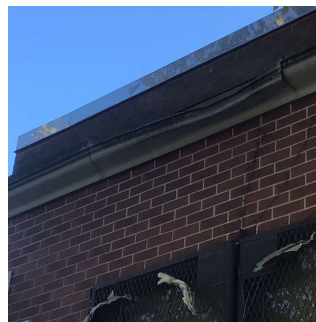
Facade D

METAL: DETERIORATED

REPLACE

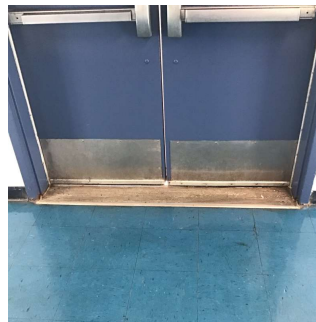
Facade C - Exit 85B

METAL: DETERIORATED DOOR - MINOR DETERIORATION

3
EACH
MAINTENANCE
PRIORITY 3
LEVEL 2

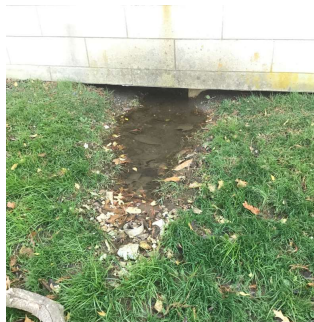
CONCRETE MASONRY UNIT: DETERIORATED MASONRY SILLS - MAJOR

Facade F - Missing CMU Section

REMOVE AND REPLACE

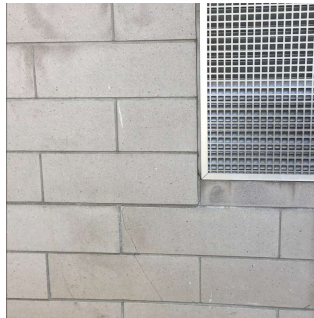
Facade D

CONCRETE MASONRY UNIT: MINOR CRACKS AND SPALLING

RESTITCH

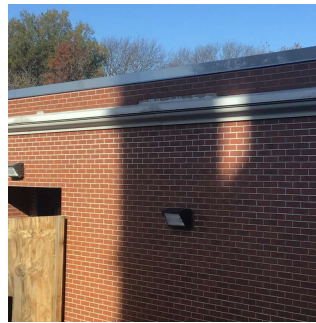
Facade D

BRICK: MINOR CRACKS AND SPALLING

RESTITCH

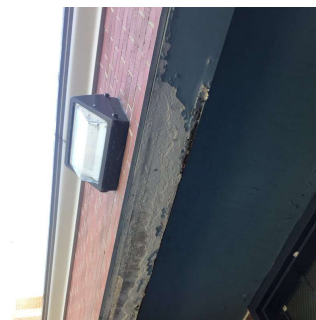
Facade A - Exit 85A

STUCCO/PLASTER: MINOR CRACKS/SPALLING

10
S.F.
REPAIR
PRIORITY 3
LEVEL 2

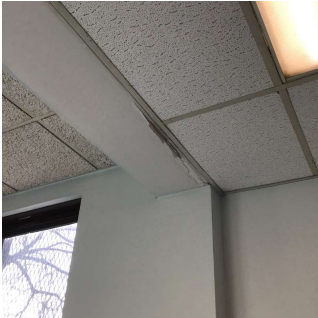
Ceiling	Inspected
Condition	2 - Between Good and Fair
Deficiency	GYPSUM BOARD: DAMAGED/DETERIORATED
Deficiency Location/Instance	Corridor near Exit 85B
Deficiency Quantity	10
Quantity Uom	S.F.
Potential Action	REPLACE
Urgency of Action	PRIORITY 3
Purpose of Action	LEVEL 2
Deficiency Photo1

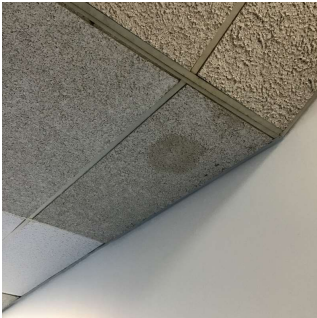
Question	Response
INTERIOR	
CLASSROOMS/CORRIDORS/ADMIN SPACES	
Ceiling	
Violations	Corridor near Exit 85B No violations recorded.
Deficiency	ACOUSTIC TILES: DAMAGED/MISSING
Deficiency Location/Instance	Near Exits 83A, 85A, Corridor near Room 860
Deficiency Quantity	30
Quantity Uom	S.F.
Potential Action	REPLACE
Urgency of Action	PRIORITY 3
Purpose of Action	LEVEL 2
Deficiency Photo1

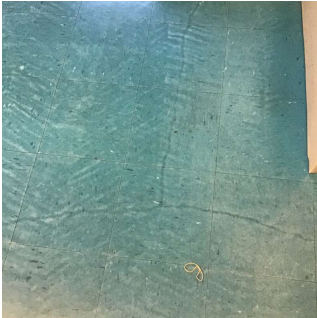
Violations	Near Exit 83A No violations recorded.
Door(s)	Inspected
Condition	2 - Between Good and Fair
Deficiency	No deficiencies recorded
Floor Finish	Inspected
Condition	2 - Between Good and Fair
Deficiency	VINYL TILES: DETERIORATED SUBSTRATE
Deficiency Location/Instance	Rooms 863, 839, Corridor near Rooms 835, 839, and others
Deficiency Quantity	100
Quantity Uom	S.F.
Potential Action	REPLACE
Urgency of Action	PRIORITY 3
Purpose of Action	LEVEL 2
Deficiency Photo1

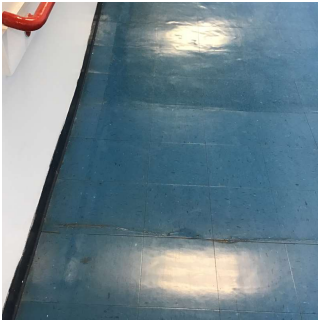
Question	Response
INTERIOR	
LOCKER ROOM	Does not Exist
MULTI-PURPOSE ROOM	Does not Exist
SCIENCE DEMO ROOM	Does not Exist
SCIENCE LAB	Does not Exist
SCIENCE PREP ROOM	Does not Exist
SHOWER ROOM	Does not Exist
STAIRS/RAMPS: INTERIOR	Inspected
Do Letter Stair Signs Exist?	No
Ceiling	Not Required
Door(s)	Does not Exist
Partition	Does not Exist
Railings	Inspected
Condition	2 - Between Good and Fair
Deficiency	No deficiencies recorded
Stairs and Landings	Inspected
Condition	5 - Poor
Deficiency	VINYL TILES: DETERIORATED SUBSTRATE
Deficiency Location/Instance	Corridor Ramp Near Exit 83D, Corridor Ramp Near Exit 85B
Deficiency Quantity	20
Quantity Uom	S.F.
Potential Action	REPLACE
Urgency of Action	PRIORITY 3
Purpose of Action	LEVEL 2
Deficiency Photo1

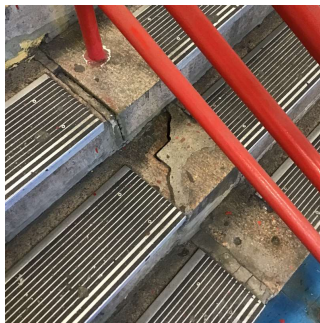
Corridor Ramp Near Exit 83D	
Violations	No violations recorded.
Deficiency	STONE: BROKEN/MISSING
Deficiency Location/Instance	Near Exits 83A, 85A
Deficiency Quantity	50
Quantity Uom	S.F.

Potential Action	REPLACE
Urgency of Action	PRIORITY 3
Purpose of Action	LEVEL 2

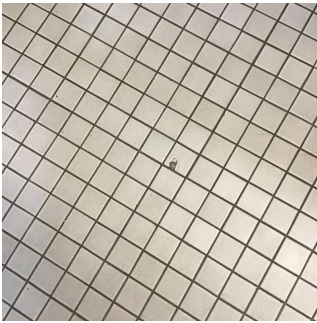
Near Exit 83A
Violations	No violations recorded.
Walls	Not Required
TOILET ROOMS - STAFF	
	Inspected
Ceiling	Inspected
Condition	2 - Between Good and Fair
Deficiency	No deficiencies recorded
Door(s)	Inspected
Condition	2 - Between Good and Fair
Deficiency	No deficiencies recorded
Floor Finish	Inspected
Condition	2 - Between Good and Fair
Deficiency	No deficiencies recorded
Stalls	Does not Exist
Walls	Inspected
Condition	2 - Between Good and Fair
Deficiency	No deficiencies recorded
TOILET ROOMS - STUDENTS	
	Inspected
Ceiling	Inspected
Condition	2 - Between Good and Fair
Deficiency	No deficiencies recorded
Door(s)	Inspected
Condition	2 - Between Good and Fair
Deficiency	No deficiencies recorded
Floor Finish	Inspected
Condition	2 - Between Good and Fair
Deficiency	CERAMIC TILE: BROKEN/MISSING TILES
Deficiency Location/Instance	Room 854

Deficiency Quantity	10
Quantity Uom	S.F.
Potential Action	REPLACE
Urgency of Action	PRIORITY 3
Purpose of Action	LEVEL 2
