NYC Department of Education
Building Condition Assessment Survey 2023 - 2024

Architectural Inspection

K940

Asset: I.S. 30 - BROOKLYN, 415 OVINGTON AVE, New York, 11209

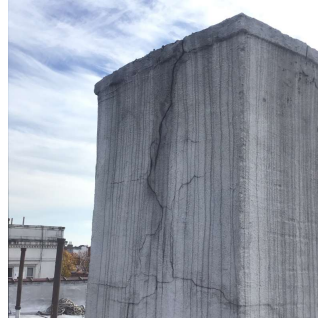
Roof 1 - CH

Deficiency CONCRETE MASONRY UNIT: MAJOR / THRU CRACKS

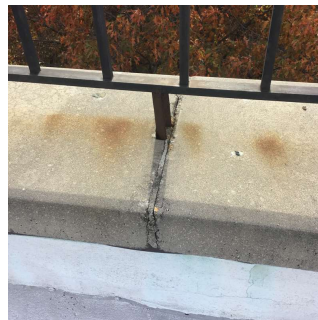
Roof 1 - Facade A

CAST STONE: DETERIORATED TRANSVERSE JOINTS

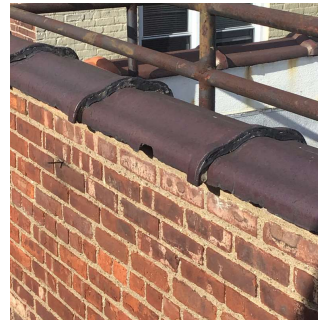
Roof 1 - Facade B

TERRA COTTA: CRACKED/BROKEN PIECES

REPLACE-IN-KIND

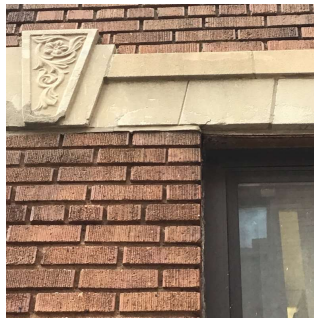
STONE: CHIPPED/SPALLED/BROKEN PIECES - MINOR

REPAIR

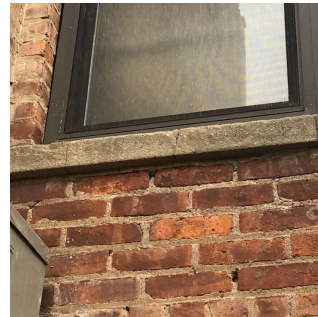
Facade B

BRICK: DETERIORATED MASONRY SILLS - MINOR

REPAIR

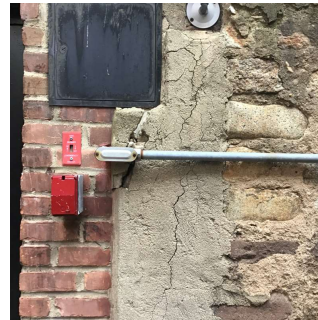
Facade B

**CAST IN PLACE / PRE-CAST CONCRETE: MAJOR
CRACKS/SPALLING**

REPLACE

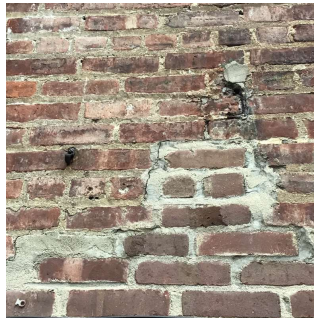
Facade B

BRICK: MINOR CRACKS AND SPALLING

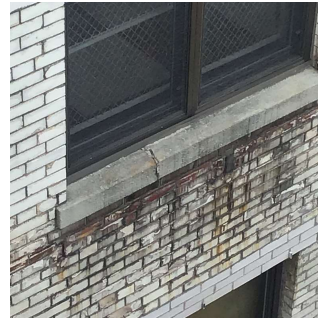
Facade E

BRICK: DETERIORATED MASONRY SILLS - MAJOR

REMOVE AND REPLACE

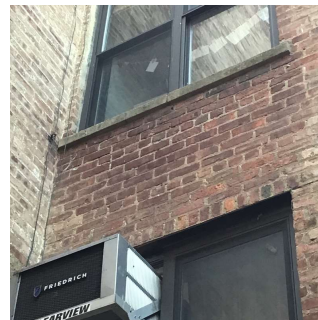
Facade B

BRICK: DETERIORATED JOINTS

500
S.F.
REPOINT
PRIORITY 3
LEVEL 2

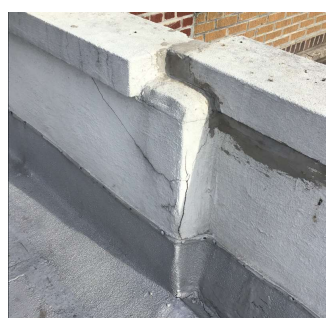
Question	Response
EXTERIOR	
PARAPETS	
Instance Condition	3 - Fair
Instance Quantity	1,500
Instance Quantity Uom	C.F.
Deficiency	CONCRETE: MINOR CRACKS, SPALLING
Roof Plan reference	<p>K940</p>

Deficiency Quantity	100
Quantity Uom	S.F.
Potential Action	REPAIR
Urgency of Action	PRIORITY 3
Purpose of Action	LEVEL 2
Deficiency Photo1

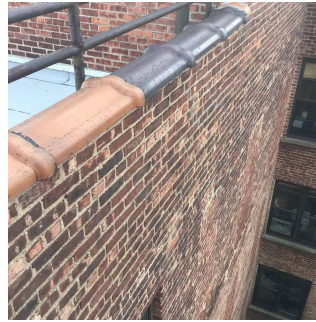
Roof 1 - Facade B

Violations	Roof 1 - Facade D No violations recorded.
Deficiency	BRICK: DETERIORATED JOINTS
Roof Plan reference	<p>K940</p>

Deficiency Quantity	200
Quantity Uom	S.F.
Potential Action	REPOINT
Urgency of Action	PRIORITY 3
Purpose of Action	LEVEL 2

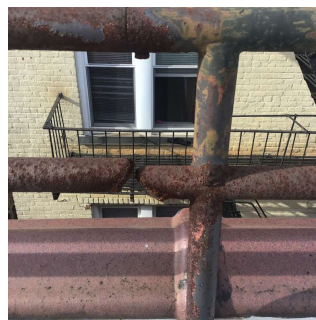
Roof 1 - Facade B

RAILINGS/PANELS: DETERIORATED, MAJOR RUSTING

REPLACE

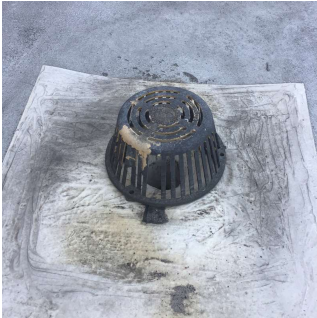
Violations	Roof 1 No violations recorded.
ROOFING DRAINS	
Condition	Inspected 5 - Poor
Deficiency	DETERIORATED
Roof Plan reference	K940

Deficiency Quantity	3
Quantity Uom	EACH
Potential Action	REPLACE
Urgency of Action	PRIORITY 4
Purpose of Action	LEVEL 2
Deficiency Photo1

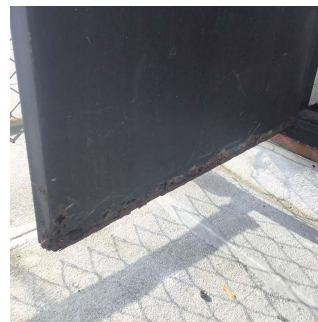
BH1
No violations recorded.

Violations	Roof 1 - Near BH2 No violations recorded.
Specialties	
BULKHEAD/PENTHOUSE	
Condition	Inspected 3 - Fair
Deficiency	BULKHEAD/PENTHOUSE DOORS: DETERIORATED DOOR

2
EACH
REPLACE DOOR
PRIORITY 3
LEVEL 2

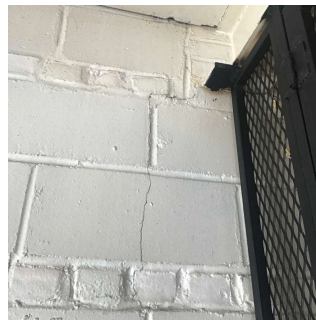
BH1

**BULKHEAD/PENTHOUSE WALLS/INTERIOR: CMU
CRACKS/SPALLING**

REPLACE

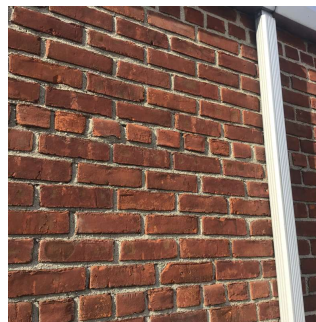
BH1

**BULKHEAD/PENTHOUSE WALLS/EXTERIOR: DETERIORATED
JOINTS**

500
S.F.
REPOINT
PRIORITY 3
LEVEL 2

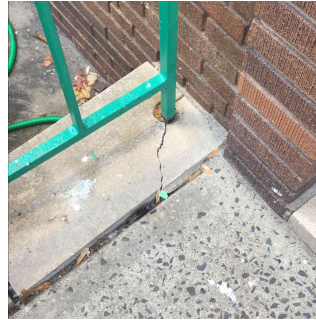
Facade A - Main Entrance

BRICK: DETERIORATED COPING STONE

S.F.
 REPLACE
 PRIORITY 4
 LEVEL 2

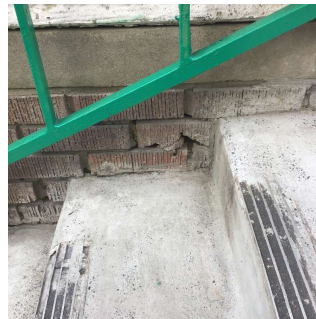
Facade A

BRICK: CRACKS/SPALLING - MAJOR

10
 S.F.
 REPLACE
 PRIORITY 4
 LEVEL 2

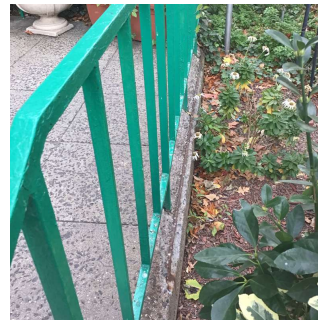
Facade A - Main Entrance

CONCRETE: CRACKS/SPALLING - MAJOR

REPLACE

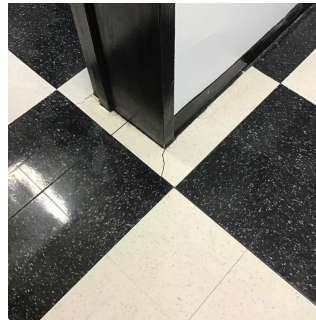
Corridor near Stair A/4

VINYL TILES: BROKEN/DETERIORATED/MISSING TILES

REPLACE

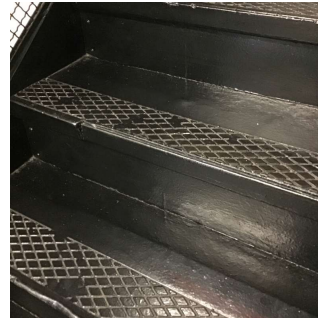
Stair B/2

SHEET VINYL: BROKEN/DETERIORATED

REPLACE

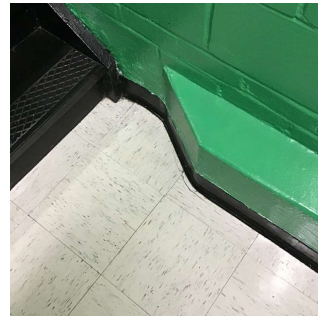
VINYL TILES: BROKEN/DETERIORATED/MISSING TILES

REPLACE

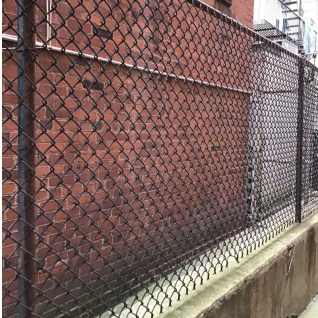
Priority Condition Exist Last Year?	Priority Category	Condition Description	Component Affected	Location Description	Person(s) Notified	Person(s) Title	PhotoImage
Yes	Potential Falling Debris	Leaning Fence is a potential safety hazard.	SITE FENCES	Rear of the Building	Juan Otero	Cleaner

Question	Response
SITE	
FENCES	
Deficiency Quantity	150
Quantity Uom	S.F.
Potential Action	REPLACE
Urgency of Action	PRIORITY 3
Purpose of Action	LEVEL 2
Deficiency Photo1
